"2007" SEMINAR INFORMATION

GM & Ford

"Tech is Rev'n in 2007"

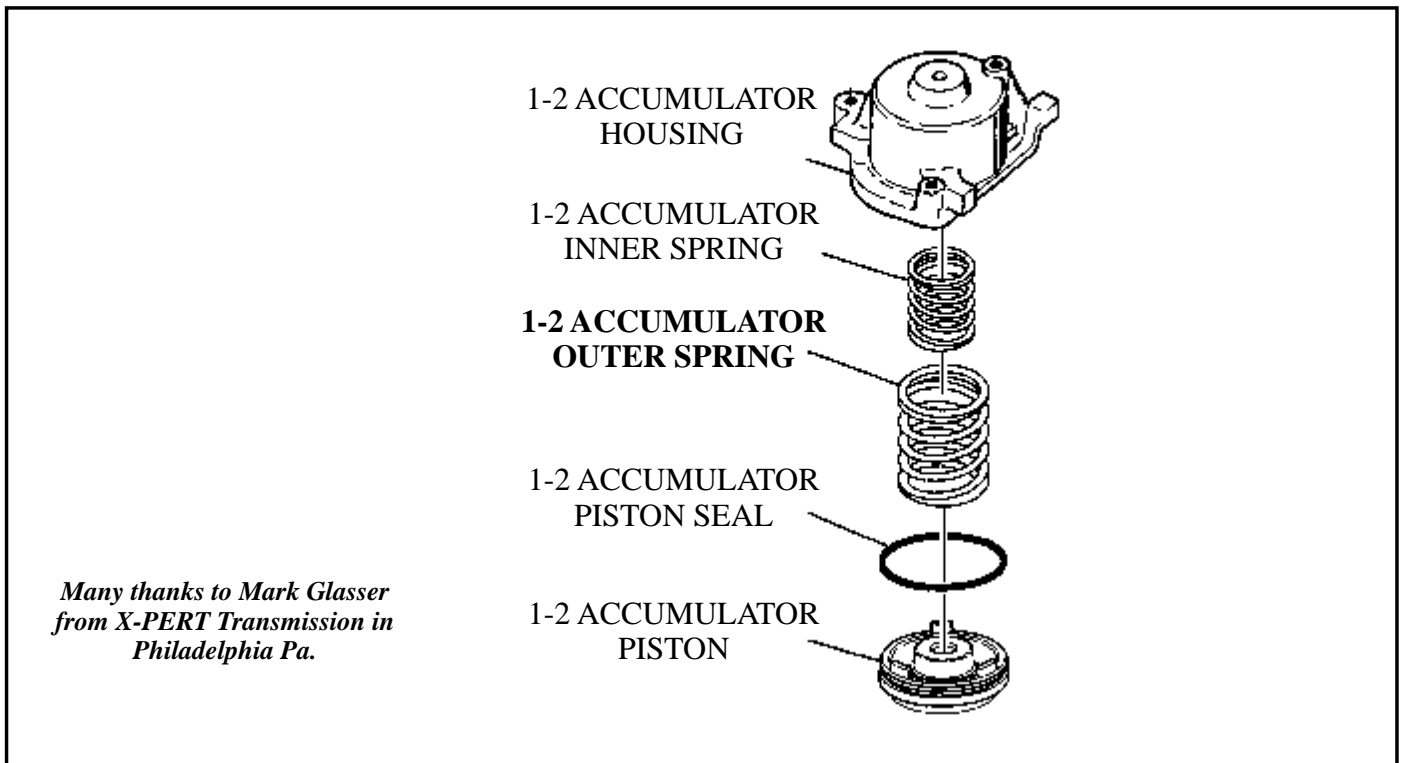
Figure 1

CAUSE: The 1-2 accumulator spring rate may be one cause of the problem.

CORRECTION: Check and verify that there are no line pressure and rise problems that may indicate a faulty pressure control solenoid, worn boost valve sleeve in the oil pump cover or actuator feed limit valve bore wear problem in the valve body.
Check for a sticking accumulator valve in the valve body.
Check servo apply pin length and 1-2 accumulator assembly for piston or pin wear and repair or replace as necessary.
If all of the previous checks indicate no problems then the complaint may be resolved by removing the outer accumulator spring and replacing it with a much lighter spring.
A suitable replacement may be found from an earlier version 700R4/4L60 transmission 1-2 or 3-4 accumulator. (See figure 1)

Note: *This only applies to 1-2 accumulators with double springs and the piston arrangement as shown in figure 1.*

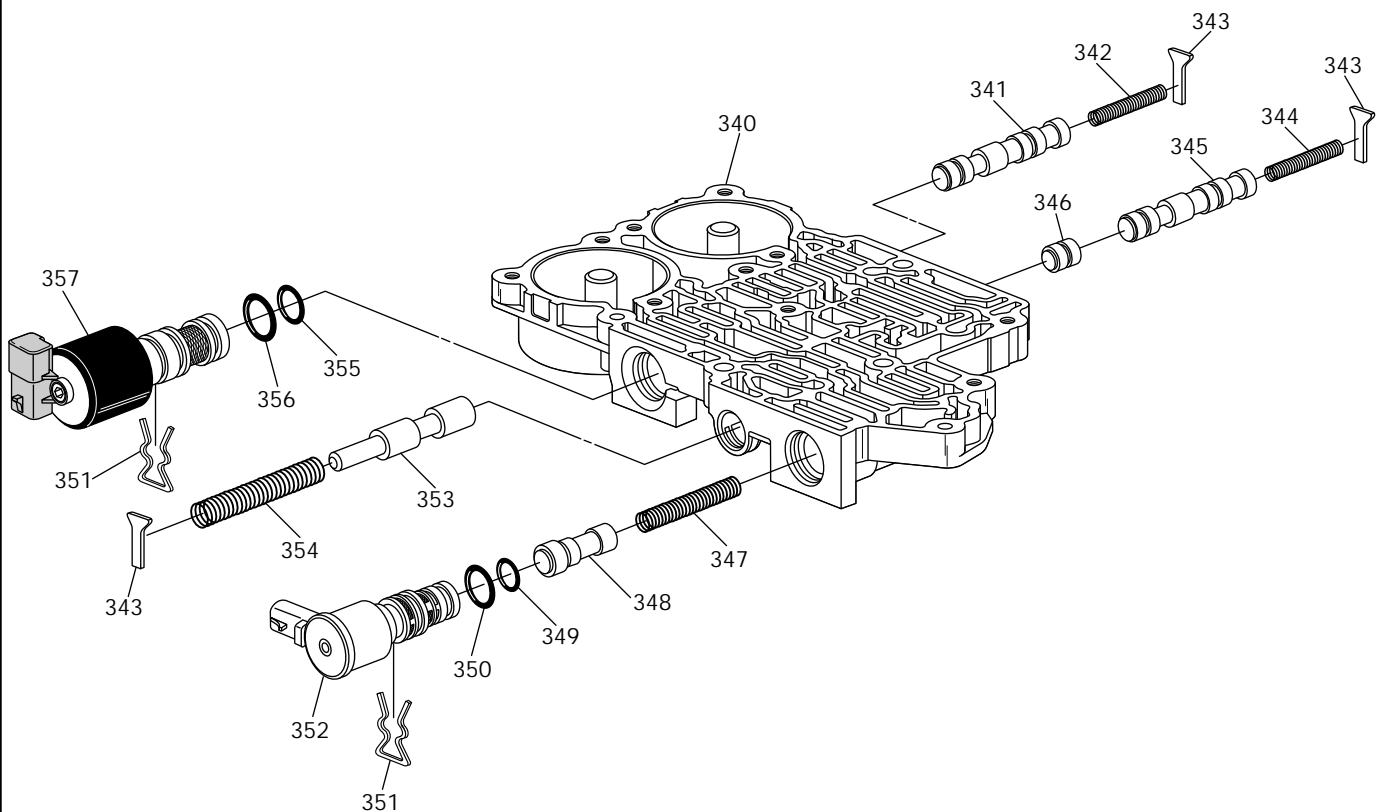
Figure 3

CAUSE: One cause may be a restricted or flooded TCC PWM SOLENOID. Oil pressure from the manual valve is directed to the TCC PWM Solenoid in 2nd, 3rd, 4th, 5th, and Reverse gears. If the solenoid becomes restricted in Reverse, oil pressure can build up and cause the REVERSE LOCKOUT VALVE to stroke in the valve body, and prevent the reverse clutch from applying, leaving the vehicle with no reverse engagement. Refer to Figures 1 and 2 for a partial hydraulic schematic of the PWM Solenoid and the Reverse Lockout Valve.

CORRECTION: Replace the TCC Pwm Solenoid and verify the Reverse Lockout valve is not stuck. Refer to Figures 3 and 4 for the location of the Solenoid and the Reverse Lockout Valve-train.

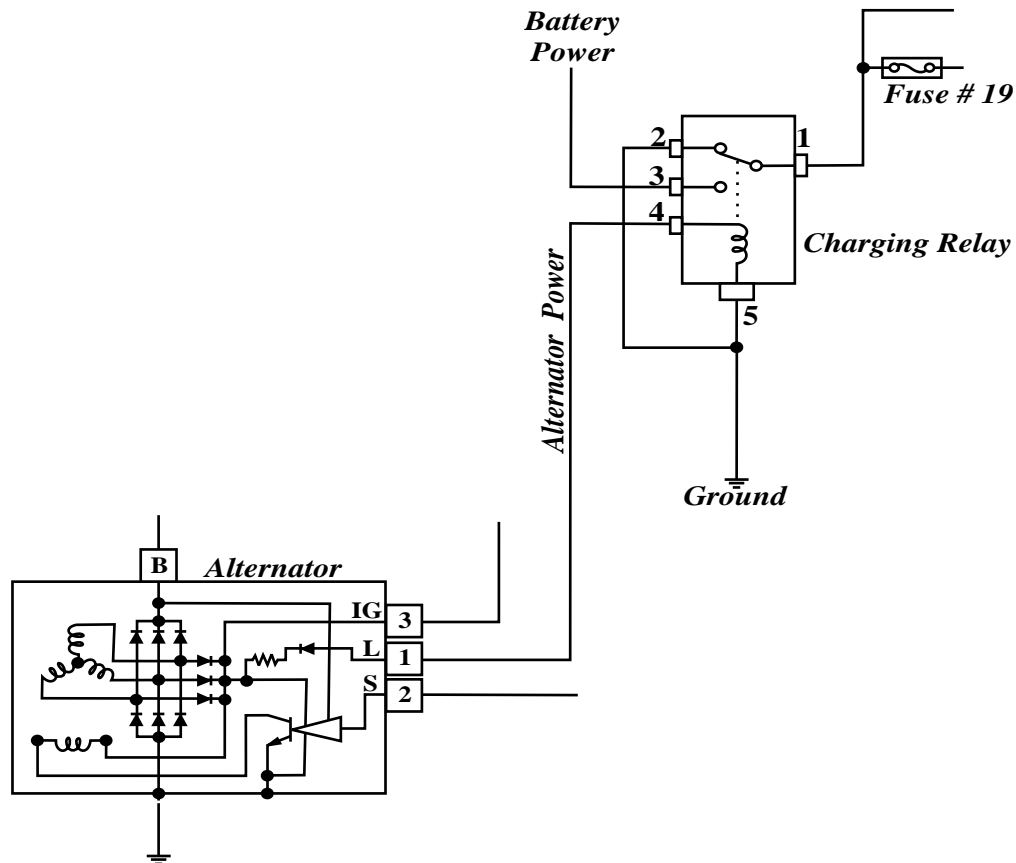
Figure 3

CORRECTION: When the charging relay acts as a ground, the alternator may be bad, the wire from terminal 1 at the alternator to terminal 4 of the charging relay is broken or the relay is malfunctioning. The relay will not interchange with any other relay in the underdash fuse box which is why it is the only BLUE colored relay in the panel as shown in Figure 4. Replace the relay or repair the broken wire.

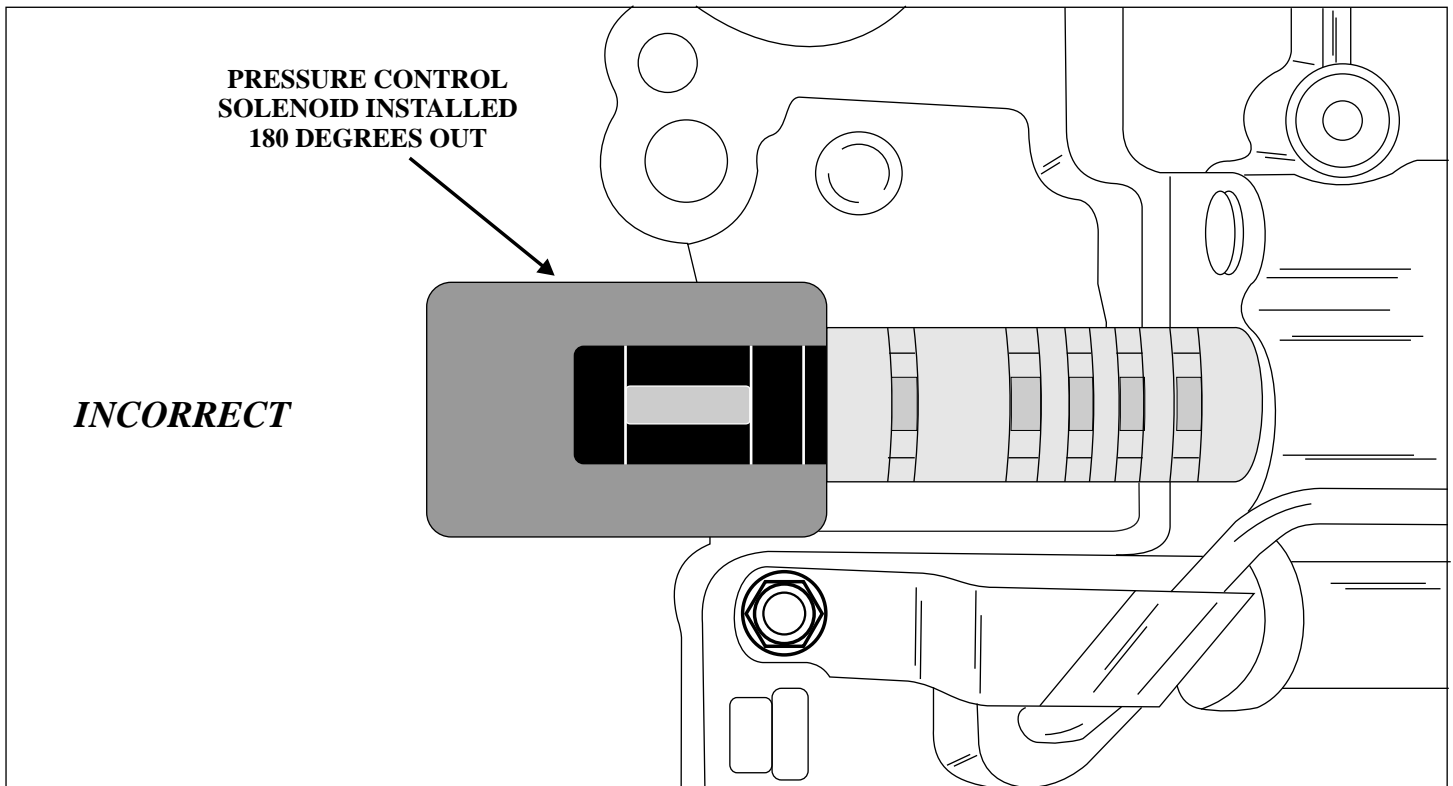
Figure 1

CAUSE: The pressure control solenoid has been installed 180 degrees out as shown in Figures 1 and 2.
