Yellow River		co-0819-001	Severity Score 1																																																																																
<u>Common:</u> 3.4mi SW of Horn Hill <u>Drainage:</u> Blackwater Bay <u>GPS:</u> 31.210386, -86.357481 <u>Land owner:</u> LB: Rayonier Woodlands LLC/ RB: T. Ivey Powell & Sons Inc		<u>County:</u> Covington <u>State:</u> Alabama <u>PLSS:</u> 3N-17E-21 <u>Parcel No.:</u> 4/3

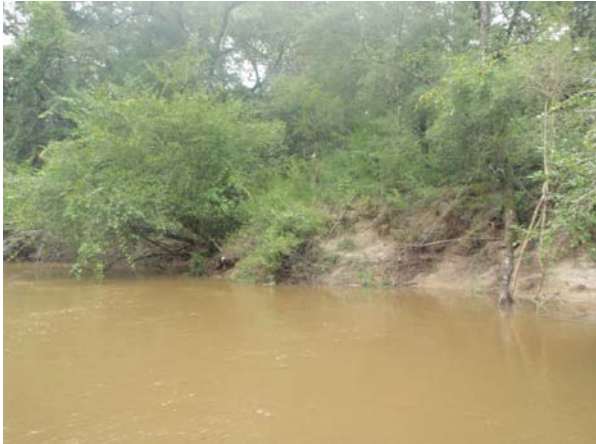
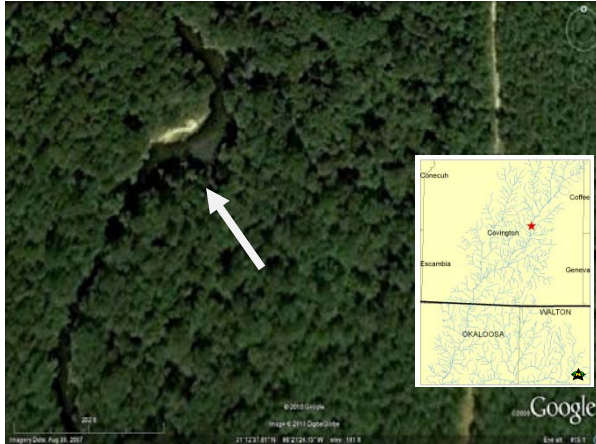
Notes: Some erosion, but may be a natural meander incision.
