Five Runs Creek		co-0923-003	Severity Score 3.75																																																																																
<u>Common:</u> 9.6mi S of Andalusia <u>Drainage:</u> Yellow River <u>GPS:</u> 31.16969204, -86.484788179 <u>Land owner:</u> U.S.A- Conecuh Nat. Forest		<u>County:</u> Covington <u>State:</u> Alabama <u>PLSS(T-R-S):</u> 2N-16E-6 <u>Parcel No.:</u> 1

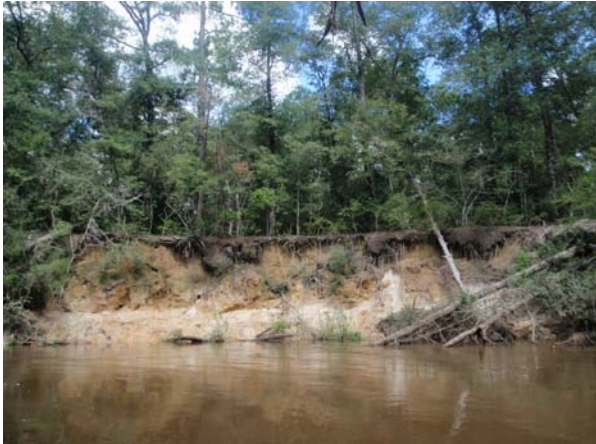
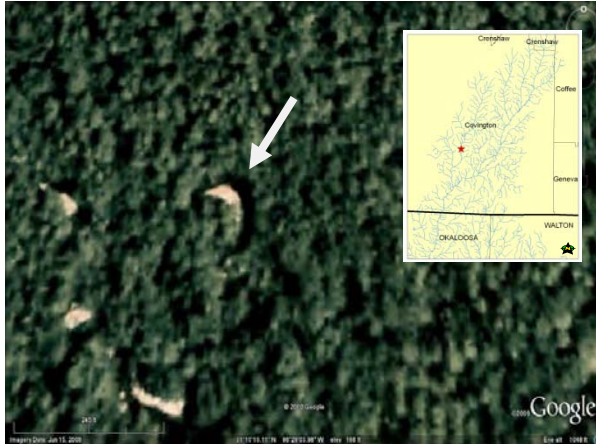
Notes: Active erosion but with some new growth on bank.
