| Gum Creek | | | wa-1026-004 | | Severity Score 2.25 | |
| <u>Common:</u> 7.7mi NW of DeFuniak Springs <u>Drainage:</u> Shoal River <u>GPS:</u> 30.782837831, -86.22350037 <u>Land owner:</u> Victoria Arlene Trustee | | | <u>County:</u> Walton <u>PLSS:</u> 3N-20W-2/3 <u>Parcel No.:</u> 7; 1 | | <u>State:</u> Florida | |

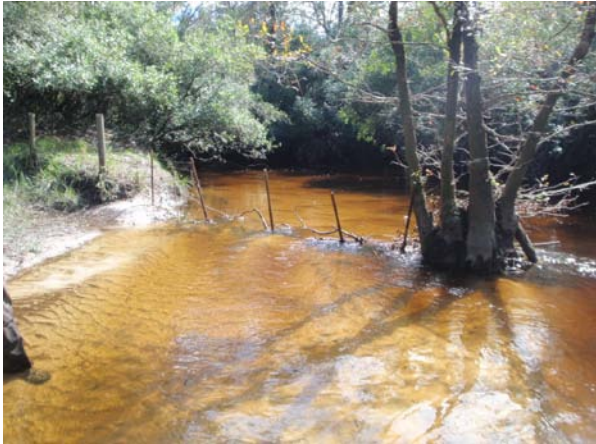
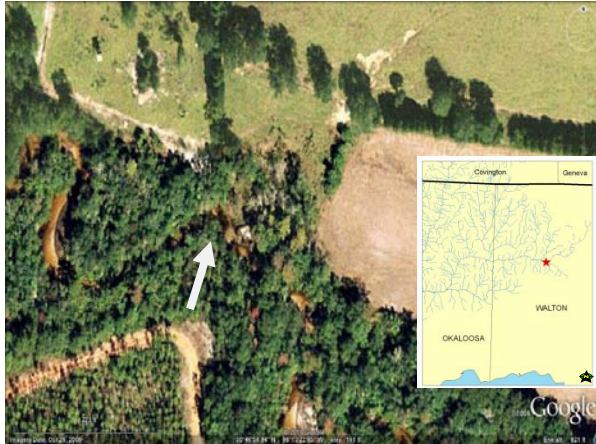
| Gum Creek | | | wa-1026-004 | | Severity Score 2.25 | |
|--|---|---|---|---|--|--|
| US | | | | | | |

Notes: Old fence in stream and small creek on right bank.

Appears to be an access point for livestock, but there are none currently around.
