Inappropriate Implantable Cardioverter-Defibrillator Therapy During Surgery: An Important and Preventable Complication

Marc A. Rozner, PhD, MD^{*,†}, Edward A. Kahl, MD[‡],
Peter M. Schulman, MD[‡]

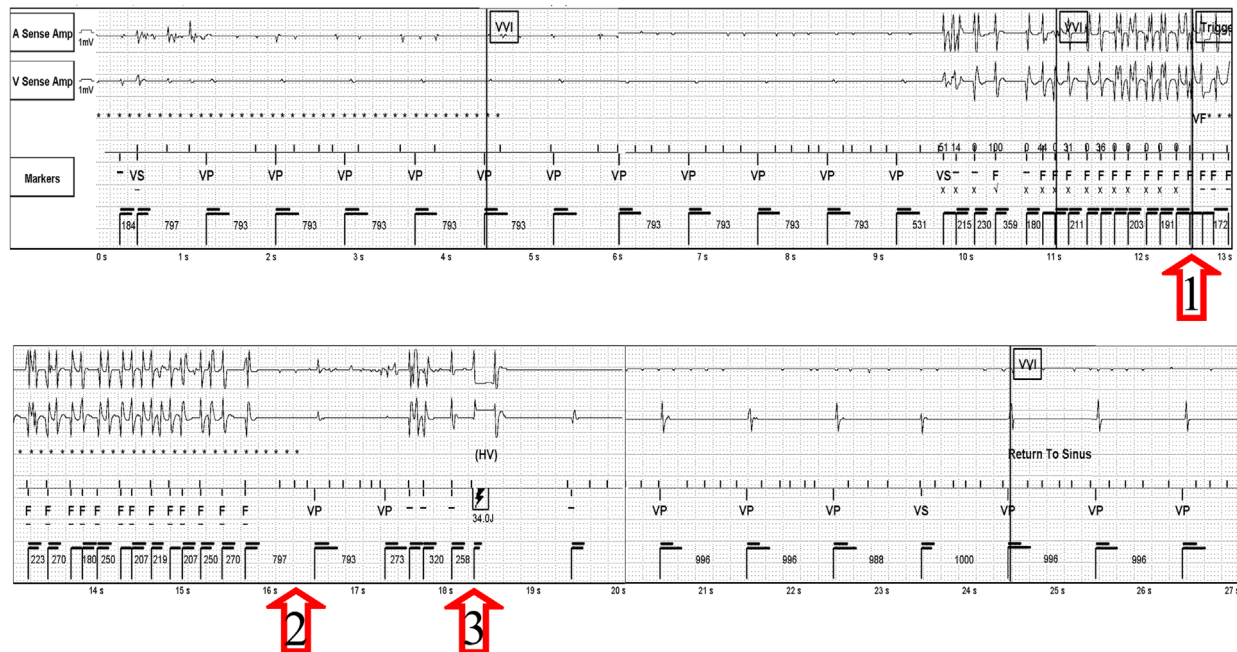
Fig 2. Electromagnetic interference (EMI), sensed by the implantable cardioverter-defibrillator (ICD) as ventricular fibrillation, instigating a 34-joule shock. The ICD treatment record shows an aborted charge followed by another round of EMI leading to a shock. Recordings (top to bottom) are atrial electrogram, ventricular electrogram, markers (reflecting the ICD decision tree), ventricular timing data (milliseconds), and elapsed time (in seconds). Above the marker line are vertical hash marks identifying the atrial signal (atrial fibrillation), and the small numbers represent the percent match to normal QRS morphology. The symbols immediately below the marker line show the ventricular classification (see the following). The paper speed was 25 mm/sec. *** from time 0 to 4.6 seconds reflects ICD charging due to a ventricular fibrillation (VF) detection with ICD activation that did not deliver a shock because the EMI transiently stopped. Resumption of the EMI at 9.6 seconds led to a second charge at 12.5 seconds (red arrow 1). The charge cycle finished at 16.5 seconds (red arrow 2). The EMI again ended, but a short burst at 17.6 seconds during the rhythm reconfirm period caused the ICD to deliver a shock (red arrow 3). -, ventricular event that could not be characterized because of discrepancy between the average calculated rate over the last 4 events and the short interval from the previous V sense (however, the measured V-V interval is used in the calculation of average V rate); F, a ventricular event falling into the VF zone by timing; (HV), delivery of a shock; "Return To Sinus," the end of the episode; VS, ventricular sense; VP, ventricular pace.

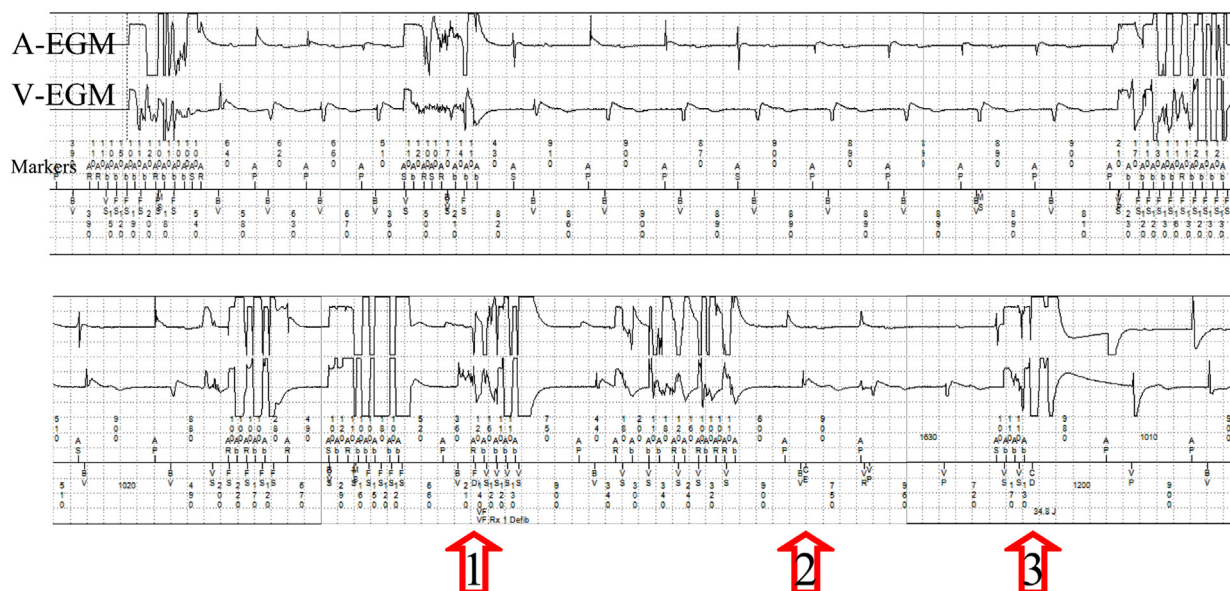
A 62-year-old man with a Medtronic (Minneapolis, MN) D224TRK biventricular ICD and suspected ICD pocket infection presented for pocket exploration, debridement, and repositioning of the ICD to a subpectoral location. The ICD was not examined or reprogrammed preoperatively. No magnet was placed. Instead, short bursts of monopolar electrosurgery were planned to mitigate the risk of EMI and prevent unwanted pacing inhibition and ICD firing. In the operating room, a "whole-body electrode" (Megadyne Mega Soft dual-cord patient return electrode system [Draper, UT]) was placed. Soon after the surgical incision, an ICD shock caused apparent patient movement. The patient remained hemodynamically stable in an A-V sequentially paced rhythm. The surgical care team then reprogrammed the ICD to disable its high-energy therapy. At the conclusion of the procedure, ICD high-energy therapy was restored, the patient's airway was extubated, and the patient was taken to the recovery room in stable condition. Postoperative examination revealed the following programmed parameters (mode: VVE-DDDRV): Lower pacing rate limit: 60 beats/min; upper pacing tracking rate: 120 beats/min; upper pacing sensor rate: 120 beats/min; and ATP or shock rate > 182 beats/min.

The stored shock electrogram (Fig 3) shows a "ventricular fibrillation (VF)" event at the 6th short burst of EMI. The additional short bursts of EMI during capacitor charging and the VF reconfirm period led to the inappropriate shock.

Fig 3. Short bursts of monopolar electrosurgery do not protect against implantable cardioverter-defibrillator (ICD) shocks. Short bursts of electromagnetic interference (EMI) during surgery resulting from monopolar electrosurgery were sensed by the ICD as atrial fibrillation, ventricular tachycardia, and ventricular fibrillation. At the sixth “burst” of EMI (red arrow 1), the ICD declared a “VF” event and began charging, likely due to the relative periods of EMI on and EMI off, which did not allow the VT/VF counters to completely clear. About 3.9 seconds later, the ICD completed the charge (“CE,” red arrow 2) and began the “reconfirm period.” The EMI during the charge cycle and again 2.3 seconds after CE led to the delivery of a 34.8-joule shock (“CD,” red arrow 3). Recordings (top to bottom) are atrial electrogram, right ventricular electrogram, and markers (atrial markers above the line, ventricular markers below the line) reflecting the ICD decision tree. The numbers reflect the time between 2 adjacent events in milliseconds. The paper speed was 25 mm/sec. Ab, atrial event in the “blanking period” and thus completely ignored by the ICD; AP, atrial pace; AR, atrial event sensed during the postventricular refractory period and therefore not tracked into the ventricle or any atrial event occurring after an appropriately sensed atrial event but before any ventricular event (these events are counted for mode switch determination); AS, atrial sense; BV, biventricular (ie, both right and left ventricular) pace; CD, delivery of high-energy (shock) therapy; CE, end of the ICD charge cycle and beginning of the reconfirm period; FD, tachydysrhythmia episode declaration in the VF zone—initiation of an ICD charge cycle; FS, ventricular sensed event occurring in the VF timeframe; MS, entry into or out of the “mode switch” mode—during MS, the ICD acts as if the pacing mode is DDI rather than DDD; TS, ventricular sensed event occurring in the VT timeframe; VP, ventricular pace; VR, any ventricular event occurring in a nonphysiologic window and that does not inhibit the next expected ventricular pace; VR-VP, a ventricular-sensed event occurring in the safety or crosstalk window that results in a VP approximately 60 milliseconds later; VS, ventricular sense.

Before any elective procedure, the perioperative care team should verify proper ICD function and obtain a prescription from a CIED expert for the perioperative management of the device because not all CIEDs operate correctly.¹⁹ A plan should be developed and carried out for mitigating intraoperative EMI, which might include either ICD reprogramming or the application of a magnet (if appropriate). For some patients, selection of surgical instruments (eg, bipolar electrosurgery or ultrasonic devices) that will not create EMI might be appropriate. Furthermore, the electrosurgery dispersive electrode should be positioned appropriately to prevent the presumed electrosurgery unit current path from crossing the chest and ICD circuitry. Testing of newer equipment, such as the whole-body dispersive electrode, to determine whether it should be used during surgery in the patient with a CIED should take place. In addition, practitioners should not rely solely on the use of short bursts of monopolar electrosurgery; this strategy failed to protect the patient in case 3 from shock because the VT/VF counters were incremented quickly based on the high-frequency EMI but only slowly decremented based on the paced rate of 75 beats/min (800-millisecond cycles).
