Use Caution When Applying Magnets to Pacemakers or Defibrillators for Surgery

Peter M. Schulman, MD* and Marc A. Rozner, PhD, MD†

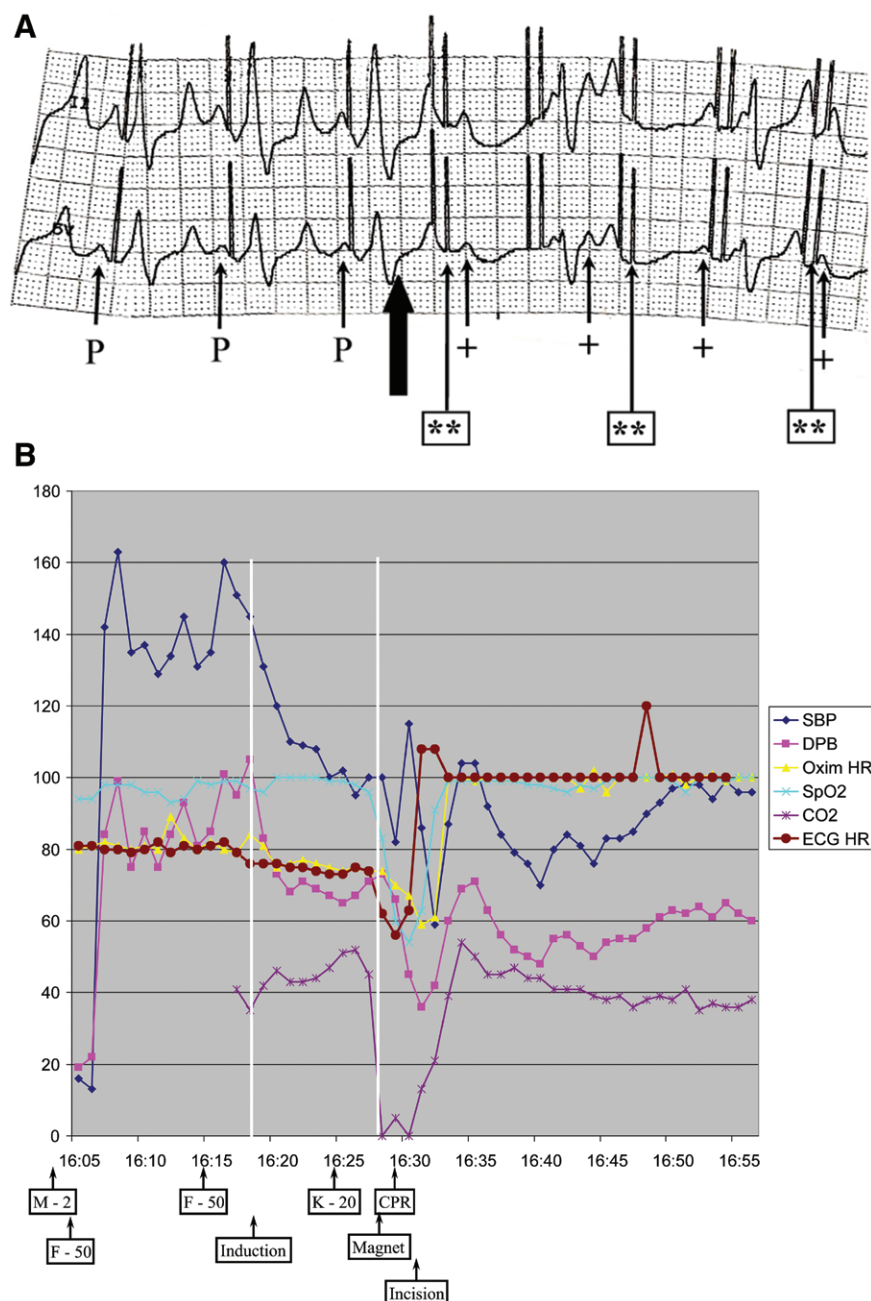
100 bpm. As his vital signs deteriorated, cardiopulmonary resuscitation was commenced, quickly followed by emergent minithoracotomy with improvement of conditions. Postoperative review of the electronic anesthetic record and electroencephalogram tracing at magnet application (Fig. 1, A and B) found magnet application, as expected, initiated asynchronous AV pacing at 100 bpm. However, complete failure of atrial capture and ventricular noncapture every other pace (ventricular electrical alternans) effectively converted the previously AV synchronous activity at 75 bpm to ventricular-only pacing at 50 bpm, which appears to have exacerbated the hemodynamic compromise. Postoperative PM check showed the most recent interrogation was 15 months before surgery. The postoperative interrogation also demonstrated new (since the prior interrogation) inadequate atrial and longstanding (known at the prior interrogation) inadequate ventricular pacing outputs relative to pacing threshold in this pacing-dependent patient.

Both the ASA¹⁹ and HRS¹ recommend preoperative collection of CIED programmed variables. The ASA further recommends preoperative CIED evaluation and caution with magnet use. In case 1, magnet application did indeed produce asynchronous pacing. However, it caused acute loss of AV synchrony, because atrial pacing never depolarized the atrium, ventricular pacing depolarized the ventricle only 50% of the time, and the patient's complete heart block prevented native ventricular depolarization. Although this patient had tamponade physiology and received positive pressure ventilation, the loss of atrial transport caused by magnet application likely further compromised the worsening hemodynamics. In cases 2 (BOS-GDT H-170) and 3 (BOS-GDT H-175), knowledge of the BOS-GDT ICD tone functions could have allowed determination that magnet placement did not disable antitachycardia therapy. Although both of these ICDs will emit tones on magnet placement to indicate the presence of a magnet and status of antitachycardia therapy, neither record has documentation suggesting that tones were sought or that auscultation of the device was performed. In both instances, the magnet switch had been disabled in response to a product advisory,²⁰ and no tones would have been emitted, alerting the anesthesiologists that ICD antitachycardia therapies were still active. In case 3, the failure of the operative personnel to reliably observe movement during shocks likely reflects use of muscle relaxants and the incomplete operative view of the heart in the right lateral position.

Figure 1. A, Magnet application to a dual chamber pacemaker programmed to DDD mode actually reduces effective heart rate and abolishes atrioventricular (AV) synchrony. A 33-year-old man with recurrent lymphomatous pericardial effusion and third-degree heart block with a pacemaker developed hemodynamic compromise during his anesthetic induction. A magnet was applied (up-arrow), intending to increase his heart rate from 75 to 100 bpm and improve cardiac output. However, inadequate pacing outputs on both leads resulted in complete atrial noncapture as well as intermittent ventricular noncapture, producing loss of AV synchrony and actual reduction in effective heart rate, likely reducing his cardiac output and worsening his hemodynamic status. The electrocardiographic tracing at the time of magnet placement is shown. Although asynchronous dual chamber pacing began at 100 bpm with an AV delay of 100 milliseconds (normal magnet function for a Guidant pacemaker), atrial pacing failure-to-capture (“+,” note no change in P-wave rate) and ventricular electrical alternans (note noncaptured ventricular pacing “**” every other pace) effectively produced asynchronous ventricular-only pacing at 50 bpm. Postoperative interrogation revealed a last-check date 15 months before this surgery, inadequate atrial and longstanding (known at the prior interrogation) inadequate ventricular pacing outputs relative to pacing threshold in this pacing-dependent patient. B, Selected vital signs and actions around the time of cardiopulmonary resuscitation (CPR) in a pericardial window. Data recovered from the electronic medical record (EMR) are presented, along with drug administration and relevant events (induction, magnet placement, and CPR) documented by the anesthesia care team. As shown, the EMR documents each vital sign every 60 seconds. However, each of these vital signs can be acquired at different time points during this period, each vital sign could have been affected by the CPR, and the data averaging of each signal might be different. For example, the electroencephalogram (ECG; A) clearly shows an instantaneous change in the ventricular rate from 75 to 50 bpm on magnet placement. However, the EMR inaccurately reports that the ECG rate decreased over 2 minutes, and the lowest documented pulse oximeter heart rate was 59 bpm. Drugs were M-midazolam (2 mg), F-fentanyl (50 μ g twice), and K-ketamine (20 mg). SBP = systolic blood pressure, DBP = diastolic blood pressure, HR = heart rate.

quite difficult. In case 1, we believe that inappropriate PM programming (inadequate pacing outputs) and the acute loss of AV synchrony with magnet placement worsened the clinical situation. In cases 2 and 3, both patients received

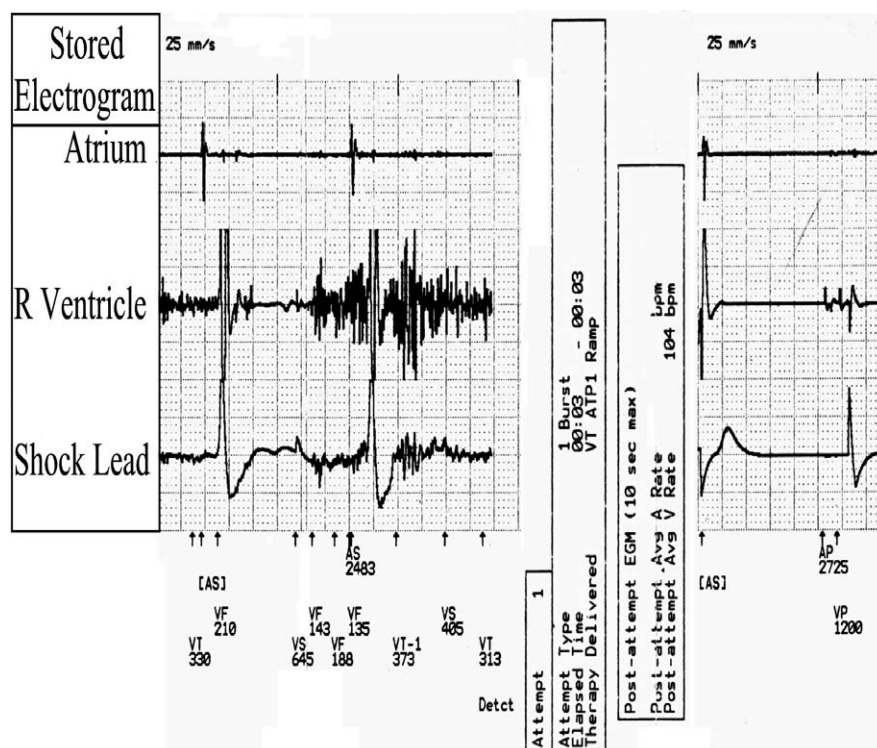
A 70-year-old man with a BOS-GDT H-170 biventricular-ICD presented for median sternotomy and revision of a prior esophagectomy—colonic interposition. His device was implanted 25 months earlier for ischemic cardiomyopathy and to provide cardiac resynchronization therapy. Immediate preoperative interrogation revealed an episode of antitachycardia pacing (ATP) for what appeared to be electrical noise (Fig. 2) approximately 8 months earlier. Investigation revealed that the ATP was delivered during his initial esophageal surgery. Data stored in the ICD indicated an interrogation 13 days before the first surgery, but no interrogation report was in his chart. The anesthesiologist who performed the first case reported that he placed a magnet on the ICD to prevent firing as instructed by the cardiologist. The anesthesiologist was unaware that this ICD likely had a disabled magnet switch in accordance with a manufacturer's product advisory⁹ issued 10 months earlier.

Figure 2. Electromagnetic interference (EMI) during surgery results in antitachycardia pacing from a Guidant (Boston Scientific, Natick, MA) H-170 implantable cardioverter defibrillator (ICD). An episode of antitachycardia pacing during median sternotomy and esophagectomy revision caused by EMI from monopolar electrosurgery took place despite the presence of a magnet on this Guidant ICD, as the perioperative personnel were unaware that the magnet switch had been disabled. The 3 traces show electrical signals (called intracardiac electrograms) from the atrial lead (top), right ventricular pacing lead (middle), and the right ventricular ICD shock coil (bottom). The patient's underlying sinus rhythm at 48 bpm appears on all leads, but EMI can be seen on the right ventricle and shock signals. The interpretation made by the ICD (called the marker channel) is shown under the gratitudes. The ICD has identified this "rhythm" as >2.5 seconds of ventricular tachycardia (VT), resulting in the delivery of antitachycardia pacing ("VT ATP1 RAMP"), which was deemed successful therapy because the EMI ceased. Had a stethoscope been placed on this ICD while the magnet was present, the lack of an audible sound would have indicated the lack of magnet response. The chart speed is 25 mm/sec. AS is atrial sense; the brackets ([AS]) indicate that the ICD has ignored the event. AP/VP are atrial/ventricular pace and VT-1, VT, and VF reflect ventricular sensed events that are in timing windows associated with the 3 programmed zones of tachycardia detection. The numbers associated with each symbol is the time (in milliseconds) from the last event on that lead.
