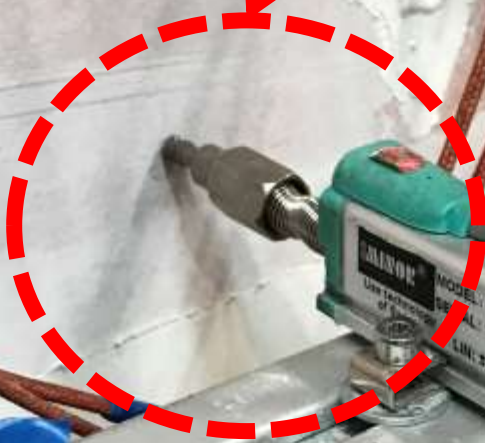
Excessive
contraction in
LVDT

Excessive
bowing on
ambient side
plasterboard
(Pb4)
