Multi LE Image Streamer Removal Process Secondary LE Update from Group failed: Troubleshooting steps

Logical Enclosure Type: Multi LE with more than 1 pair of Image Streamer appliances.

Customer: Duval School of Florida

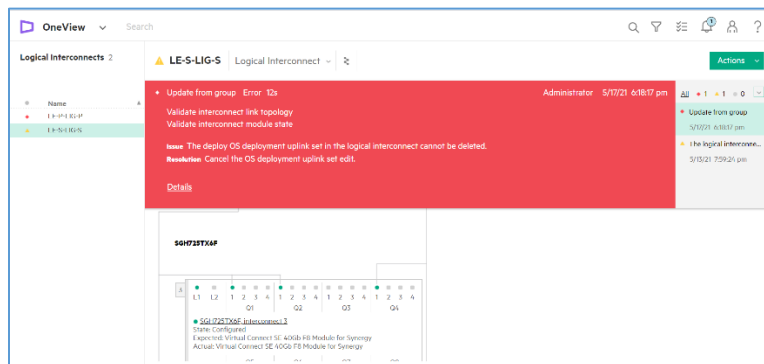
Removed I3S intent from the Secondary LE. Performed LE update from group. LE update from group failed. Please refer to the screen shot below.

The issue was with CRM (OV networking) code where in, for the given i3s uplink set, a wrong logical interconnect was mapped. Due to this, the validation code which checked for non-existence of LI, kicked in and hence the issue.

As it was the wrong logical interconnect (primary in this case), the deployment mode was not none and further validation code for checking the existence of LI was executed.

OVS-32779: "Update from group" in LI to update the uplink sets fails in multi-LE setup

The below defect is been fixed in 6.2 version. A code fix was submitted to 6.20 to map the correct logical interconnect to the i3s uplink set being deleted.

1) Set deployment mode to "None" and manage os deployment to "false" in the OS deployment settings table that corresponds to the primary EG template.

- a. Locate the LI of the secondary pair
- b. LI update from the group
- c. Verify streamer uplink is removed

3) Correct/Restore the db entry for the PRIMARY EG template OS deployment settings table.

4) Perform secondary-LE update from the group . It should go through without issues.
