Turret Indexer Assembly - SL-10/30 ST-10/15 - Troubleshooting Guide

Turret Indexer Assembly

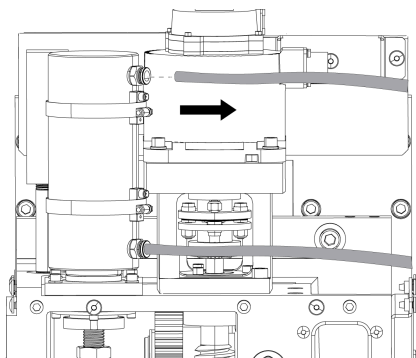
Air Cylinder

Note: There may be some variation of the cylinder cushion dampening between directions of movement for different vendors. Verify the air cylinder operation when installed. Do not test by hand.

With the turret clamped test the air cylinder for faulty piston seal.

Remove the upper hose (unclamp) on the cylinder.

If air is escaping from the upper hose (unclamp) connection on the cylinder the cylinder piston seal is bad and piston should be replaced.
