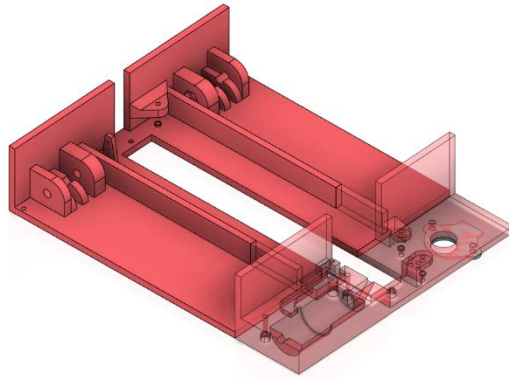
On the picture above we can see the platform split into two parts, one has its opacity a little lower to distinguish the difference.

At the end of the session, I started the impression of the part on the left, after coming back 30min it had failed and needed to be restarted.
