StappenMotorSturing
13-1-2014 21:30:11
Sheet: 1/1

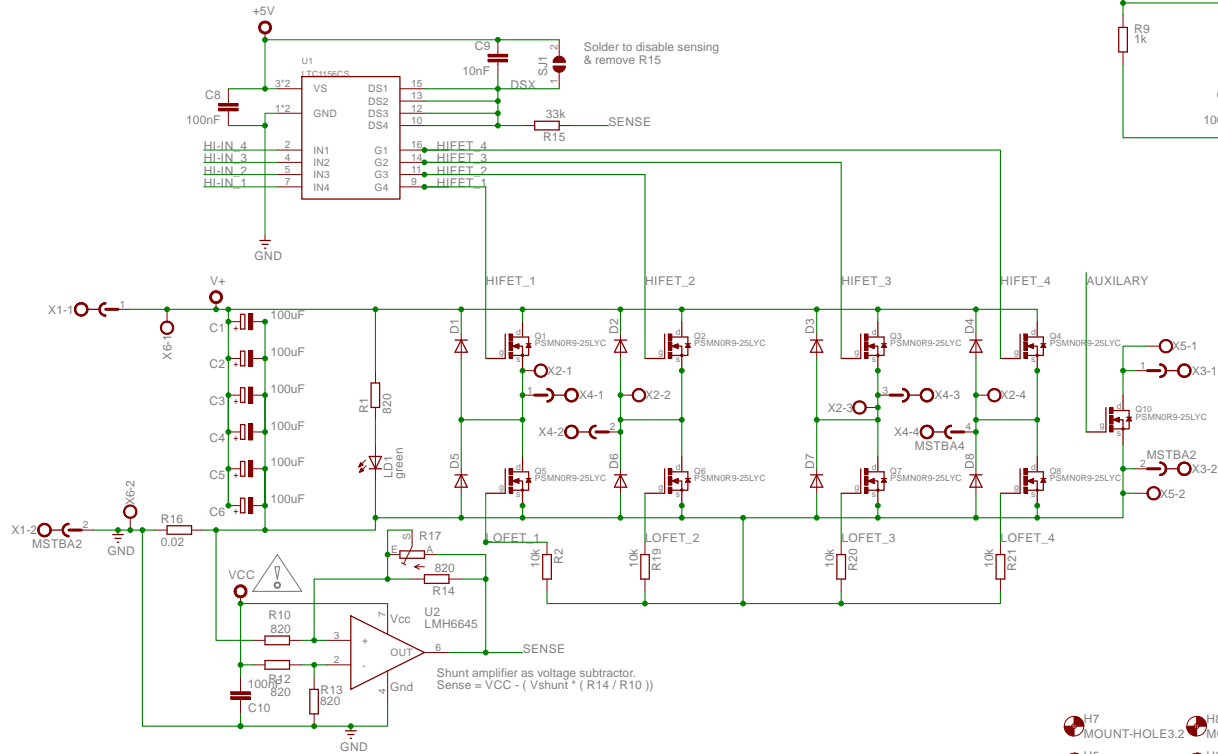
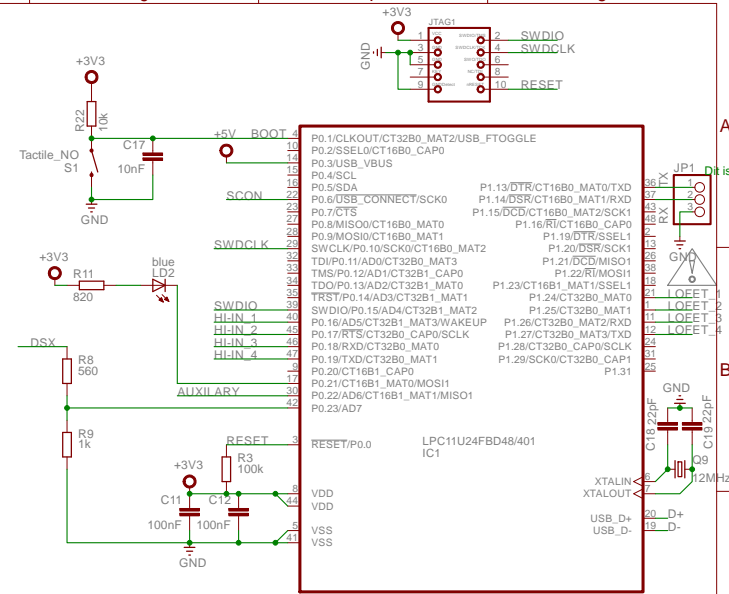
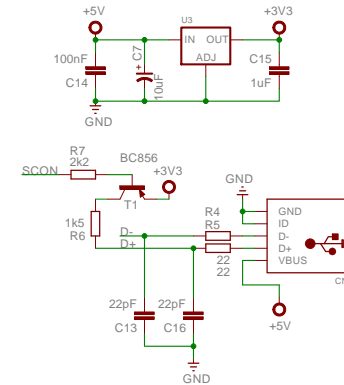
Bug: LOFET signals to CT32B0 timer, only 3 concurrent PWM outputs possible

Bug: Opamp Vcc should be 5v, manual re-trace required

Improvement: Pull down termination on HI_FET gate signals
