6.3 UNSYMPATHETIC EXTENSIONS

6.4 UNSYMPATHETIC ALTERATIONS

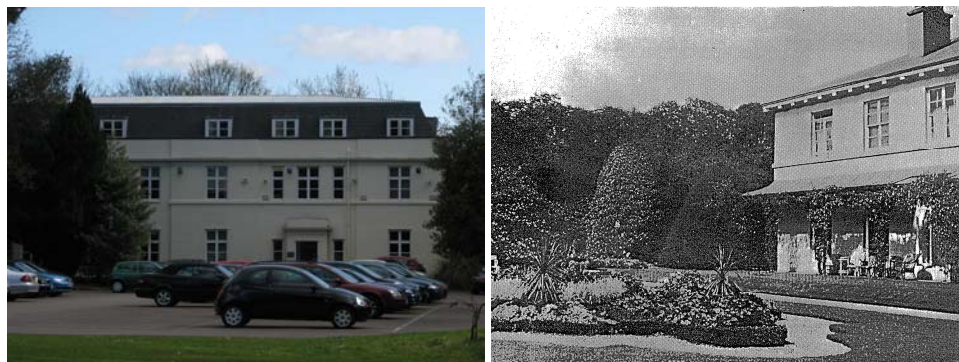
6.3.1 The terraced housing positioned directly onto the road allows little scope for extensions that make a significant impact on the character of the conservation area, although rear extensions can be still be unattractive when visible across open fields behind the houses. A greater threat to the area is the effect of extensions to the larger, unlisted buildings. Eastham Hall (formerly Hooton Mount) is sadly virtually unrecognisable from the building that was built in the middle of the 19th century. The symmetry of the main

south-west facing façade has been lost as a result of the significant extension to the north. Similarly the addition of a third floor within a modern mansarded roof has adversely affected the proportions of the façade. The quality of the modern materials used is not sympathetic with the original character of the building or that of the village as a whole.

Eastham Hall (Hooton Mount) today compared with a photograph taken in around 1920

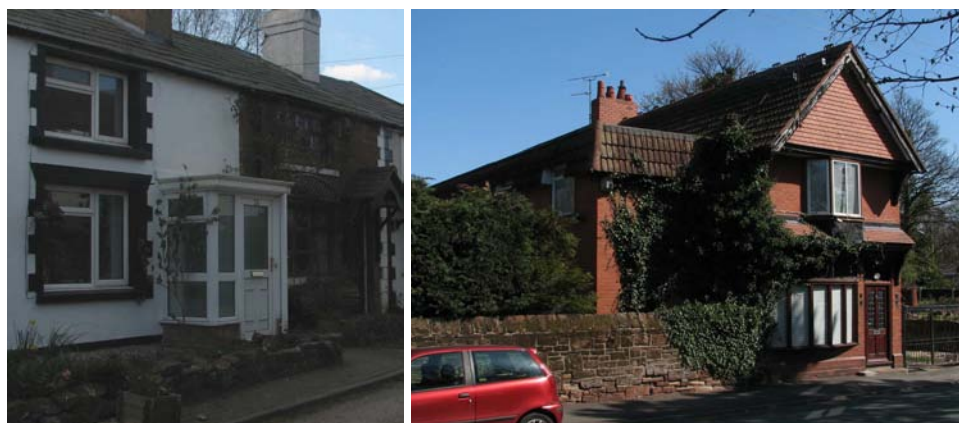
(left) the additional of a porch onto the front of a terrace can be damaging to the visual rhythm in the group; (right) a larger extension which changes the character of a building.

- 6.3.7 A few unsympathetically constructed porches exist within the village. Where a porch or large side extension is added onto a building, unless carefully designed, it can change the character of a building and therefore potentially reduce its positive contribution to the conservation area. Some additions can completely overwhelm the original character and form of the building leaving the building to appear (at least at first glance) to be modern.

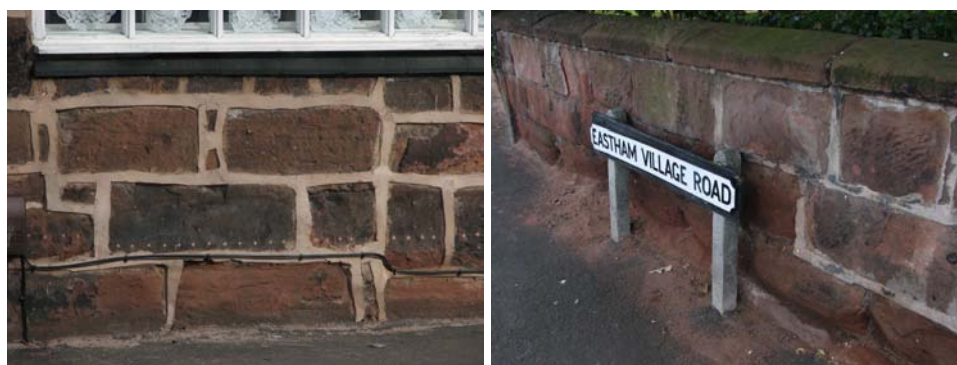
- Changes to chimneys, most notably reduction in their height and loss of pots.
- Rendering of brick and stonework.
- Damage to historic building fabric as a result of changes to the traditional building materials. The use of hard pointing and impermeable coatings generally accelerate the rate of decay of the softer historic materials, most notably sandstone. In certain instances the effect of this phenomenon threatens not only the physical fabric but also the appearance of that part of the conservation area.

- The insertion of injected damp proof courses into stonework. This practice is generally ineffective and damaging to the appearance of the building.
- Painting of Victorian brickwork. This detrimentally changes the character of the building. Lime washing (or painting with a modern breathable alternative) of stone / older more friable brickwork is likely to be a traditional way of preserving the building's fabric and therefore may be appropriate in some instances.

(left) the visually detrimental effect of the insertion of an injected damp proof course and poor quality pointing; (right)
