River name: Dumacaa River

Location: Lucena city, Quezon, Calabarzon

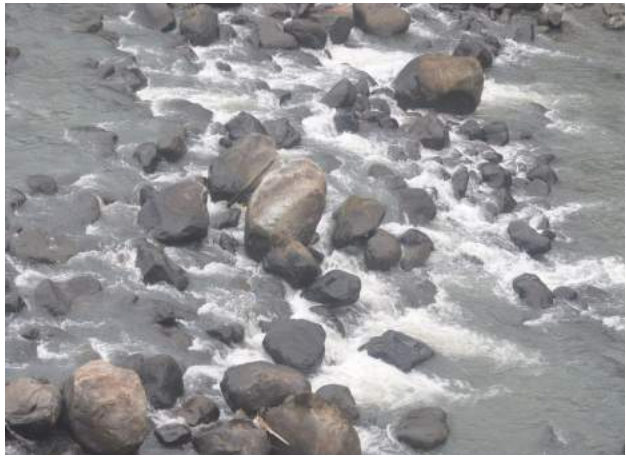
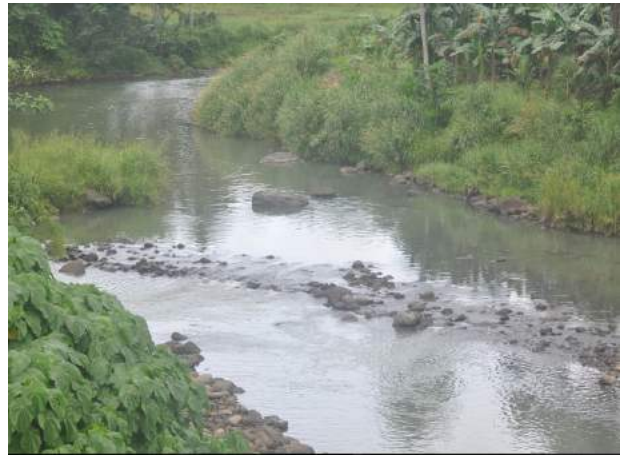
Section 1	Score	Remarks
Channel Condition	10	No dikes, no structures near
Hydrologic Alteration	10	No dams
Riparian Zone	8	Vegetation extends one active channel along bank
Bank Stability	7	Signs of path near river, banks are low
Water Appearance	3	Cloudiness, pea-green color?
Nutrient Enrichment	3	Greenish water along reach
Barriers to Fish Movement	8	Seasonal water withdrawals inhibit movement within the reach
Instream Fish Covers	3	Cobbles, overhanging vegetation
Pools	3	Less than 3 ft deep pools
Invertebrate Habitat	7	Cobble, boulders , leaf packs
Canopy Cover	3	20-50% shaded
Manure Presence	-	
Salinity	-	
Riffle Embeddedness	8	20-30% embedded cobbles
Macroinvertebrates Observed	-

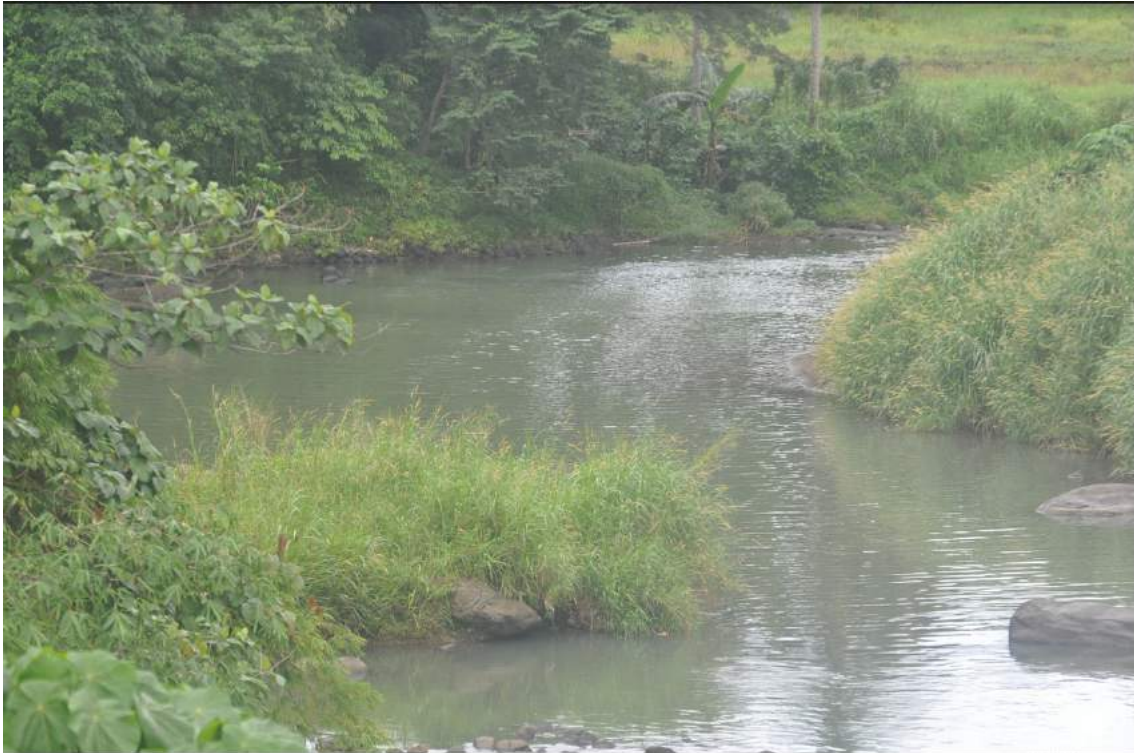
Section 2	Score	Remarks
Channel Condition	10	Natural channel, no evidence of dikes construction
Hydrologic Alteration	-	
Riparian Zone	10	Natural vegetation extends at least two active channel widths on each side.
Bank Stability	10	No visible signs of erosion, abundant roots from trees surrounding area
Water Appearance	7	Occasionally cloudy, but relatively clear
Nutrient Enrichment	10	Little algal growth present
Barriers to Fish Movement	10	No barriers present
Instream Fish Covers	3	Debris, cobbles/boulders, riffles
Pools	3	Less than 3 ft. deep
Invertebrate Habitat	7	Potential habitat exists
Canopy Cover	1	<20% of water reach is shaded
Manure Presence	-	
Salinity	-	
Riffle Embeddedness	5	30-40% embedded cobbles
Macroinvertebrates Observed	-

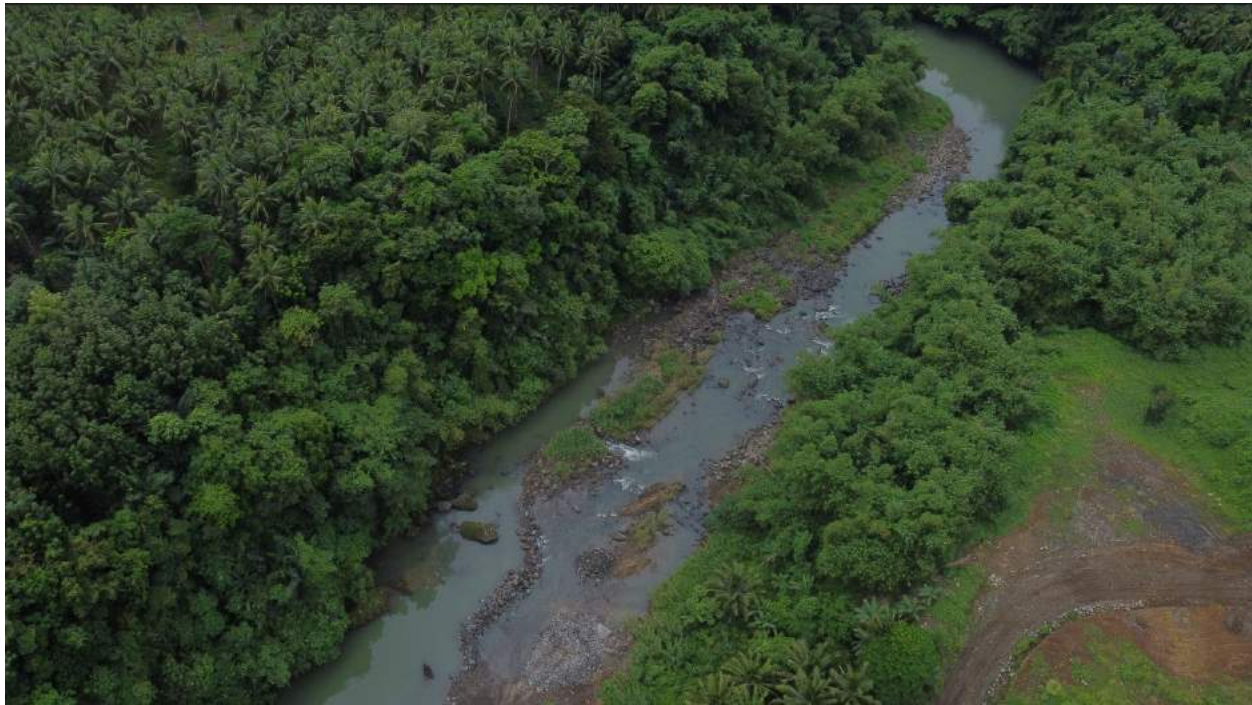
Section 3	Score	Remarks
Channel Condition	10	Natural channel, no dikes and structures present
Hydrologic Alteration	-	
Riparian Zone	8	Natural vegetation extends one active channel width on each side of the stream
Bank Stability	7	Banks are low, less than 30% of eroding surface area is protected by roots
Water Appearance	3	Cloudy with a moderate odor of ammonia or rotten eggs
Nutrient Enrichment	3	Greenish water along entire reach, abundant algal growth
Barriers to Fish Movement	10	No barriers
Instream Fish Covers	3	Cobbles and deep pool are present
Pools	3	The pool is less than 3 feet deep
Invertebrate Habitat	-	
	-	
Canopy Cover	1	Less than 20% of water surface in reach shaded
Manure Presence	-	
Salinity	-	
Riffle Embeddedness	10	Riffles are less than 20% embedded
Macroinvertebrates Observed	-

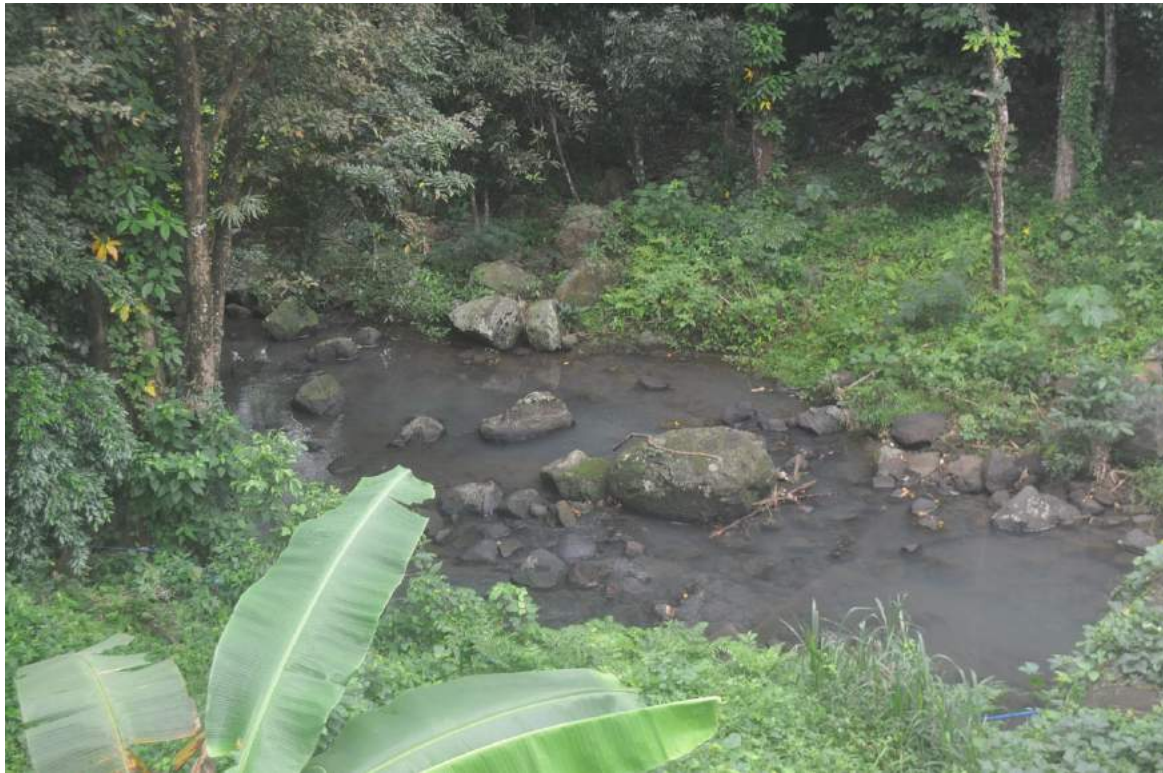
Section 4	Score	Remarks
Channel Condition	7	Evidence of past channel alterations
Hydrologic Alteration	10	No dams, dikes, or other structures
Riparian Zone	10	Natural vegetation extends at least 2 active channel widths
Bank Stability	7	Moderately stable
Water Appearance	3	Considerable cloudiness
Nutrient Enrichment	3	Greenish water along entire reach
Barriers to Fish Movement	8	Seasonal water withdrawals inhibit movement
Instream Fish Covers	3	boulders/cobbles, overhanging vegetation
Pools	3	Pools present but shallow
Invertebrate Habitat	-	
Canopy Cover	1	<20% of water is shaded
Manure Presence	-	
Salinity	-	
Riffle Embeddedness	5	Gravel or cobble particles are 30-40% embedded
Macroinvertebrates Observed	-

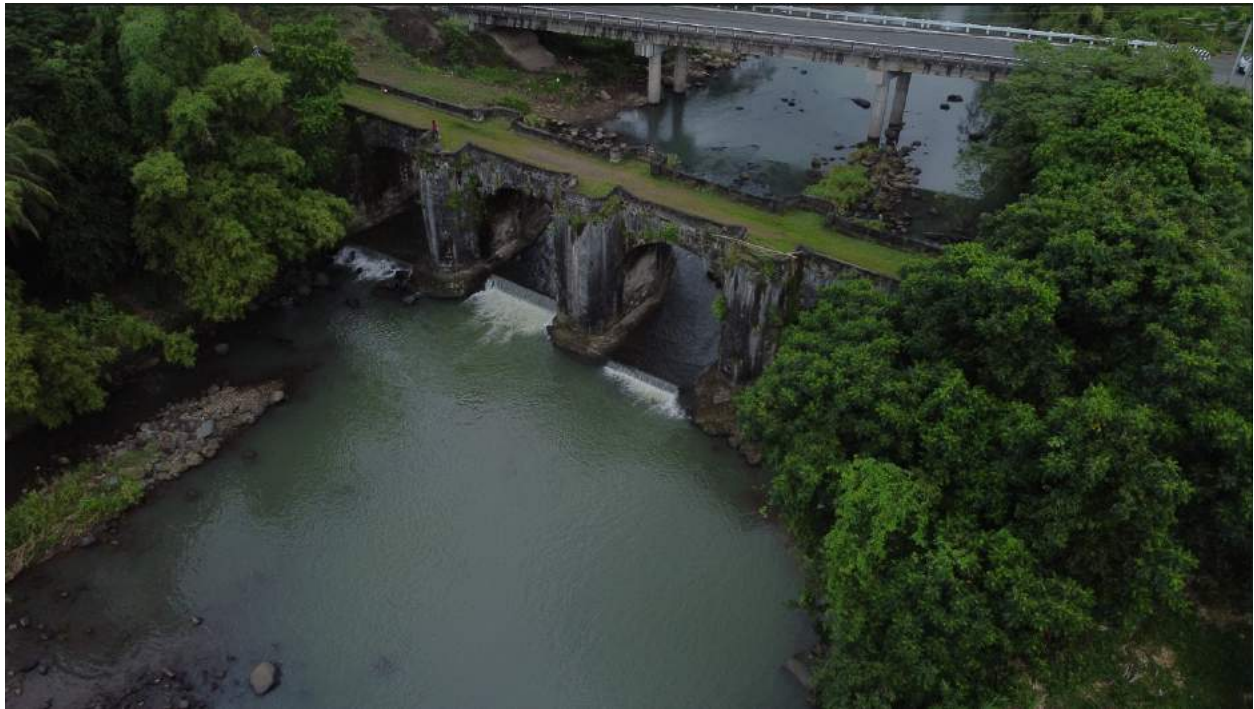
Section 5	Score	Remarks
Channel Condition	7	Evidence of past channel alterations
Hydrologic Alteration	-	
Riparian Zone	8	Natural vegetation extends one active channel
Bank Stability	7	Banks are low
Water Appearance	7	Occasionally cloudy
Nutrient Enrichment	7	Fairly clear or slightly greenish water along reach
Barriers to Fish Movement	8	Seasonal water inhibit movement
Instream Fish Covers	5	Boulders, overhanging vegetation, riffles, Thick root mats
Pools	1	Bottom is discernible
Invertebrate Habitat	3	Cobble, boulders
Canopy Cover	1	<20% of the water is shaded
Manure Presence	-	
Salinity	-	
Riffle Embeddedness	5	Gravel or cobble particles are 30-40% embedded
Macroinvertebrates Observed	-

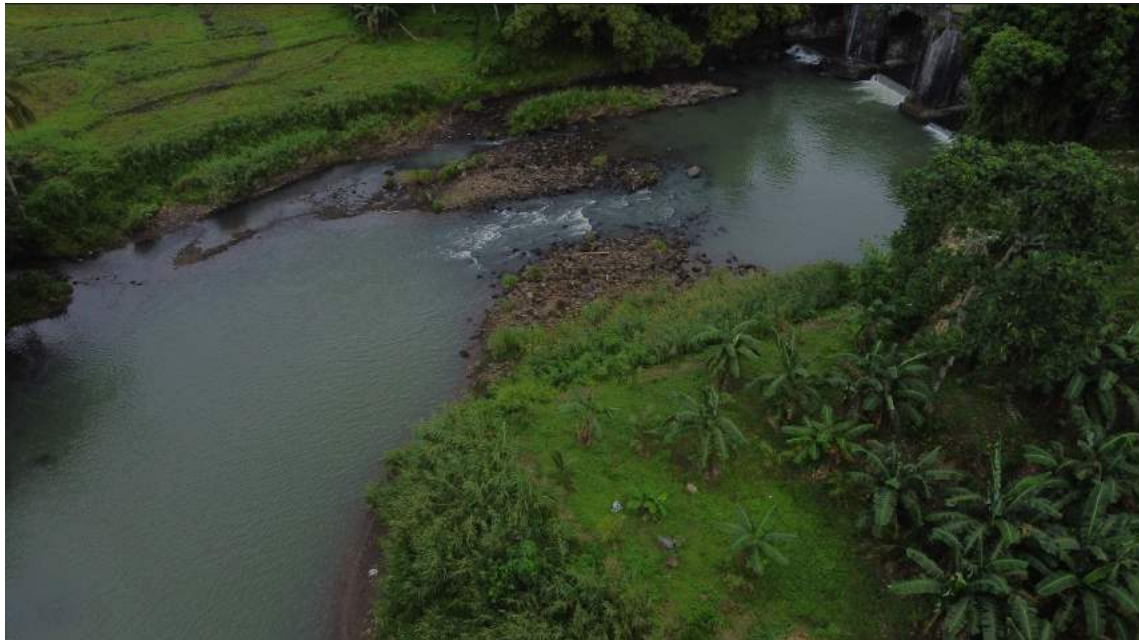
Section 6	Score	Remarks
Channel Condition	7	Evidence of past channel alteration (change in water elevation)
Hydrologic Alteration		
Riparian Zone	8	At least one active channel width vegetation on each side
Bank Stability	10	Stable low banks, no sign of erosion abundant trees along banks
Water Appearance	3	Greenish water color/appearance
Nutrient Enrichment	3	Greenish water along water reach,
Barriers to Fish Movement	5	Shallow drop present (<1 ft)
Instream Fish Covers	5	Overhanging vegetation, cobbles, pools, thick roots, riffles
Pools	7	At least 3 ft deep pools
Invertebrate Habitat	7	Cobble, boulders, coarse gravel
Canopy Cover	-	
Manure Presence	-	
Salinity	-	
Riffle Embeddedness	8	Cobbles/gravel are 20-30% embedded.
Macroinvertebrates Observed	-

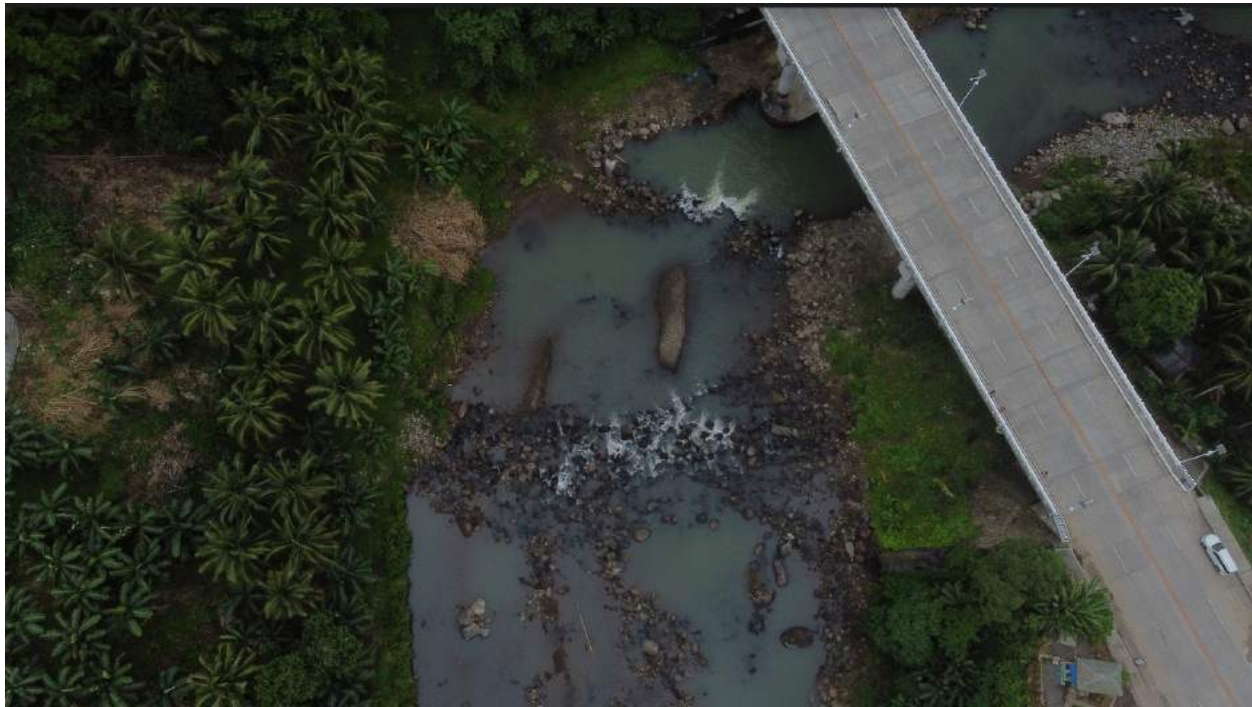
Section 7	Score	Remarks
Channel Condition	10	Natural channel; No dikes or structures nearby
Hydrologic Alteration	7	Limited channel incision
Riparian Zone	8	Natural vegetation extends one active channel width on each side
Bank Stability	7	Banks are low
Water Appearance	3	Objects are visible to depth 0.5 to 1.5 ft
Nutrient Enrichment	3	Greenish water along entire reach
Barriers to Fish Movement	8	Seasonal water withdrawals
Instream Fish Covers	3	Cobbles, isolated backwater pools
Pools	3	Pools present but shallow
Invertebrate Habitat	-	
Canopy Cover	1	<20% of water is shaded
Manure Presence	-	
Salinity	-	
Riffle Embeddedness	8	20-30% embedded
Macroinvertebrates Observed	-

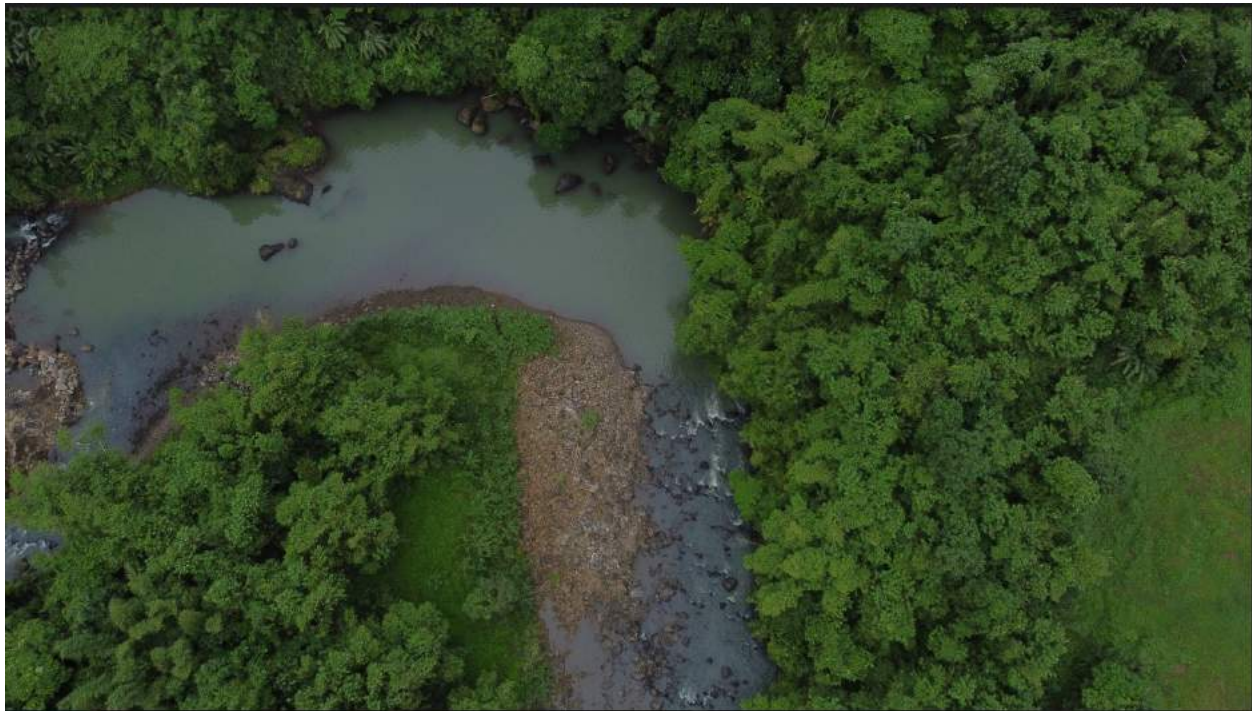
Section 8	Score	Remarks
Channel Condition	7	Evidence of past channel alteration due to built structure along the reach
Hydrologic Alteration	-	
Riparian Zone	8	Natural channel extends one active channel width on each side
Bank Stability	10	Banks are low, more than 33% is protected by roots
Water Appearance	3	Considerable cloudiness, moderate odor of ammonia
Nutrient Enrichment	3	Greenish water along reach, abundant algal growth
Barriers to Fish Movement	5	Drop structure is present
Instream Fish Covers	3	Riffles and cobbles are present
Pools	3	Pools are less than 3 feet deep
Invertebrate Habitat	3	Cobbles and boulders are present
	-	
Canopy Cover	-	
Manure Presence	-	
Salinity	-	
Riffle Embeddedness	5	Cobbles are 30% to 40% embedded
Macroinvertebrates Observed	-

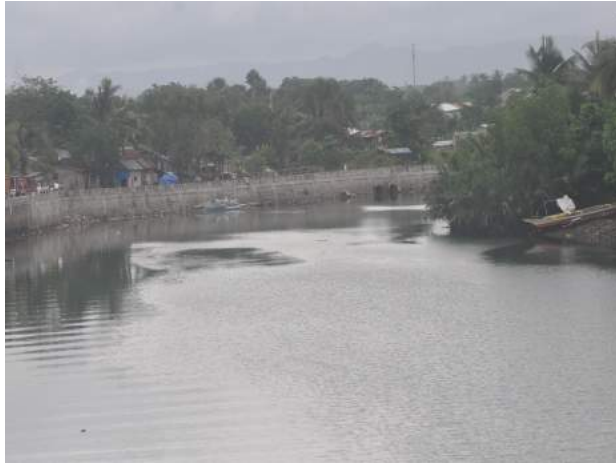
Section 9	Score	Remarks
Channel Condition	10	Natural channel; no structures, dikes.
Hydrologic Alteration	7	Limited channel incision; withdrawals, although present, do not affect available habitat for biota
Riparian Zone	8	Natural vegetation extends one active channel width on each side
Bank Stability	7	Moderately stable; banks are low (at elevation of active flood plain)
Water Appearance	3	Considerable cloudiness most of the time; objects visible to depth 0.5 to 1.5 ft;
Nutrient Enrichment	3	Greenish water along entire reach
Barriers to Fish Movement	8	Seasonal water withdrawals inhibit movement within the reach
Instream Fish Covers	3	Boulders/cobble, isolated/backwater pools
Pools	3	Pools present, but shallow
Invertebrate Habitat	-	
	-	
Canopy Cover	-	
Manure Presence	-	
Salinity	-	
Riffle Embeddedness	8	Gravel or cobble particles are 20 to 30% embedded.
Macroinvertebrates Observed	-
