Addendum 9/02/2017

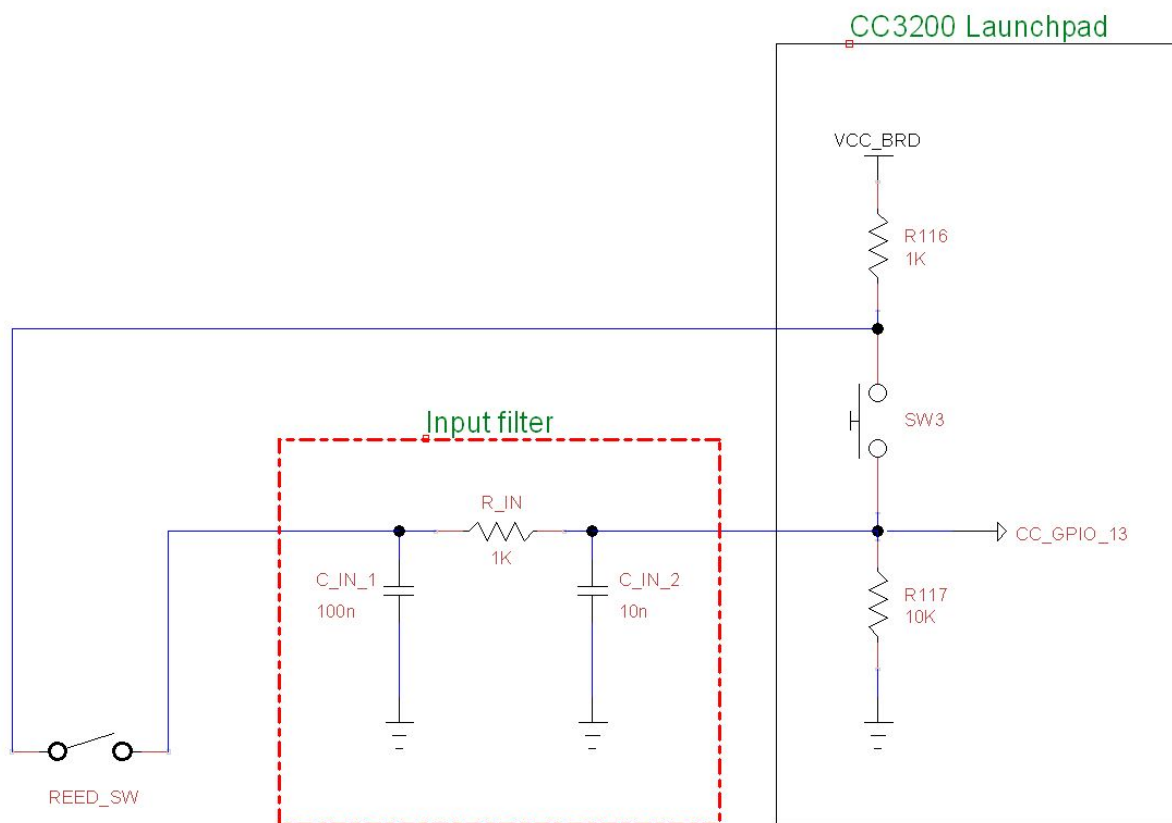
After deploying the device and observing for three months, it was noted that the red LED on the CC3200 board would occasionally turn on at the moment the sump pump turned off. This indicated that the board went through the POR due to an active wakeup input. As expected, the EMI blast from the pump was coupling on the input wire and generating a wakeup. Since the software debouncing is relatively long, the device would ignore this event and go back to hibernation. However, this could significantly impact battery life.

Figure 1: RC filter was added to the wake-up input.

In any case, it is not good practice to have the input go directly to the microcontroller pin, so it was decided to add a RC filter to the input and see if that alleviated the problem before testing other ideas (TVS, ferrites, etc.). Adding 10nF, 100nF, and 1kOhm in pi configuration to the input (see schematic below) indeed did solve the issue. This would have been an appropriate addition in the initial design.

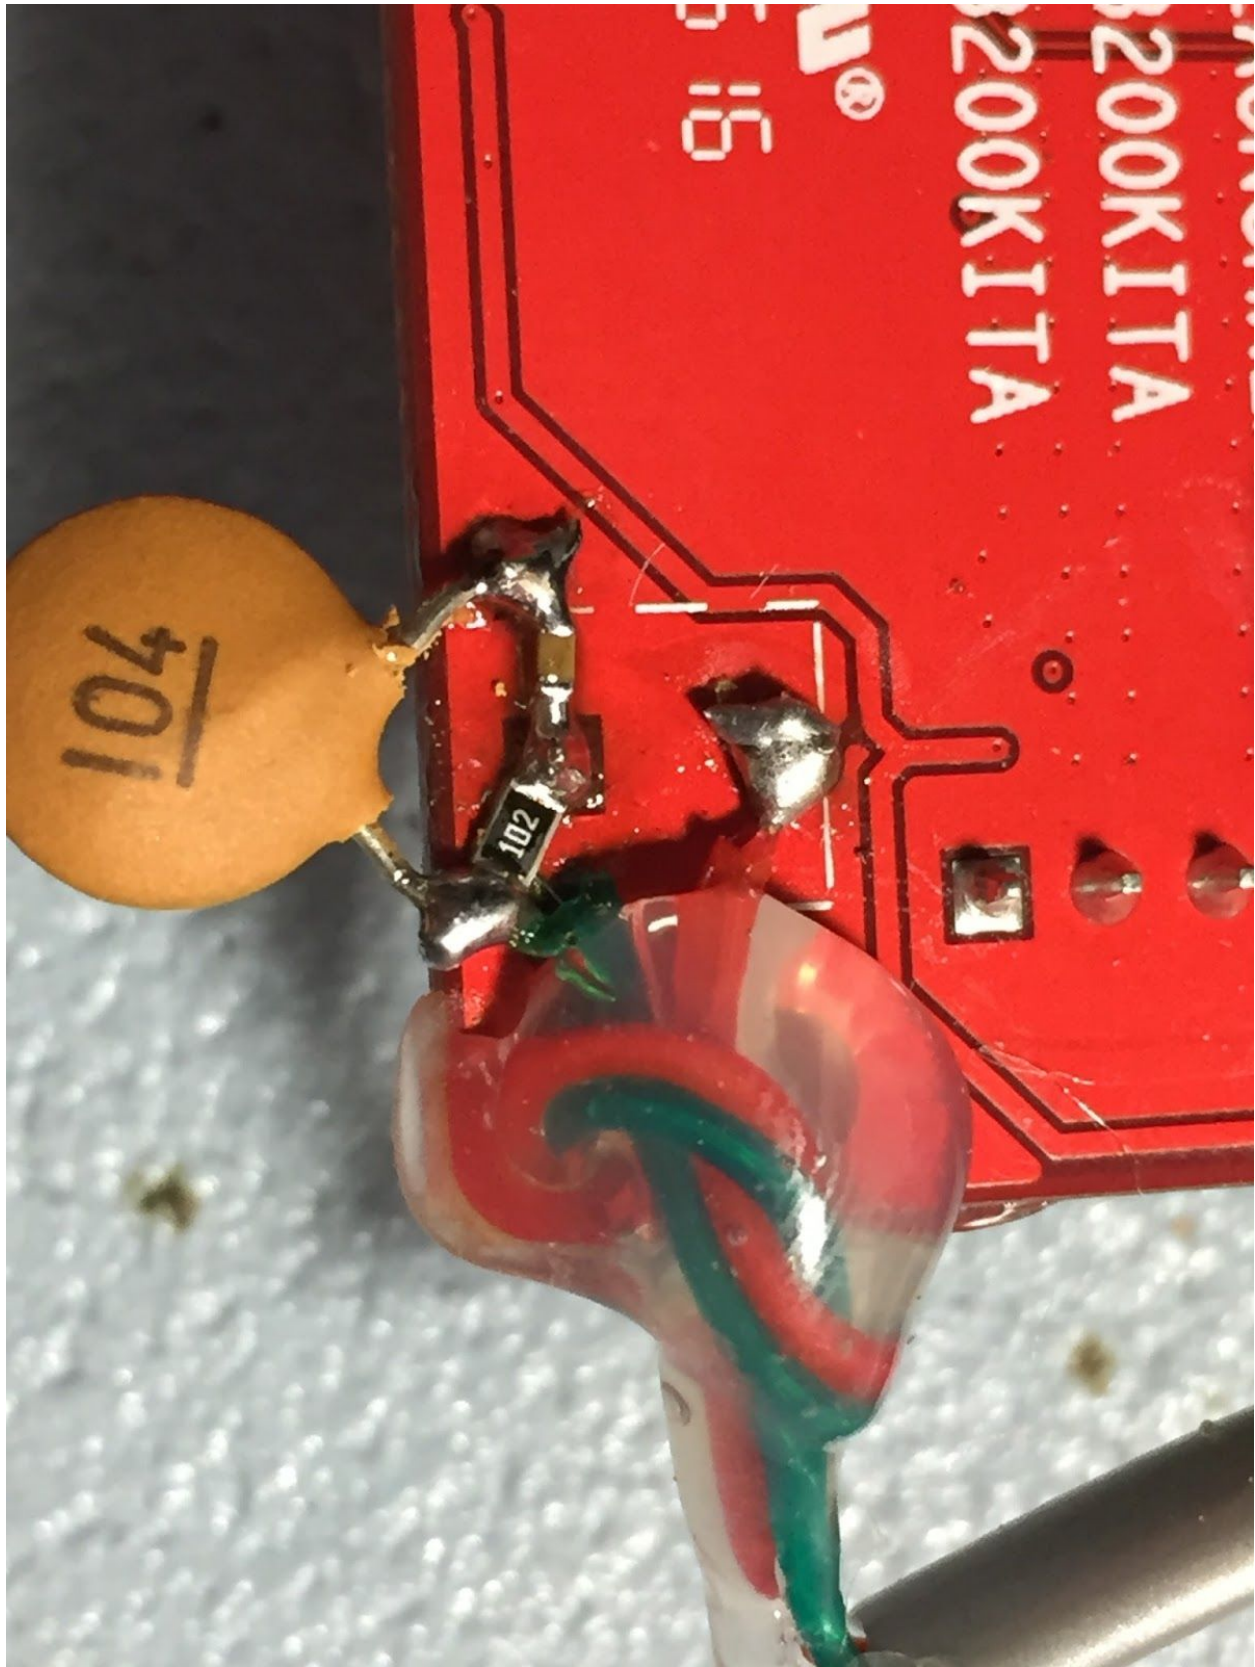
Figure 2: RC filter components were added to the bottom side of the PCB ion the SW3 area.
