LimiFrog

Known Limitations and Features To Be Aware Of

Rel. 0.2

March, 2106

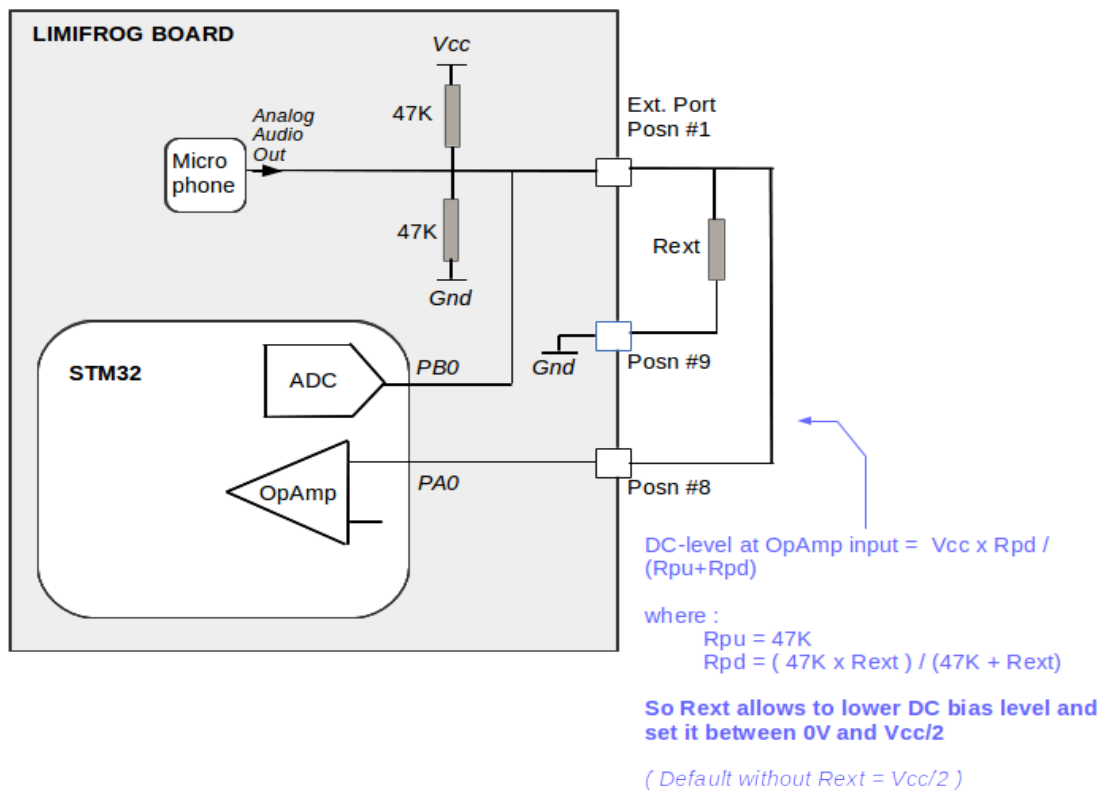
It produces a fairly weak signal that may need amplification, depending on usage scenario.

The microphone analog output is DC-biased around $V_{CC}/2$ (~ 1.47V) and is routed directly to an analog input of the STM32, as well as to position 0 of the extension port.

When amplification is required, one solution is to use the Operational Amplifier of the STM32. The positive input of the OpAmp (pin PA0 of the STM32) is available on position 8 of the extension port. Therefore an external connection from position 1 to position 8 of the extension port does the job. However, because the input to the OpAmp is DC-coupled, one must take care of setting a suitable DC-level to avoid saturation at the output of the OpAmp.

The figure below outlines a possible scheme.

The frequency response of the system is not flat. For example a whistling is much better picked than normal voice.
