# A LoRa Mystery 1 - Phantom Packets

## **A LoRa mystery 2 – Phantom packets but deeper**

## **Phantom Packets 3 - Is this the reason ?**

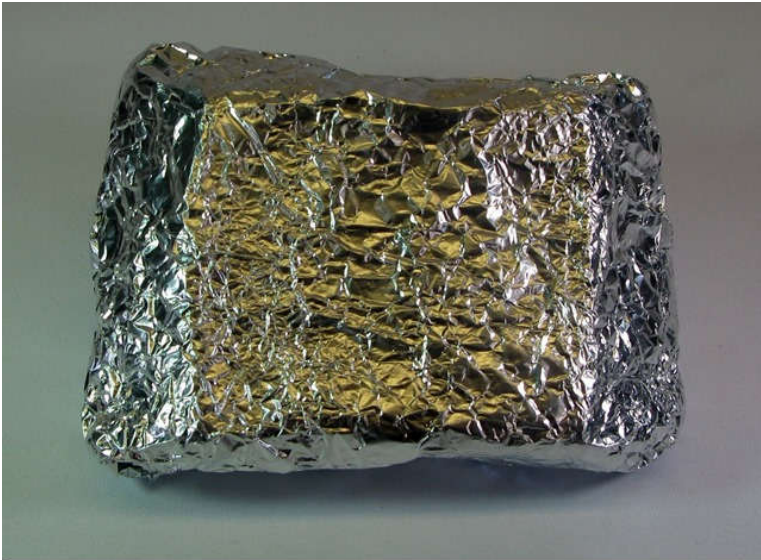
If the aluminium foil was so effective at preventing the RF getting out, it ought to be effective at preventing RF getting in. So I wrapped a LoRa receiver in foil and also put it in an aluminium box. A LoRa transmitter sending packets at

17dBm (50mW) had to be within 5cm of the box for the receiver to pick up the packets, there was a buzzer on the receiver so I could tell when packets were received. So if real world packets were getting through all that shielding they had to be very powerful indeed.

With the receiver now wrapped in foil and consequently very well screened I was still receiving phantom packets and with the similar RSSI and SNR values as before. Perhaps the phantom packets were a result of electro magnetic interference (EMI) coming from the receiver itself, but if so how could the CRCs be valid ?
