Known Limitations/Issues

This document lists all the known limitations/issues related to this release.

WBZ451 Curiosity Board

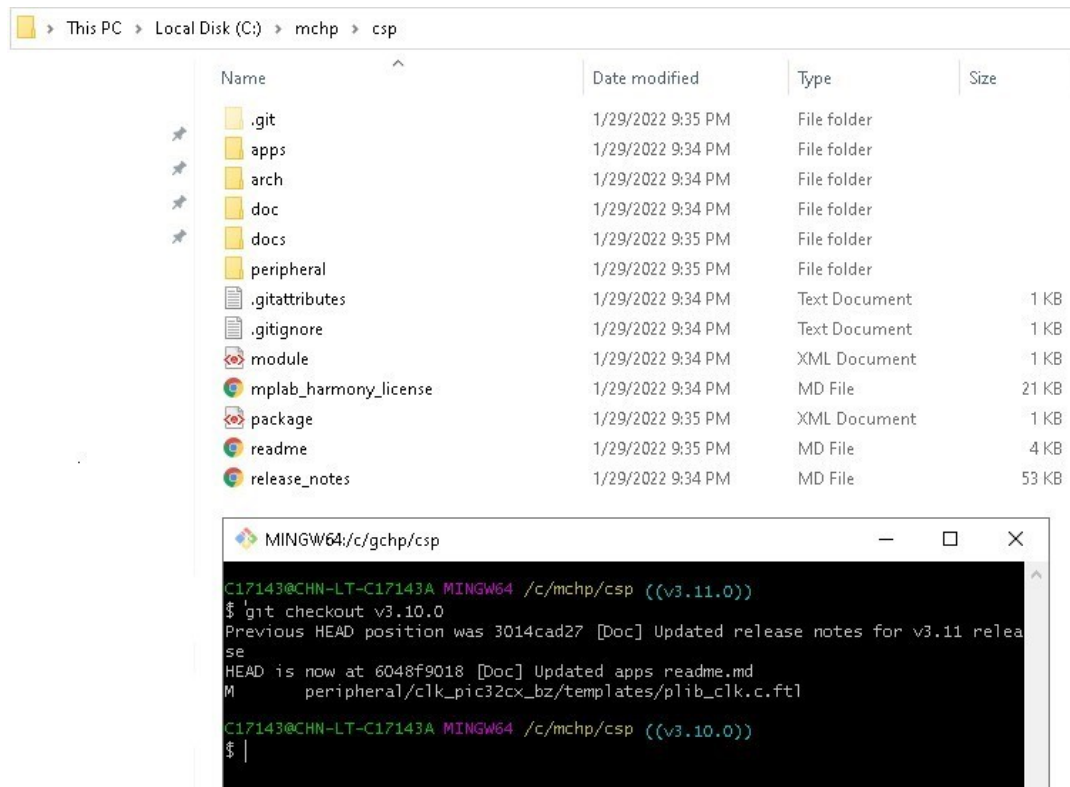
3. **Content Manager:** Downgrading the versions of Harmony Components like csp, bsp, dev_packs etc. is not working within the Content Manager

Workaround: User can checkout the individual component with version number mentioned in /Documentation/PIC32CX-BZWBZ45x SDK Setup.pdf
