## Known Limitations/Issues

This document lists all the known limitations/issues related to this release.

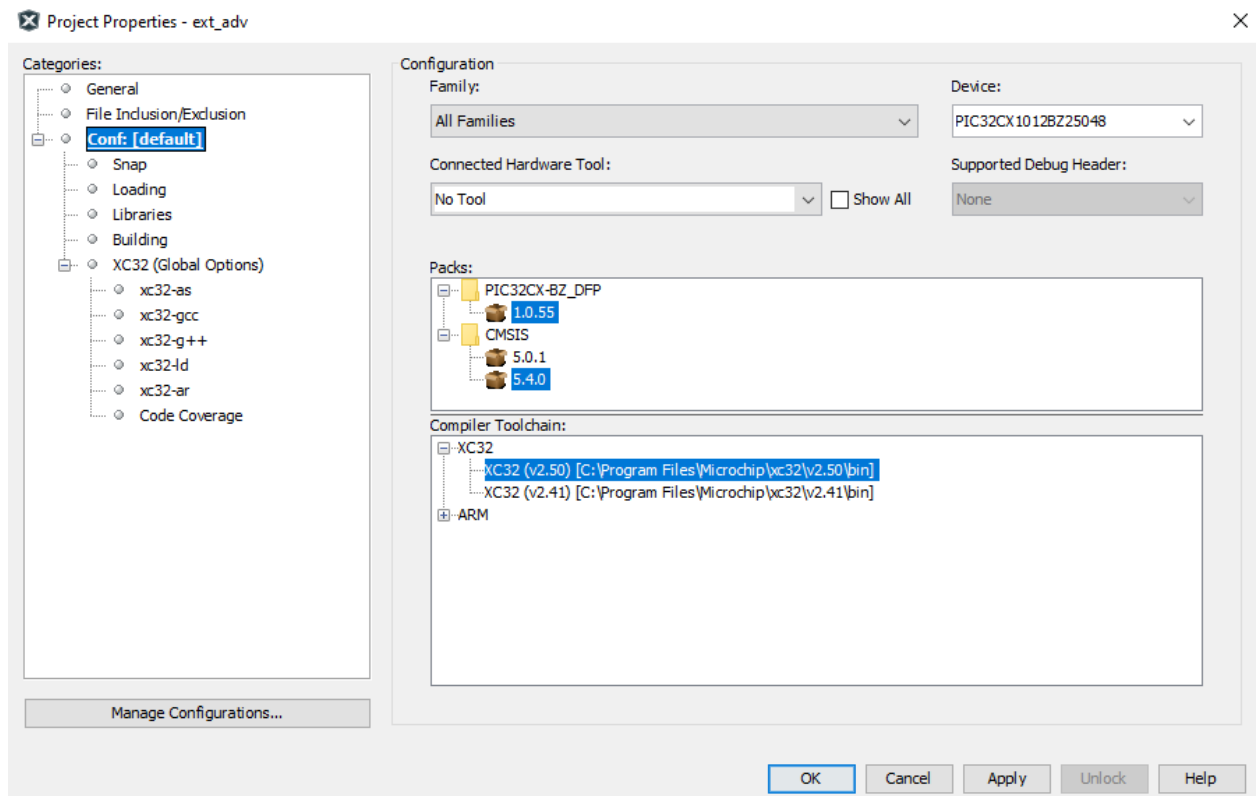
1. Application Examples/ Code Examples developed by users of this package may fail to compile due to a corrupted linker file.  
Workaround- Select Project → Open Properties → Reselect the device and compiler → Apply → Restart MPLABX IDE → Build Project.

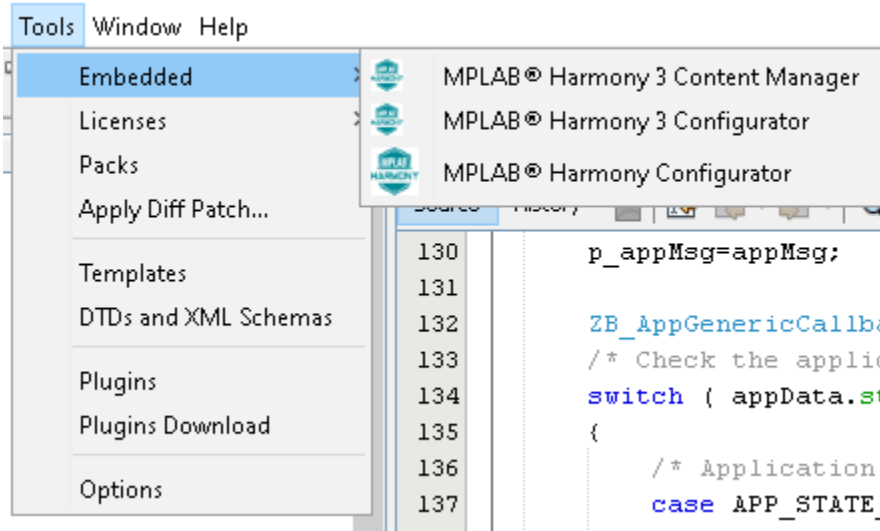
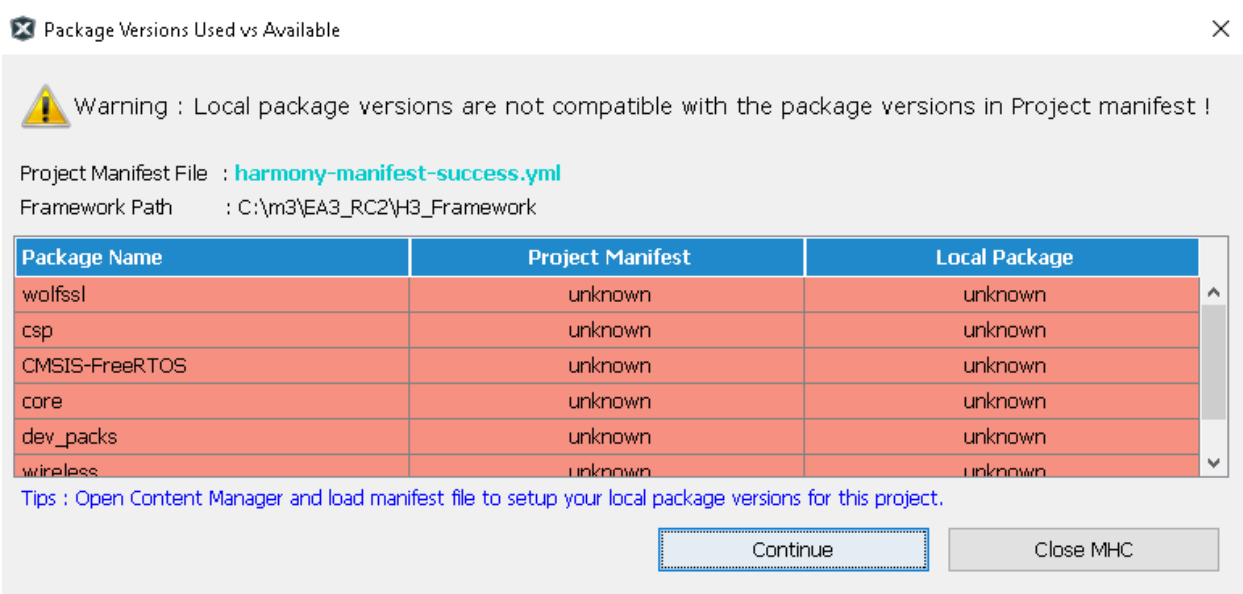
2. Users developing new applications or trying to modify existing application examples which are part of package will see the following window when opening the Tools -> MPLAB Harmony 3 Configurator

This is because Harmony configurator does not have the necessary manifest files to compare the packages used to build the example, if observed user should select continue and regenerate code, if the local Harmony 3 repo's cloned as known trusted versions. Regeneration of code will create the manifest file and user should not see this warning again
