Known Limitations/Issues

This document lists all the known limitations/issues related to this release.

MPLAB Code Configurator (MCC)

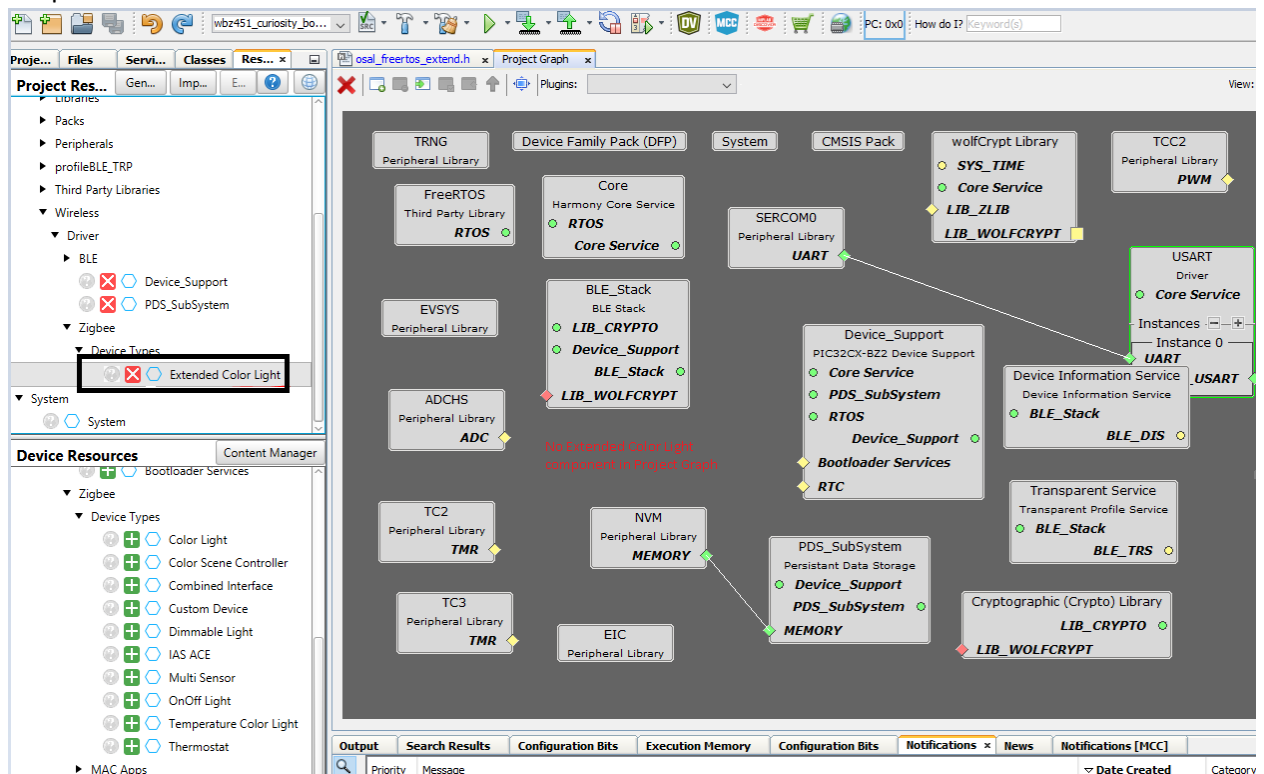
1. **Project Graph and Regeneration of Code:** Components missing in Project Graph when reopening an existing Zigbee or Multiprotocol Application Example. While component (For example – Extended Color Light) is available as Project Resources, its not available in Project Graph

If there are missing components in Project Graph and user Generates code, the existing project on which MCC is generating code will be corrupted with missing files.
