HP 9133/9134 D/H/L Service Manual

Manual part number: 5957-6560

Edition 2
E0488

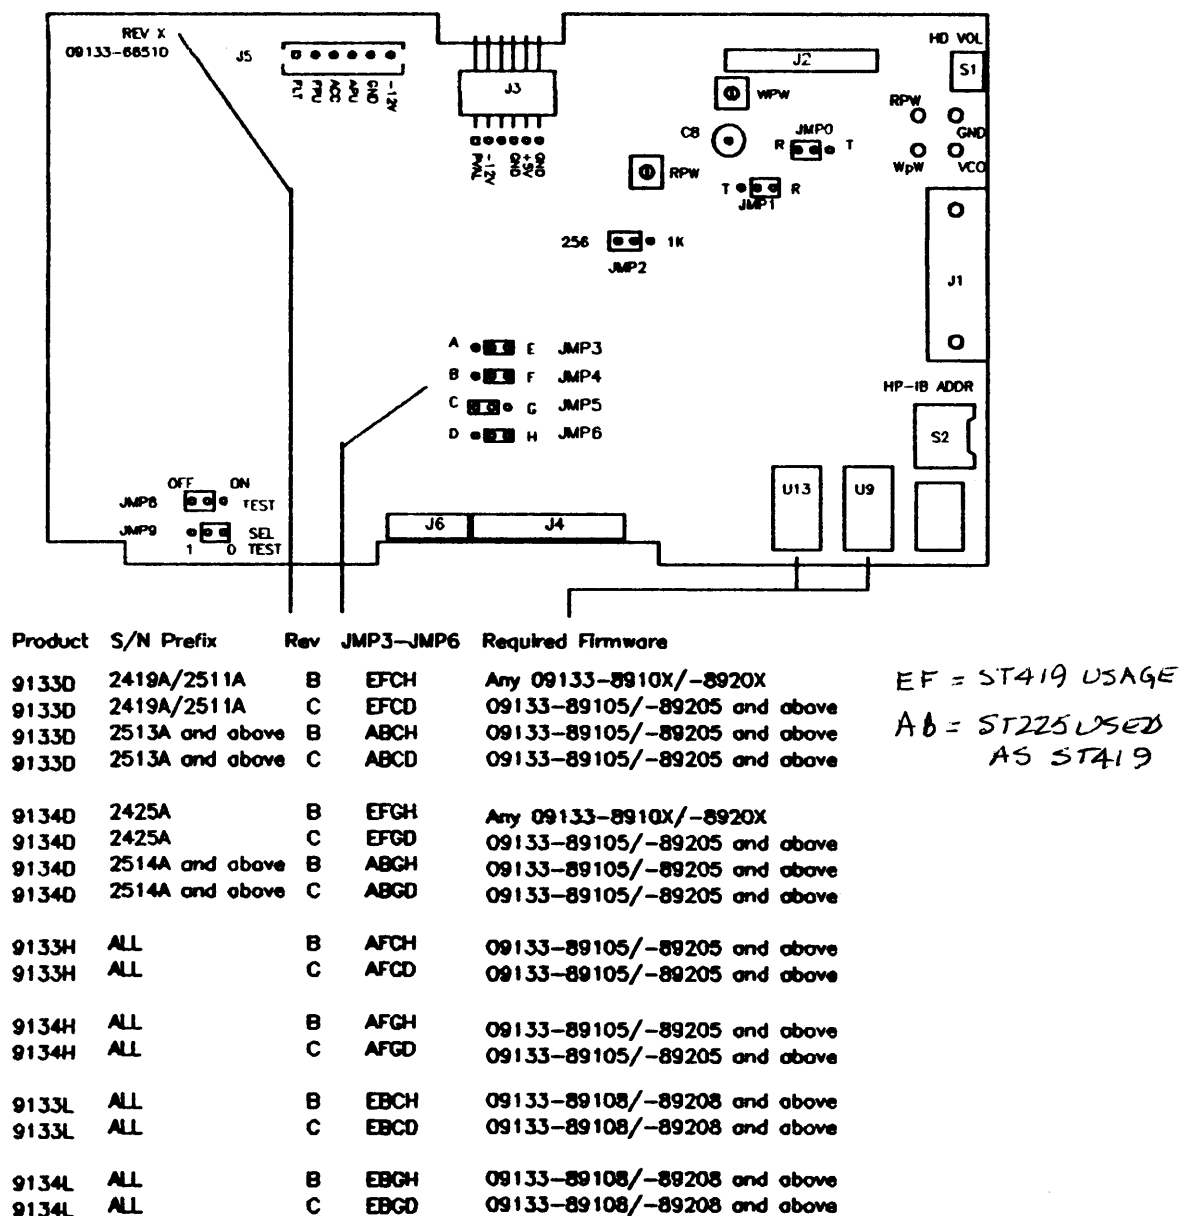
Figure 2-6. Controller board configuration.

NOTE: JMP2 is shown in the position for a standard product.
Option 001 will have JMP2 in the 1K position.

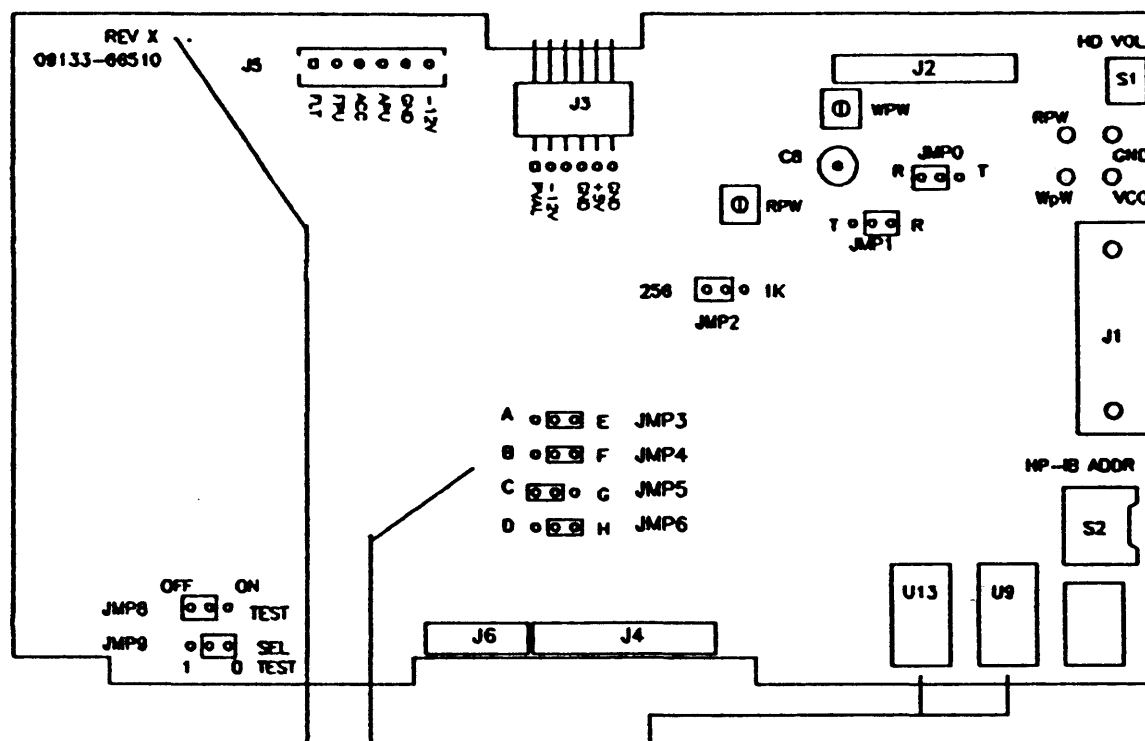
Product	S/N Prefix	Rev	JMP3-JMP6	Required Firmware
9133D	2419A/2511A	B	EFCH	Any 09133-8910X/-8920X
9133D	2419A/2511A	C	EFGD	09133-89105/-89205 and above
9133D	2513A and above	B	ABCH	09133-89105/-89205 and above
9133D	2513A and above	C	ABCD	09133-89105/-89205 and above
9134D	2425A	B	EFGH	Any 09133-8910X/-8920X
9134D	2425A	C	EFGD	09133-89105/-89205 and above
9134D	2514A and above	B	ABGH	09133-89105/-89205 and above
9134D	2514A and above	C	ABGD	09133-89105/-89205 and above
9133H	ALL	B	AFCH	09133-89105/-89205 and above
9133H	ALL	C	AFGD	09133-89105/-89205 and above
9134H	ALL	B	AFGH	09133-89105/-89205 and above
9134H	ALL	C	AFGD	09133-89105/-89205 and above

NOTE: JMP2 is shown in the position for standard product.
Option001 will have JMP2 in 1K position.

Both the Rev B and the Rev C controller assemblies will be used as exchange assembly 09133-69520. All service inventory of the original exchange assembly 09133-69510 must have firmware updated per service note 9133D-4 before being used to service any 9133D Disc Drives with serial number prefix 2511A or above. Firmware should not be updated in 9133D Disc Drives which are repaired.

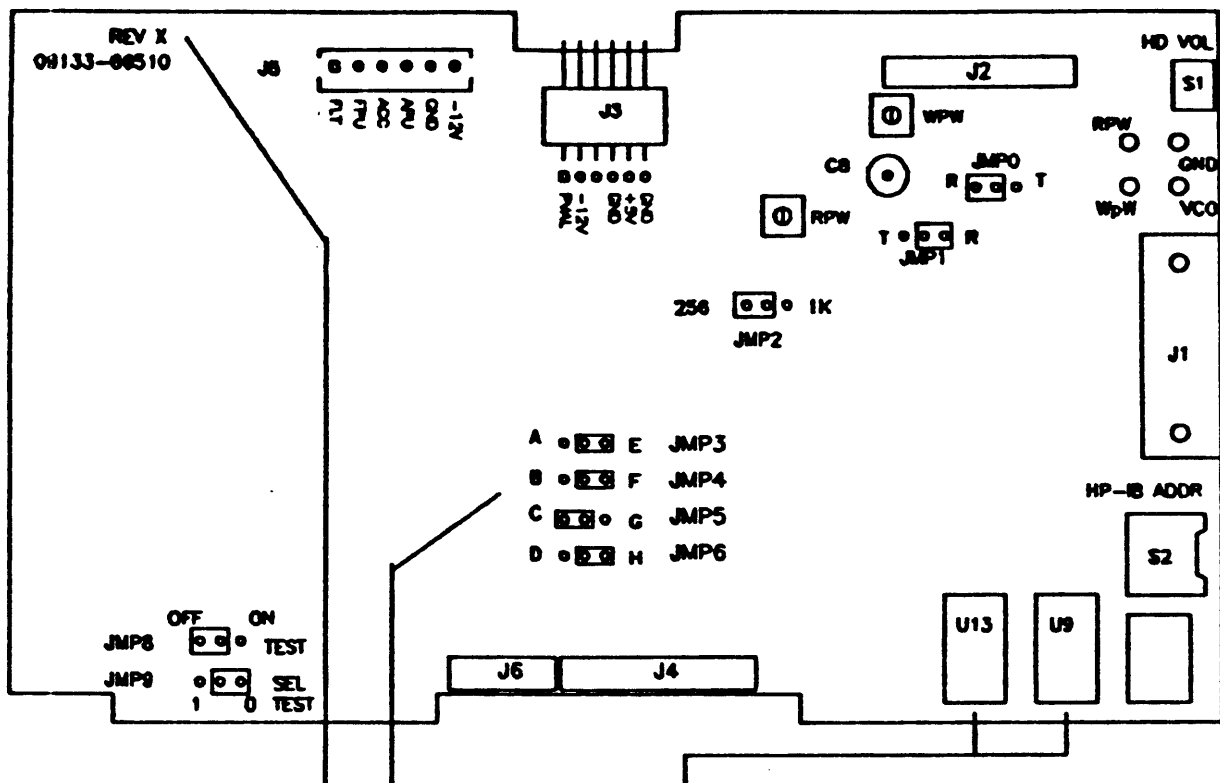
Product	S/N Prefix	Rev	JMP3-JMP6	Required Firmware
9133D	2419A/2511A	B	EFCH	Any 09133-8910X/-8920X
9133D	2419A/2511A	C	EFCD	09133-89105/-89205 and above
9133D	2513A and above	B	ABCH	09133-89105/-89205 and above
9133D	2513A and above	C	ABCD	09133-89105/-89205 and above
9134D	2425A	B	EFGH	Any 09133-8910X/-8920X
9134D	2425A	C	EFGD	09133-89105/-89205 and above
9134D	2514A and above	B	ABGH	09133-89105/-89205 and above
9134D	2514A and above	C	ABGD	09133-89105/-89205 and above
9133H	ALL	B	AFCH	09133-89105/-89205 and above
9133H	ALL	C	AFCD	09133-89105/-89205 and above
9134H	ALL	B	AFGH	09133-89105/-89205 and above
9134H	ALL	C	AFGD	09133-89105/-89205 and above

NOTE: JMP2 is shown in the position for standard product.
Option001 will have JMP2 in 1K position.
