Root Cause Analysis Report: fp_timing_f vs cts_timing_f

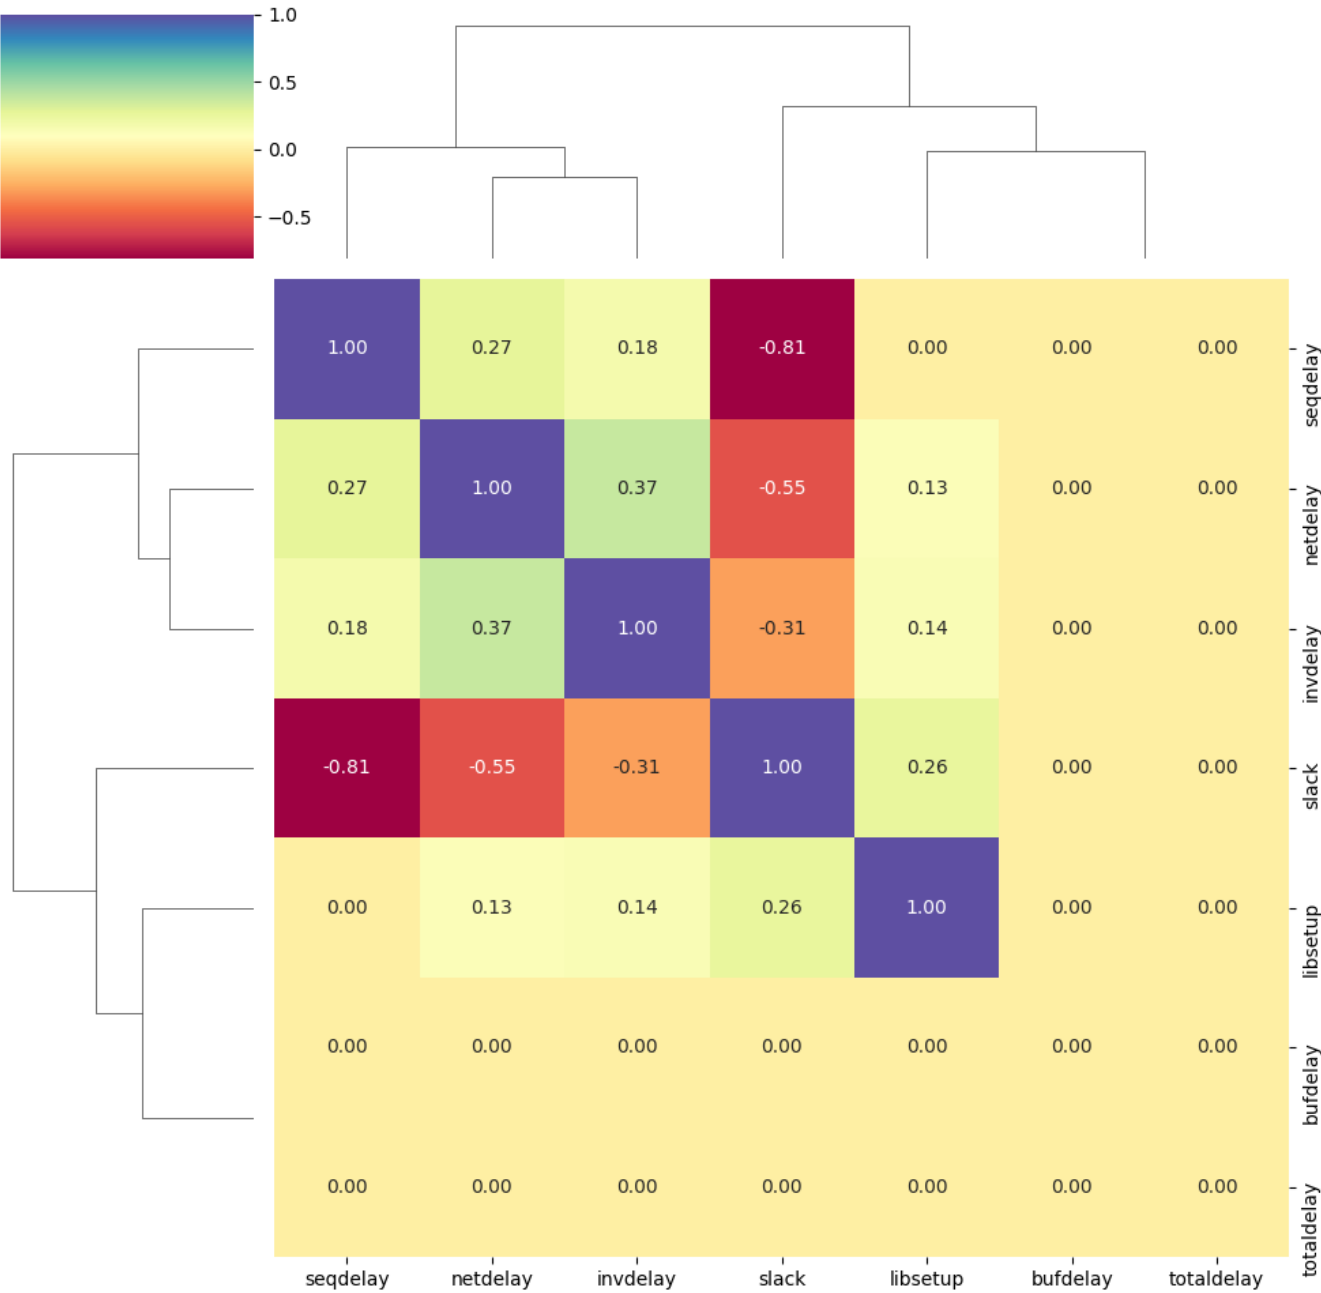
Above is a clustered correlation map for the computed delta data (fp_timing_f - cts_timing_f).

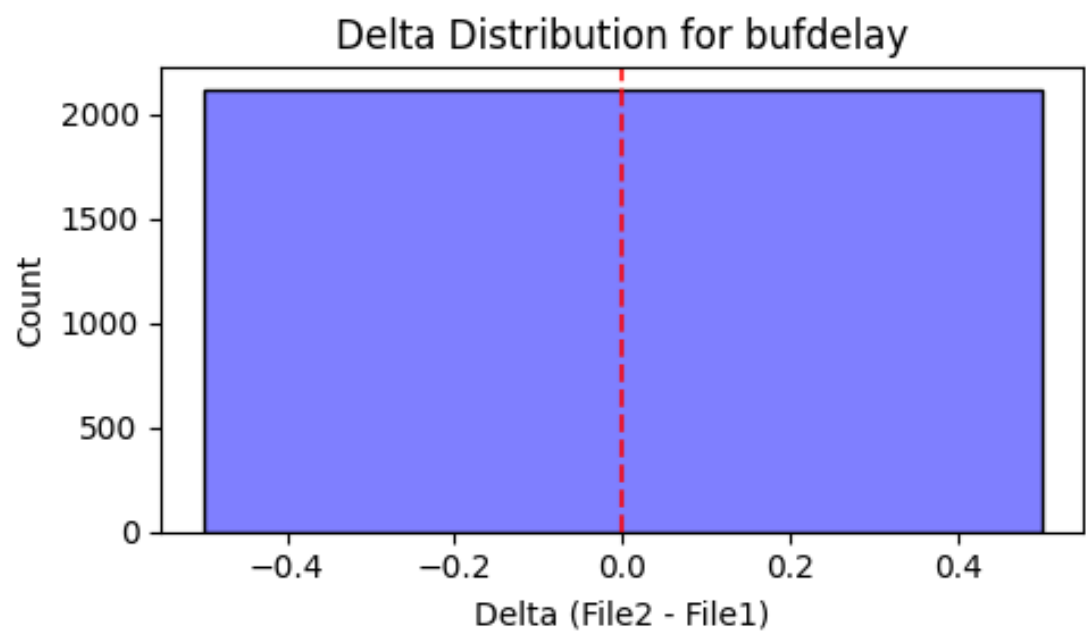
Column: bufdelay (Delta)

- Problem: No significant timing issue detected. The buffer delays are consistent across both files.

- Cause: The mean, standard deviation, minimum, maximum, and percentiles of the buffer delay values are all zero, indicating that there is no variation or shift in the delays between the two files.

- Solution: Since there is no issue detected, no action is required at this time.

- Prevention: Ensure proper design methodologies and verification processes are followed to maintain consistency in designs and avoid any potential timing issues. Regularly review and update design rules and constraints to account for process, voltage, and temperature (PVT) variations.

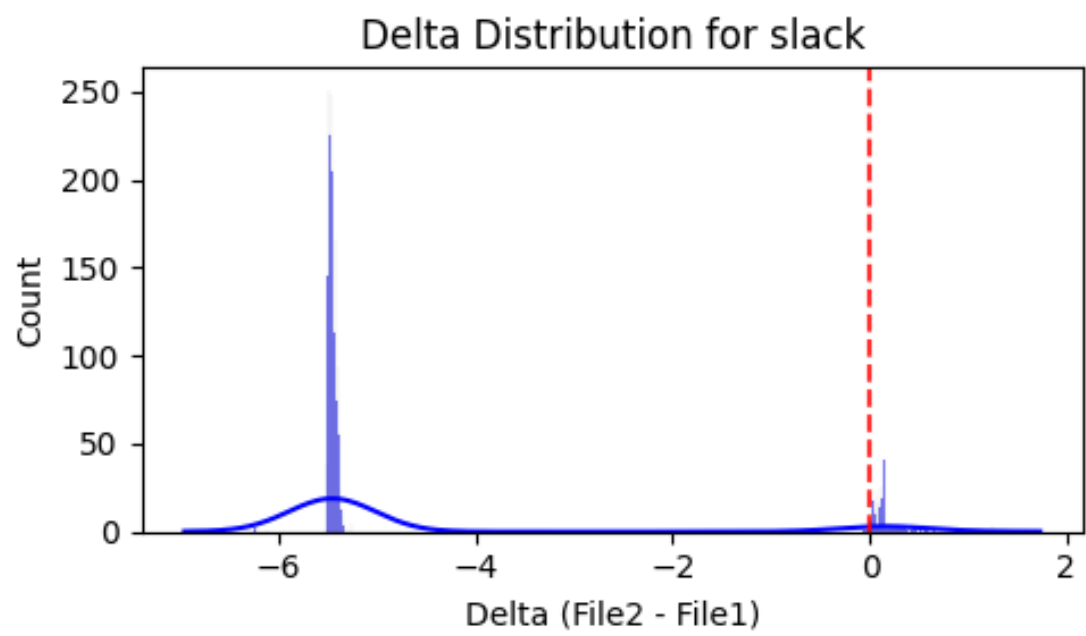
Column: slack (Delta)

- Problem: Timing Slack Deficit

- Cause: The mean slack value has decreased significantly (from File1 to File2), indicating that the timing of the circuit has worsened. This could be due to changes in logic, clock frequency, or routing delays.

- Solution: Review the design for any logic changes that may have increased path delays, adjust clock frequency if possible, and optimize routing to minimize interconnect delays.

- Prevention: Implement timing-driven design methodologies, perform regular timing analysis throughout the design process, and consider using design techniques such as buffering, clock gating, or delay tuning to maintain sufficient timing slack.

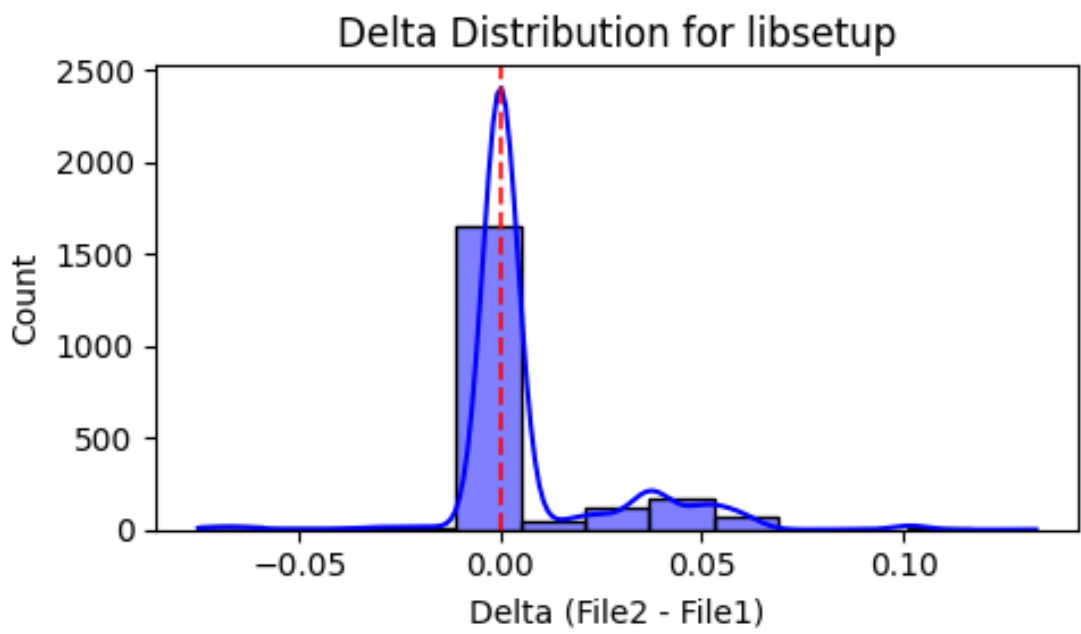
Column: libsetup (Delta)

- Problem: Significant timing variation between the two files (File2 and File1)

- Cause: The large standard deviation (Std: 0.020) and maximum value (Max: 0.133) suggest that there might be differences in the design, routing, or process variations between the two files.

- Solution: Analyze the designs of both files to identify any discrepancies in logic, clock tree, or power/ground distribution. Perform detailed routing checks and ensure that the design rules are being followed consistently.

- Prevention: Implement design for timing (DFT) methodologies early in the design process to minimize timing variations. Use consistent design styles across the project and perform thorough design rule checking (DRC). Optimize clock trees and power/ground distribution networks to reduce timing skew and delay variation.

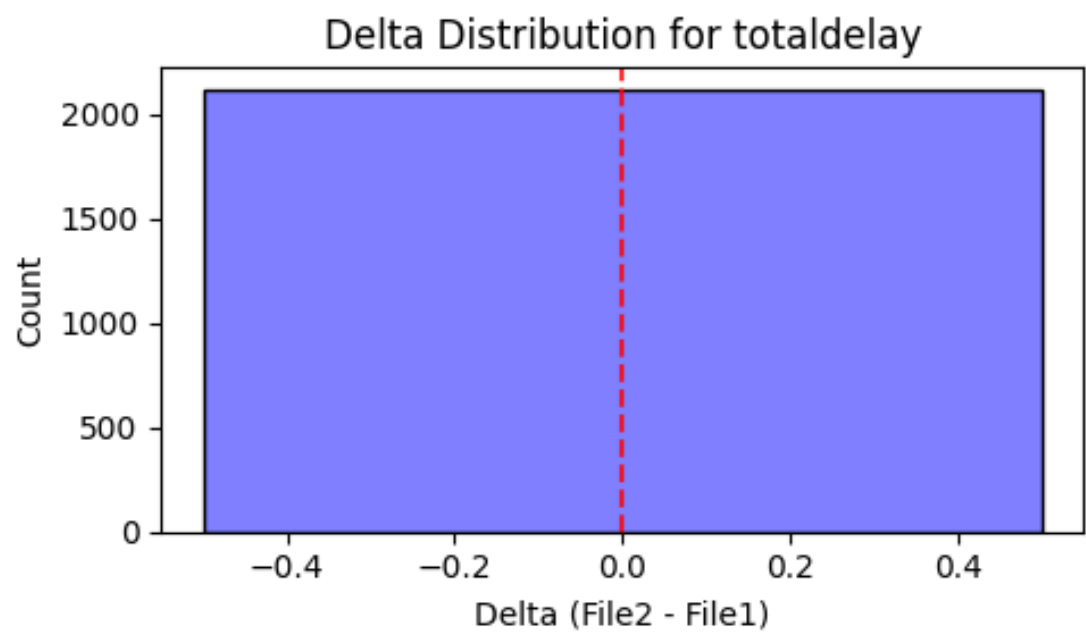
Column: totaldelay (Delta)

- Problem: No significant timing issue detected.

- Cause: The delta analysis shows no meaningful difference between the two files, indicating that there are no major design changes or timing shifts.

- Solution: Since there is no issue, no action is required at this moment. Continue with the current design flow.

- Prevention: Ensure thorough design reviews and verification checks to catch any potential issues early in the design cycle. Regularly compare designs using delta analysis to identify any changes that might affect timing.

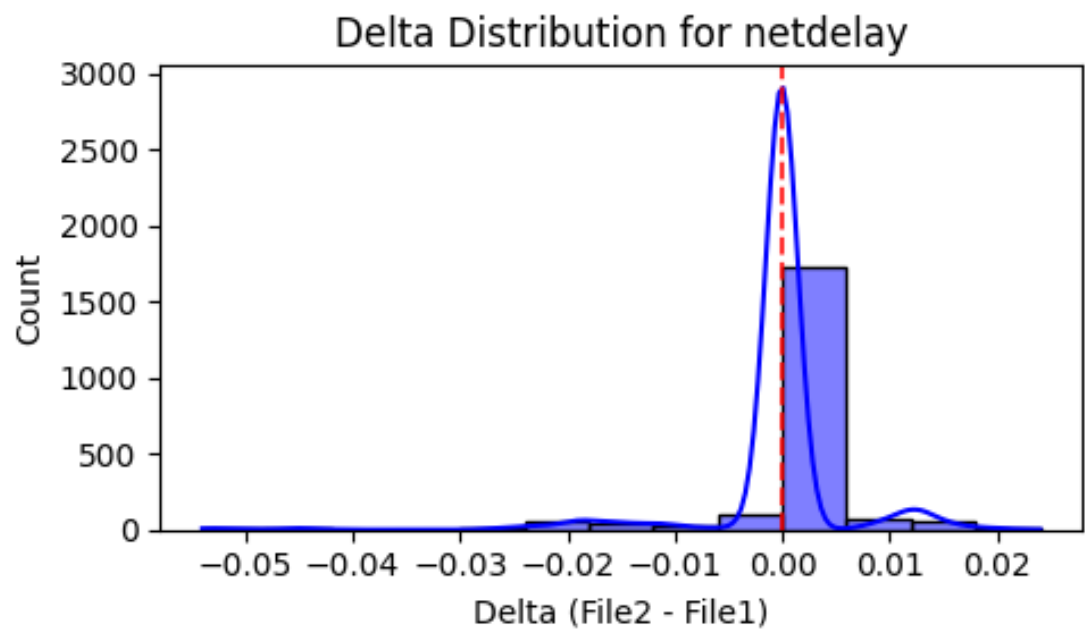
Column: netdelay (Delta)

- Problem: Negative mean net delay and large negative delta values indicate potential timing

issues.

- Cause: The cause could be a design issue such as insufficient buffer insertion, long critical paths, or improperly sized clock trees. It may also be due to process, voltage, or temperature (PVT) variations that have shifted the timing.

- Solution: Review the design for appropriate buffer placement, optimize the routing and clock tree, and consider using timing-driven placement and routing tools. Adjust the design to meet the specified timing constraints.

- Prevention: Implement timing-aware design methodologies from the start of the design flow. Use statistical timing analysis to account for PVT variations. Regularly monitor and adjust the design during the development process to maintain timing closure.

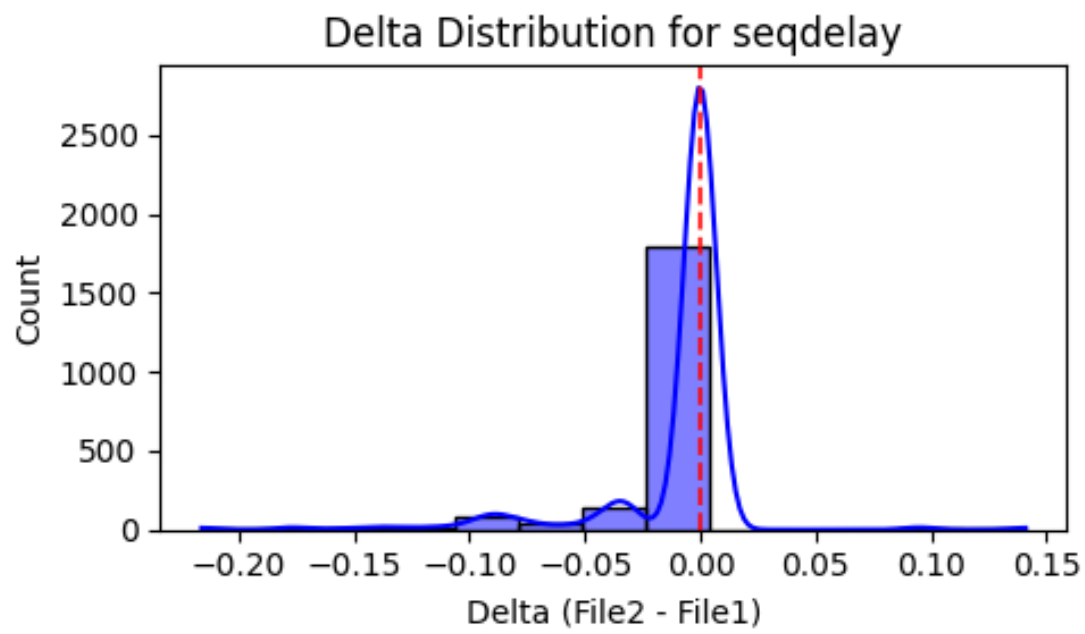
Column: seqdelay (Delta)

- Problem: Sequential delay is negative, indicating a potential timing violation.

- Cause: This could be due to slowing down of the sequential path (flip-flop) or an increase in load capacitance, or both. It might also be caused by improperly sized clock trees, incorrect clock skew compensation, or routing congestion affecting signal integrity.

- Solution: Optimize the design for speed by reducing the load on the flip-flops (e.g., minimizing fanout, optimizing logic depth), improving clock tree synthesis and routing, and ensuring proper clock skew compensation.

- Prevention: Perform thorough timing analysis during the design stage to identify potential bottlenecks and address them proactively. Use design for testability (DFT) techniques to monitor and control the timing of critical paths. Implement guard bands in the timing budget to account for process, voltage, and temperature variations.

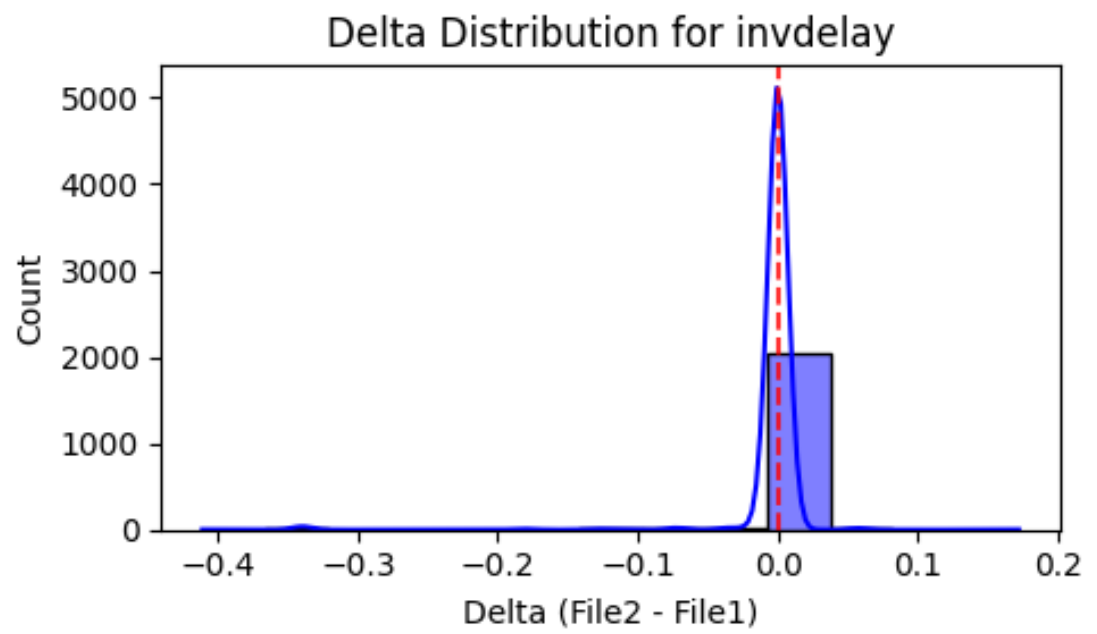
Column: invdelay (Delta)

- Problem: Negative mean delay and skewed distribution towards negative values, indicating

potential timing issues.

- Cause: The design may have critical paths with insufficient drive strength, long wirelengths, or high capacitive loads that result in delays exceeding the specified clock period. Additionally, there might be process, voltage, or temperature variations causing timing shifts.

- Solution: Optimize the design by reducing wirelengths, increasing drive strengths, and minimizing capacitive loads where possible. Consider using timing-optimized standard cells, buffering critical paths, and adding guard rings to reduce coupling effects. Perform clock tree synthesis for better clock distribution.

- Prevention: During the design phase, perform thorough timing analysis early and iteratively throughout the design flow. Use timing-aware placement and routing tools to optimize for timing and minimize delays. Ensure that the design meets the specified timing requirements before proceeding to the next stage of development. Additionally, consider using design methodologies such as power-optimized or area-optimized styles based on the specific application's requirements.
