CMD-HD Replica Design by toms01

A board review on revision 1.2 by M.Kanet / June 2021

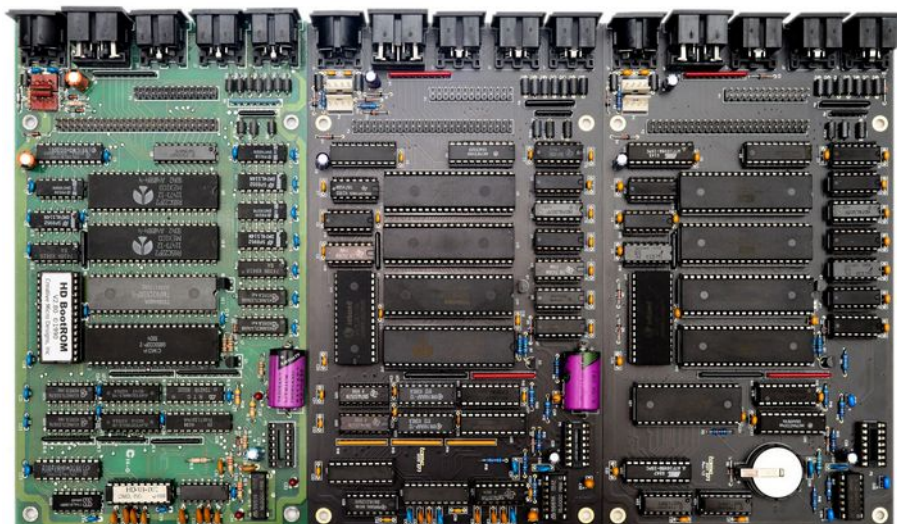
From left to right: The original board from CMD, revision 1 and the new revision 1.2 of the replica.

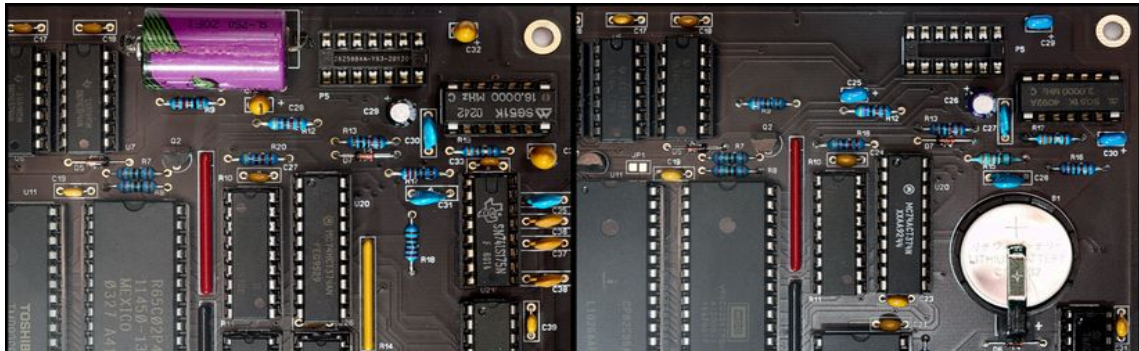
The biggest change might be the change from a fixed battery to a battery holder for a CR2032. This allows to replace the battery for the internal RTC real-time clock if needed. On the left the revision 1 with the fixed battery, on the right the revision 1.2 with the new CR2032 battery holder (Figure-03).

Also the clock (top right of the picture) could be reduced from 16Mhz to 2Mhz.

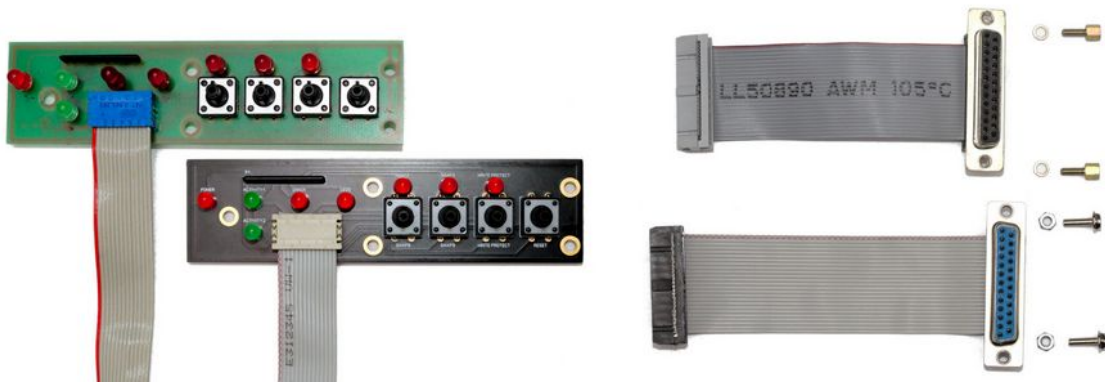
- Left/green the original board, below in black the replica.
- Right/top the original DB25 connector female/male threaded screw. This allows the screws of a DB25 connector to be attached to the housing.
- Right/bottom the replica. To fix the DB25 socket in the housing I used screws+nuts.

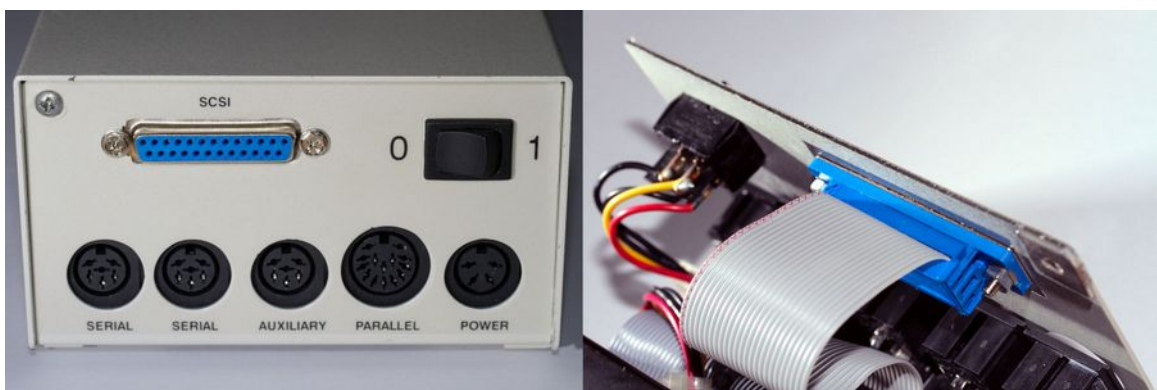
The DBV25 cable set fits into the existing opening of the CMD-HD (Figure-05):

When installing, you should pay attention to the alignment, since the ribbon cable is plugged directly onto the board. In the example above this succeeded without twisted ribbon cable.

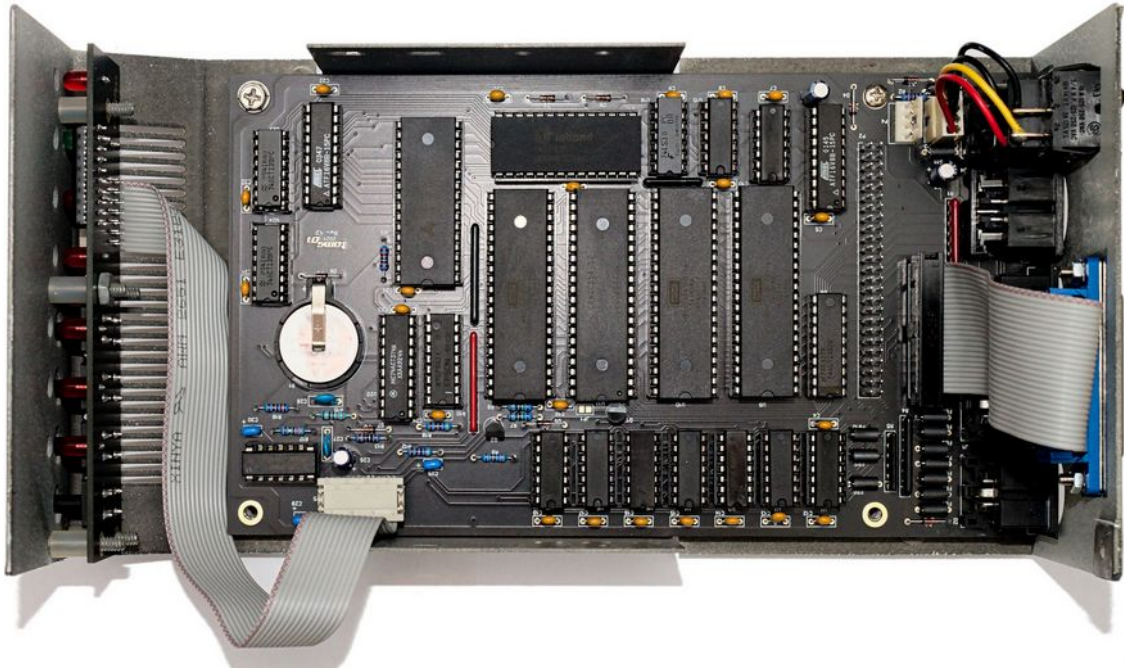
Next, the replica had to be put back into the case. There were probably various manufacturing tolerances at CMD and not every board or every case was exactly the same size. The revision 1 was at least for my case about 0.5mm wider than the original. Revision 1.2 has been optimized a bit and now fits easily and without force into the metal case. Also the holes for the mounting screws are in the right place. (Figure-06)

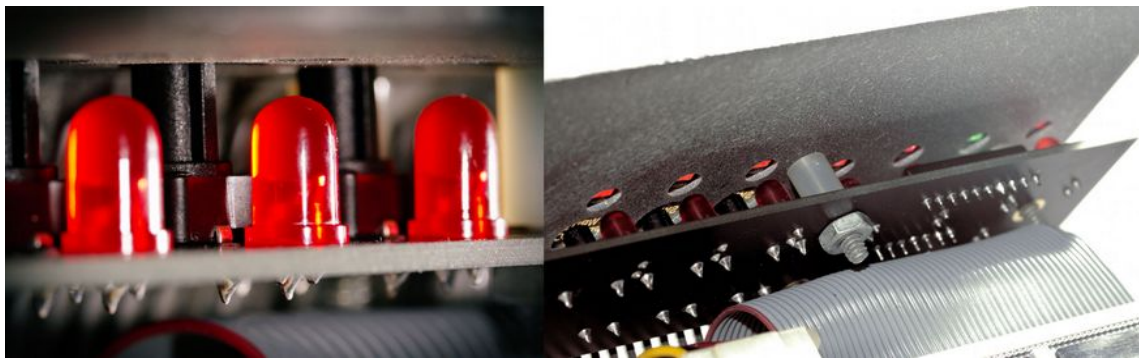
On the original board the LEDs were soldered individually, i.e. with different distance to the board itself. As you can see on picture 10, it might make more sense to install the LEDs directly on the board: On my HD, the LED had permanently pressed through the foil over the years.

The original board in my CMD-HD also required additional spacer rings: The spacer sleeves alone did not provide the correct distance to the front panel.

If the distance is too small, then the buttons are constantly under "pressure". If the distance is too large, then the buttons can no longer be pressed in. Every millimeter counts here.

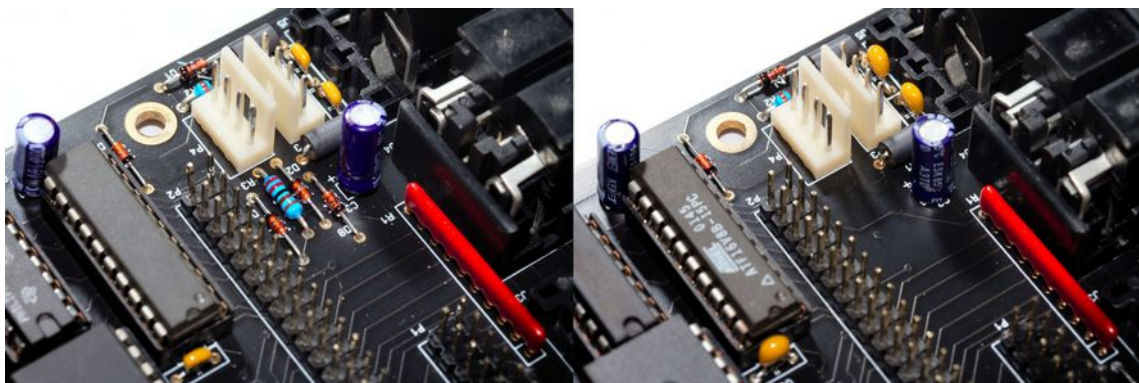
On the left the revision 1, on the right the revision 1.2. Also here the board was optimized.

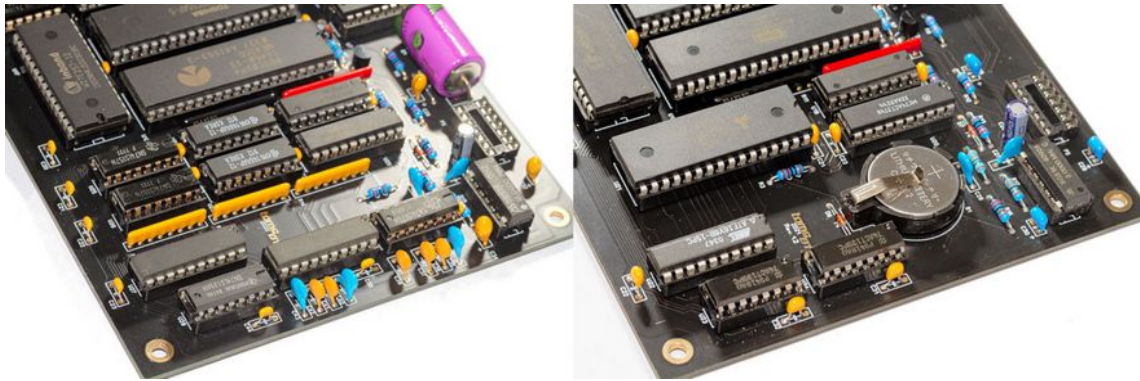
DRAM to SRAM (swapped) and then the multiplexers etc. fell out. And also the resistor networks. This also allowed the one GAL to be replaced by discrete logic (only two GALs in total). Among other things, a design flaw in the use of the clock backup battery was also fixed. This should now last longer and not unnecessarily "power" other areas when the drive is off.

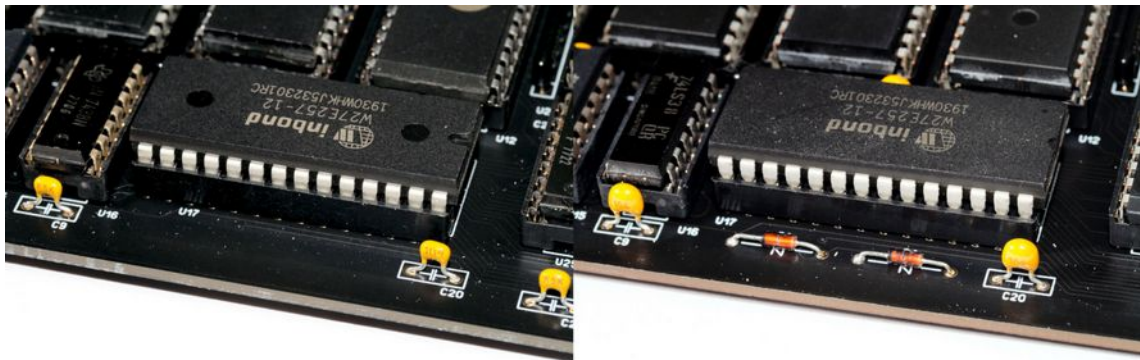
Some components were also "moved" or became necessary due to the previously mentioned optimizations (Figure-15):

The shown changes are needed so that both types (N/S) of the currently manufactured VIA W65C22 from WDC can be used.

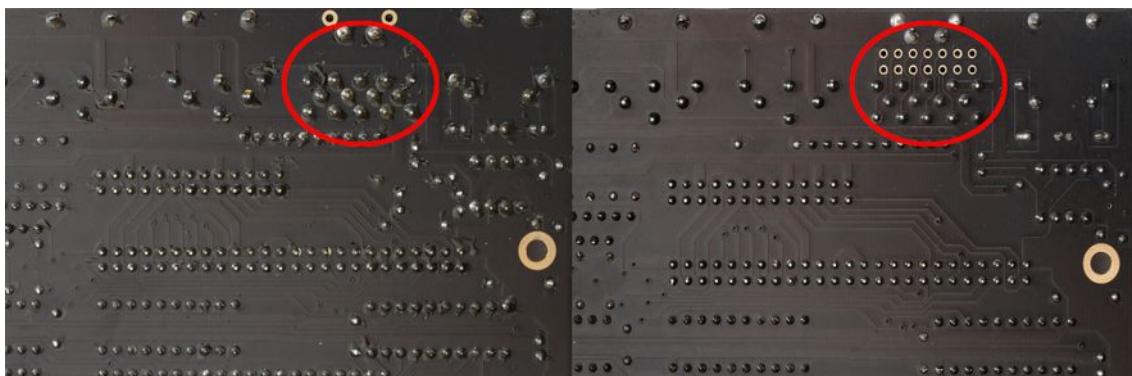
Another improvement can be found on the bottom side of the board in the area of the 14pin socket for the parallel cable: Since the plug or socket is rather a discontinued model, a 2x7 socket strip or soldering points for such a strip was provided (Figure-16):
