SciFi TELL40: Progress and Status

O. Le Dortz (LPNHE, Paris)
on behalf of the SciFi FE and BE Electronics teams

SciFi General Meeting, Feb 27th 2023

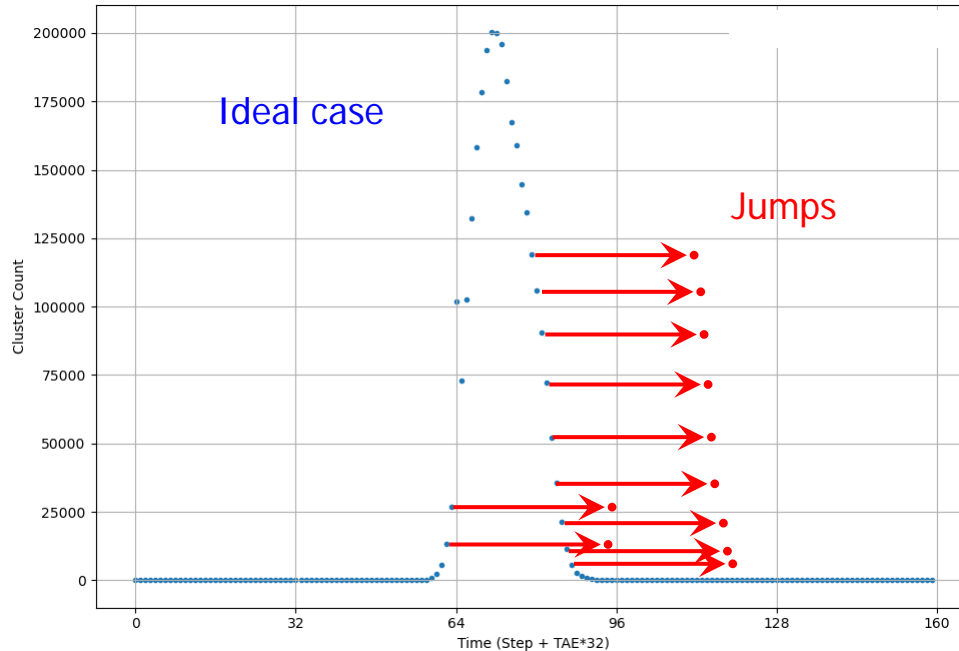
Beam Timing Scans: the BXID jumps

5 consecutive cluster counts, superimposed over the 32 steps (scan over 25 ns)

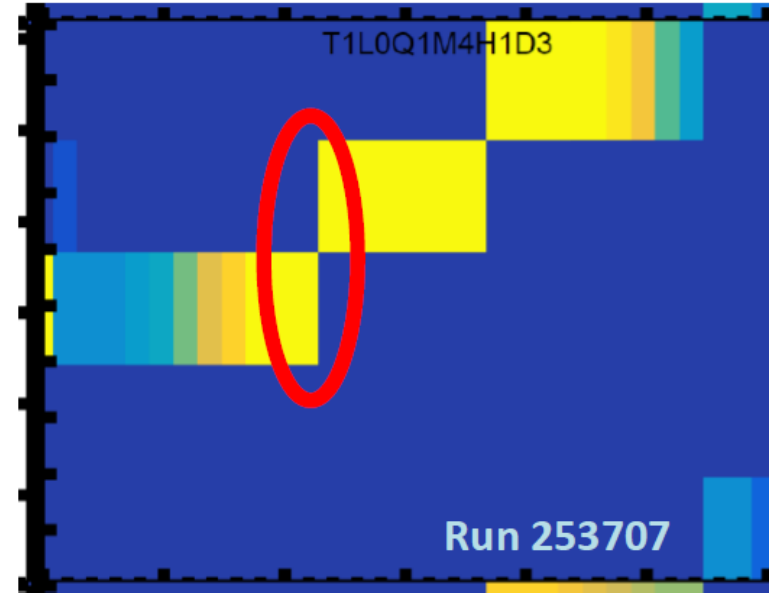
Distribution of cluster counts:

- X axis = step number (0 to 31)
- Y axis = from centralBxid-2 to +2

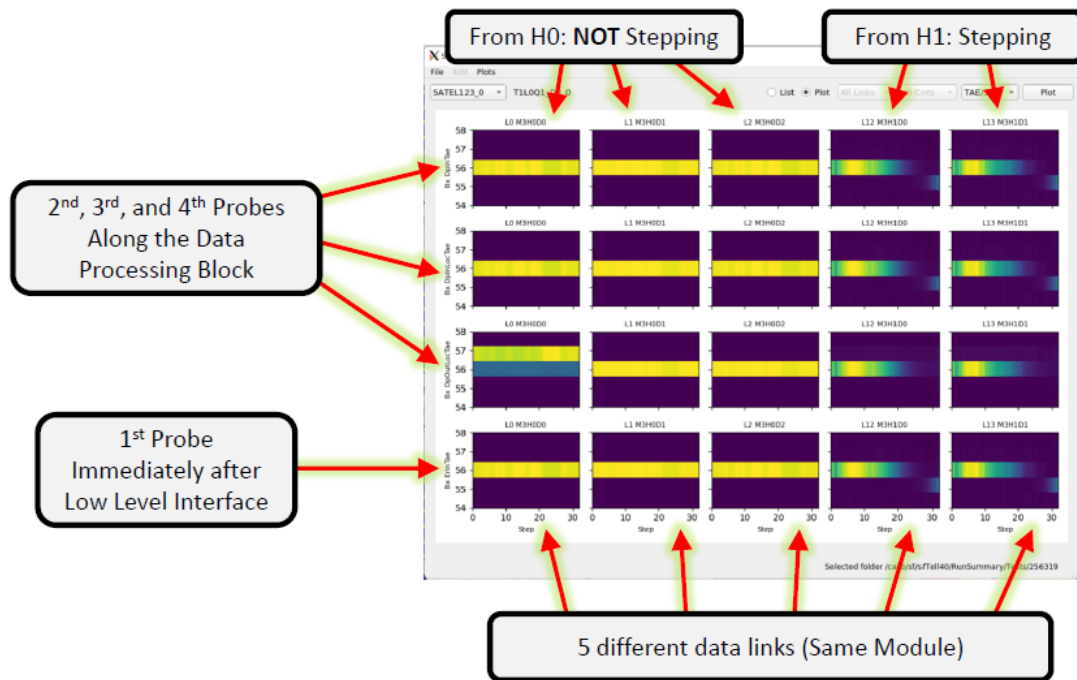
Outcome:

No BXID jumps observed from the TELL40 flow input to the Data Processing block output

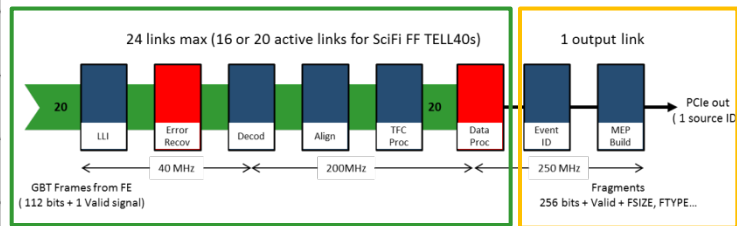
Could it come from the downstream TELL40 modules (EventID, MEP builder) or from the EB, software ?
