BUG REPORT

By Amogh Sakdeo, Radhika Sakhare, Parth Bhogate

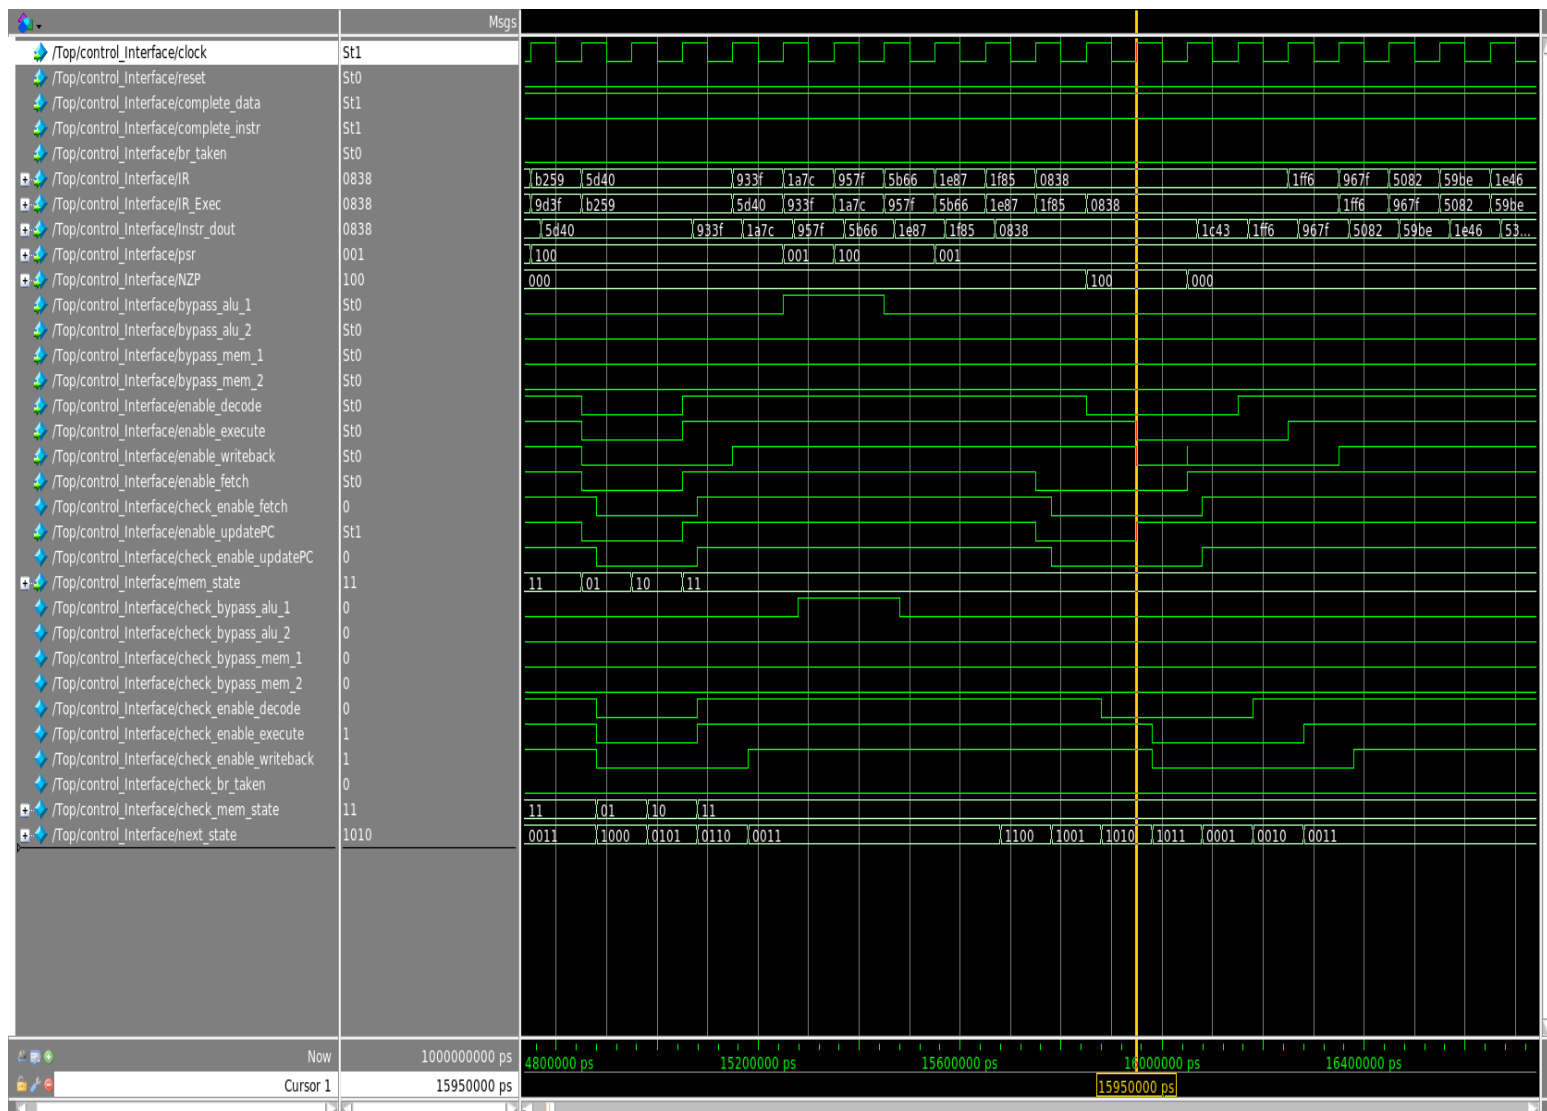
Bug 1 (data_defs_bug1.vp) Not taken branch behaving like a taken branch

The above bug is found in the controller block of the LC3 DUT. For a branch instruction appearing at the Instruction Dout (opcode: 4'b0000), the enable fetch and enable update PC signals go low, followed by enable decode going low in the next clock cycle and enable execute and writeback going low in the following clock cycle. For a not-taken branch, enable fetch and enable update PC then go high in the next clock cycle and others follow in the next cycles. If a branch is taken, it is detected at the execute stage and enable Update PC immediately goes high for the taken address. In this particular bug, for a not taken branch enable update PC goes high when the Instruction is in the execute stage hence staying low for only two clock cycles rather than staying low for three clock cycles.

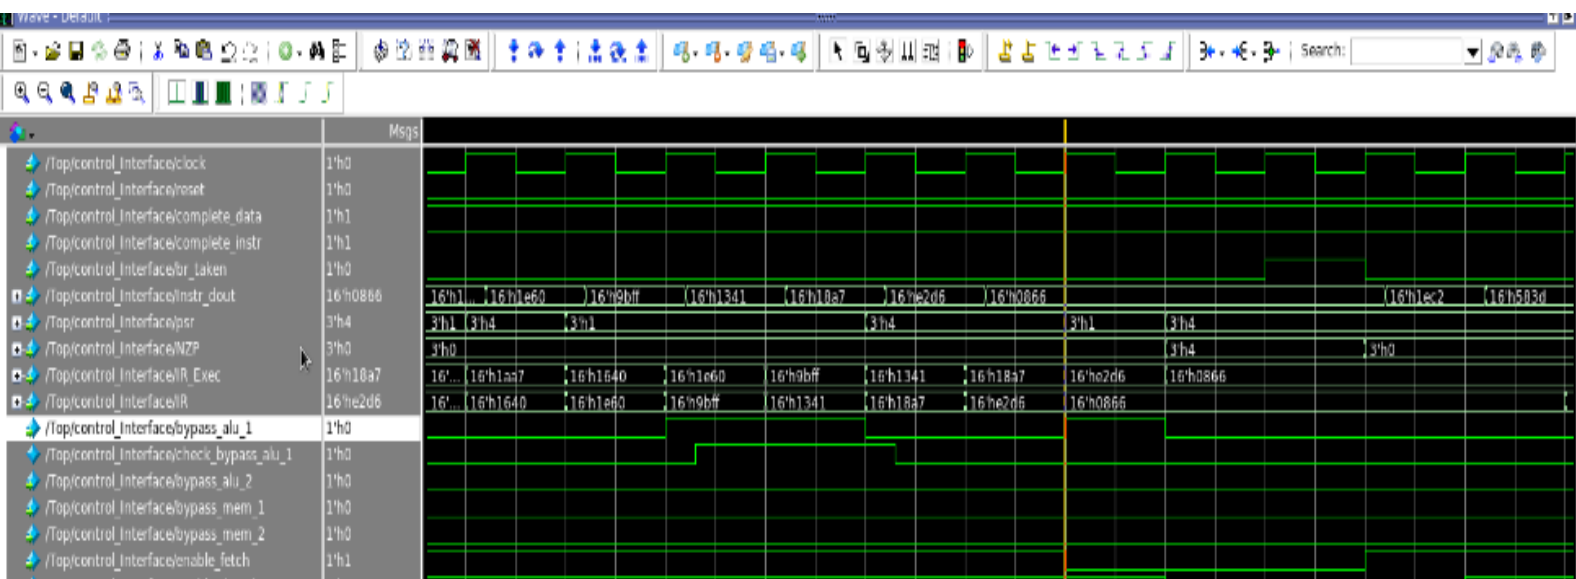
Bug 2 (data_defs_bug2.vp) Branch acting like a Jump checking for dependency IR[8:6]

Bug 2 is found in controller block of the LC3 DUT. When a branch instruction is encountered at IR, there is no need to check for the bypass ALU signals since branch checks the value of previous register being worked upon and decides whether the Branch is taken or not. However in this particular bug, Bypass ALU1 goes high at times and it is not expected. It can be seen that Branch is behaving like a Jump and whenever IR[8:6] matches with IR_Exec[11:9] bypass ALU1 goes high implying that it is checking for a condition of destination followed by source register so that it can take the value from the Bypass of Execute stage. Instruction sequence: 16'h5000 followed by 16'h0400 can help detect.

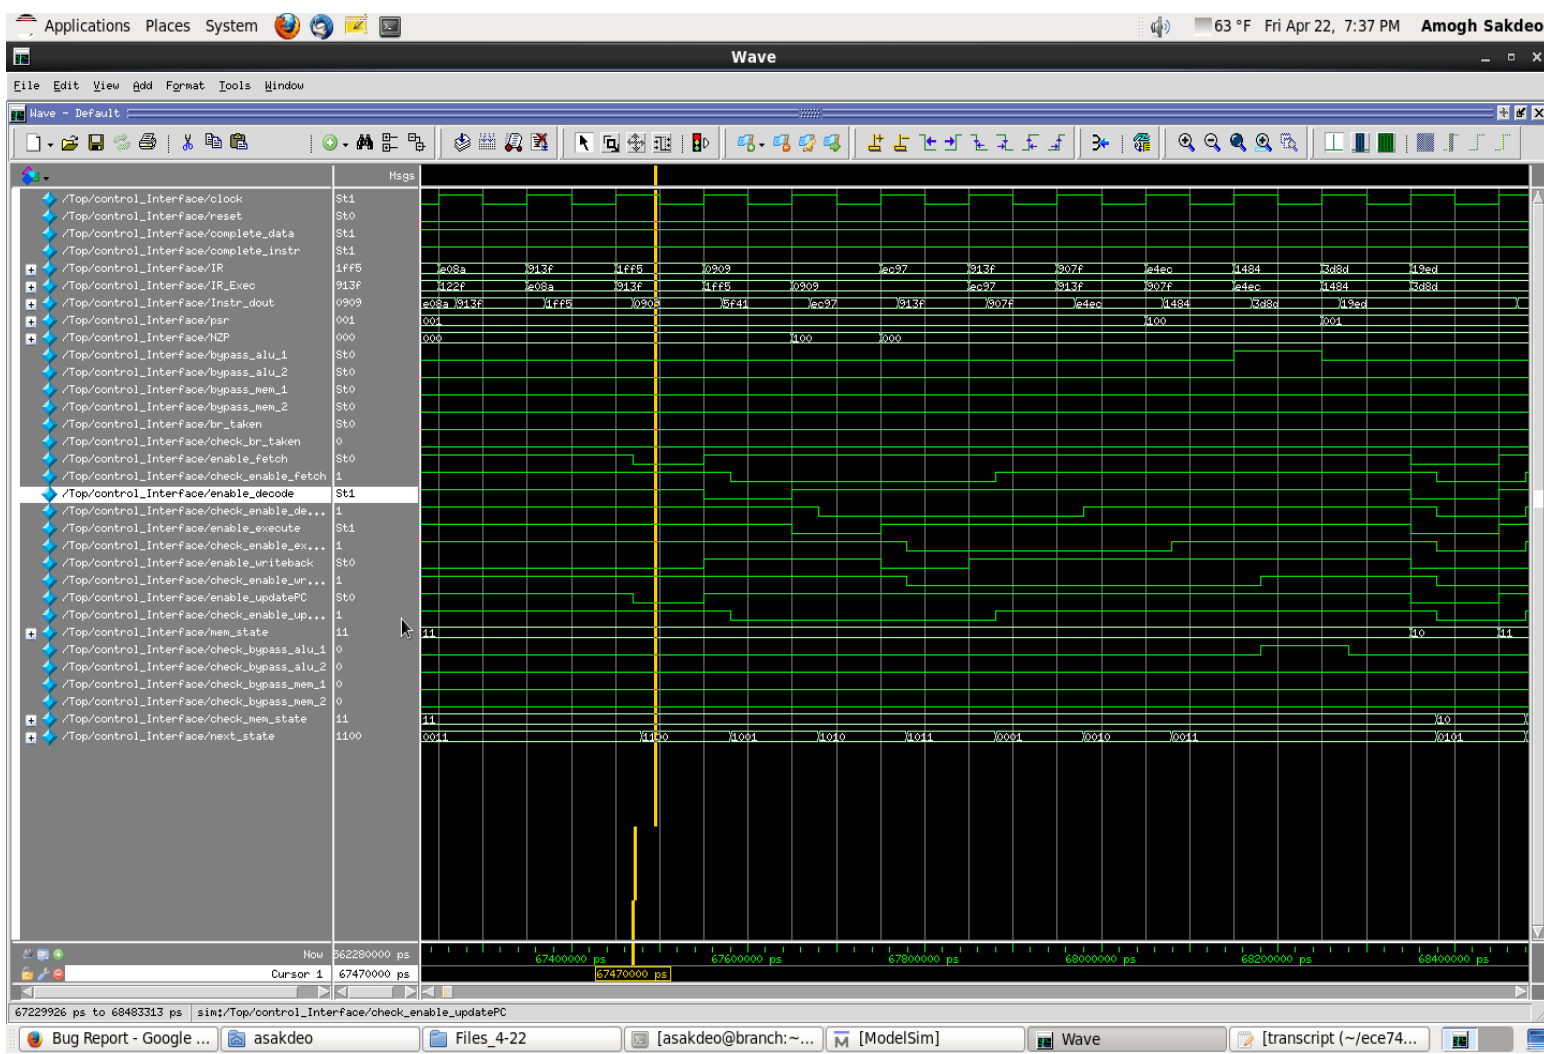
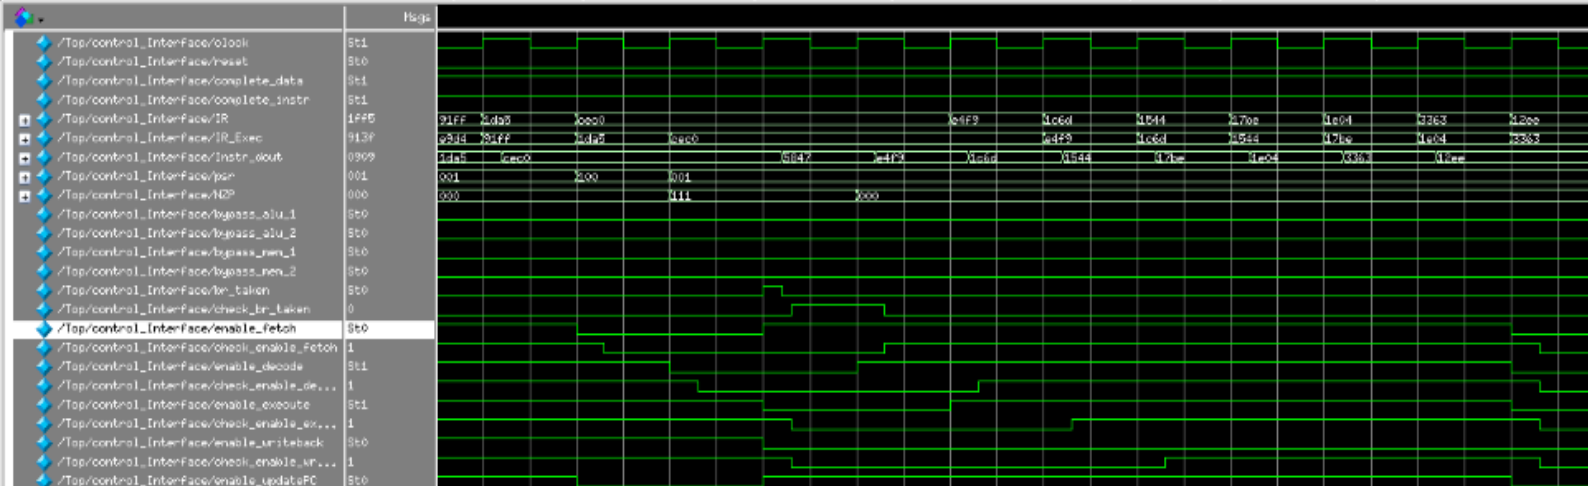
Bug 3(data_defs_bug3.vp) Wrong Enable signal sequences for Control Instruction

This bug is in the controller block of the DUT. For a control instruction appearing at Instr_dout enable fetch and update Pc go low, in the next clock cycle enable decode goes low and in the next clock cycle enable execute and writeback go low. In the following clock cycle all the enables start going high one by one. If it is a taken branch or a jmp enable goes high one clock cycle early (in the execute stage). However for this bug, when a first control instruction appears and is a taken one enable fetch also goes high along with enable update PC after 2 clock cycles. Because of which next instruction appears on the instr_dout and we don't see br_taken flag going high. All the other enables start becoming high in sequence after fetch becomes high in different clock cycles. Also enable writeback when it goes low is stuck at 0 until it encounters a next control instruction at the instr_dout. For a second control instruction enable fetch and update PC go low asynchronously and stay low only for one clock cycle, and other enable signals keep following the same behaviour in successive clock cycles in sequence. Since Enable fetch goes high so soon, instr_dout value changes early and the DUT does not compute Br_taken flag. These two sequences are then alternated for the further control instructions.

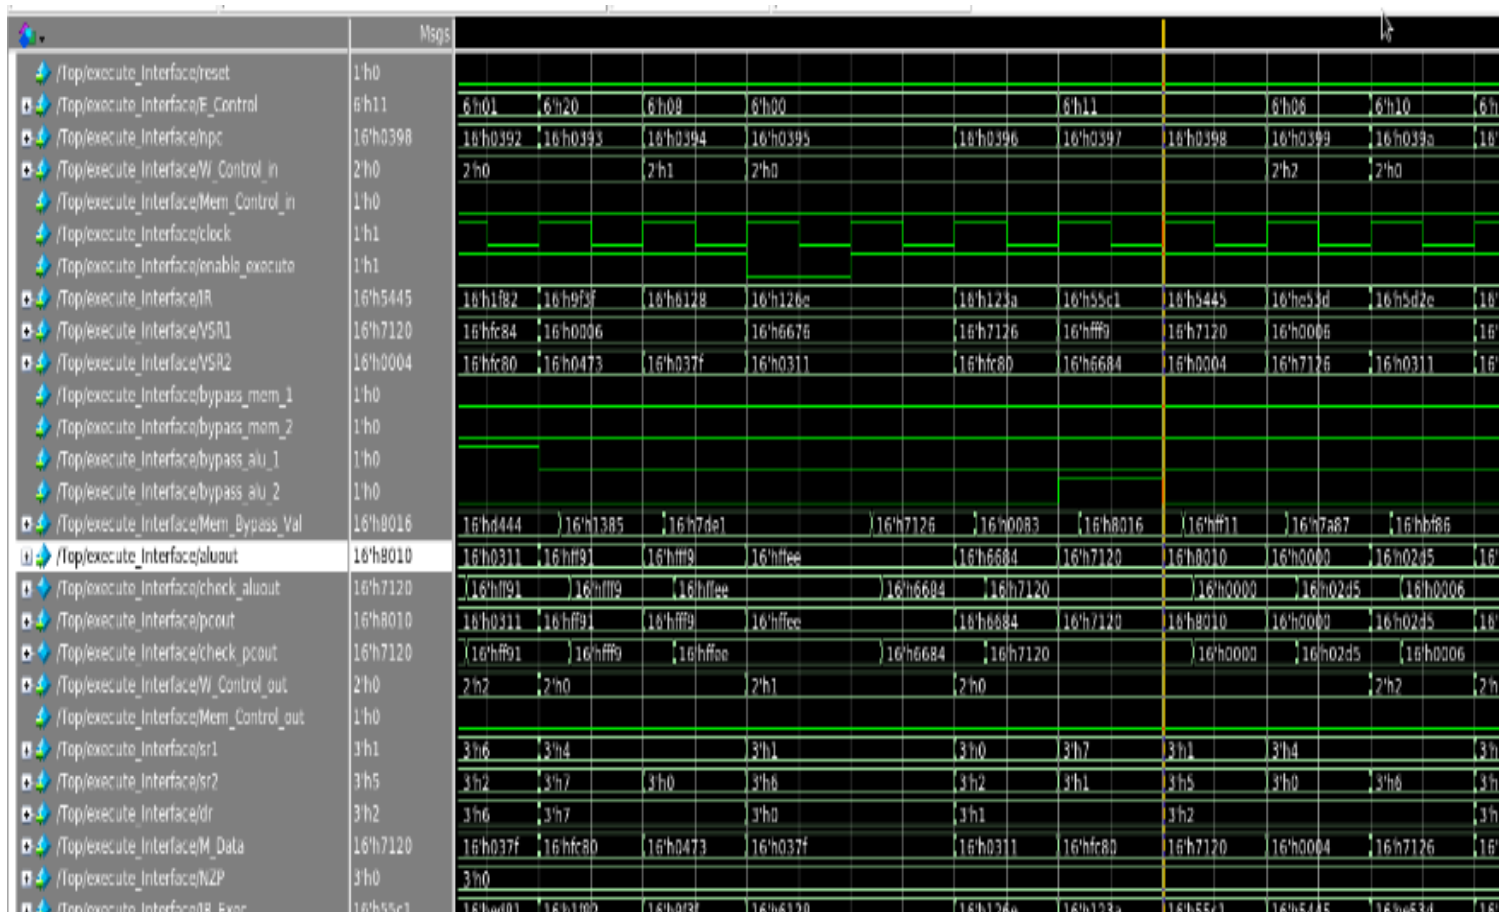
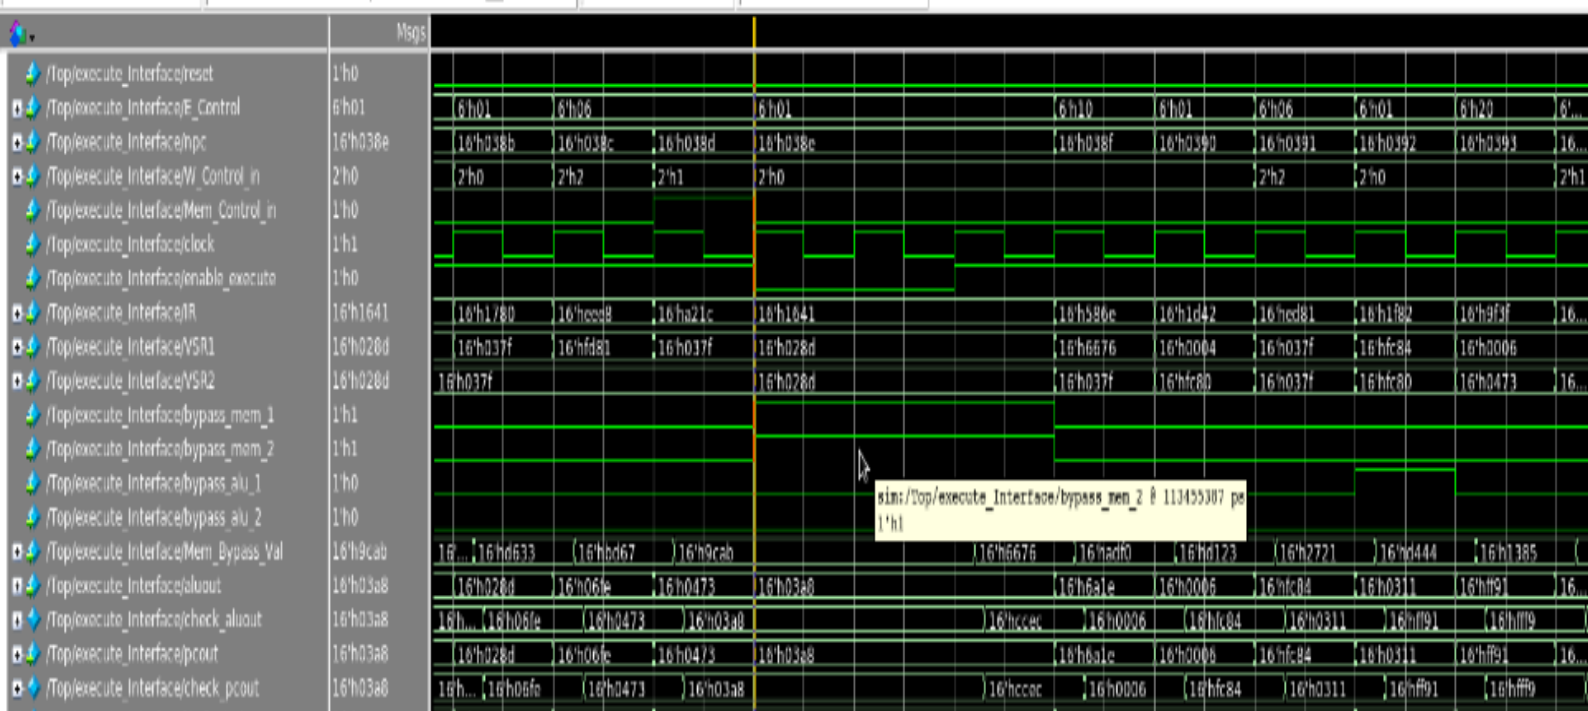
Bug 4 (data_defs_bug4.vp) Bypass ALU2 and Bypass mem2 values interchanged

This bug is found in the Execute block of LC3 DUT. When Bypass ALU1 or Bypass ALU2 is high, the values ALUout and PCout should be calculated from VSR1 or VSR2 respectively since they reflect the values from the ALU bypasses. Similarly when Bypass mem1 or bypass mem2 is high, ALUout and PCout should be calculated from the mem_bypass_val since it reflects the value from mem bypass. However in this particular case when Bypass ALU2 is high, value from Mem_bypass_val is being taken for calculating ALUout and PCout. Similarly, when Mem_bypass 2 is high, the value of previous ALUout is taken implying that it is acting like ALU bypass 2. Instruction sequence 16'h50c0 followed by 16'h1ab0 will help us detect this bug. The following waveforms show the two conditions that have been mentioned for this bug

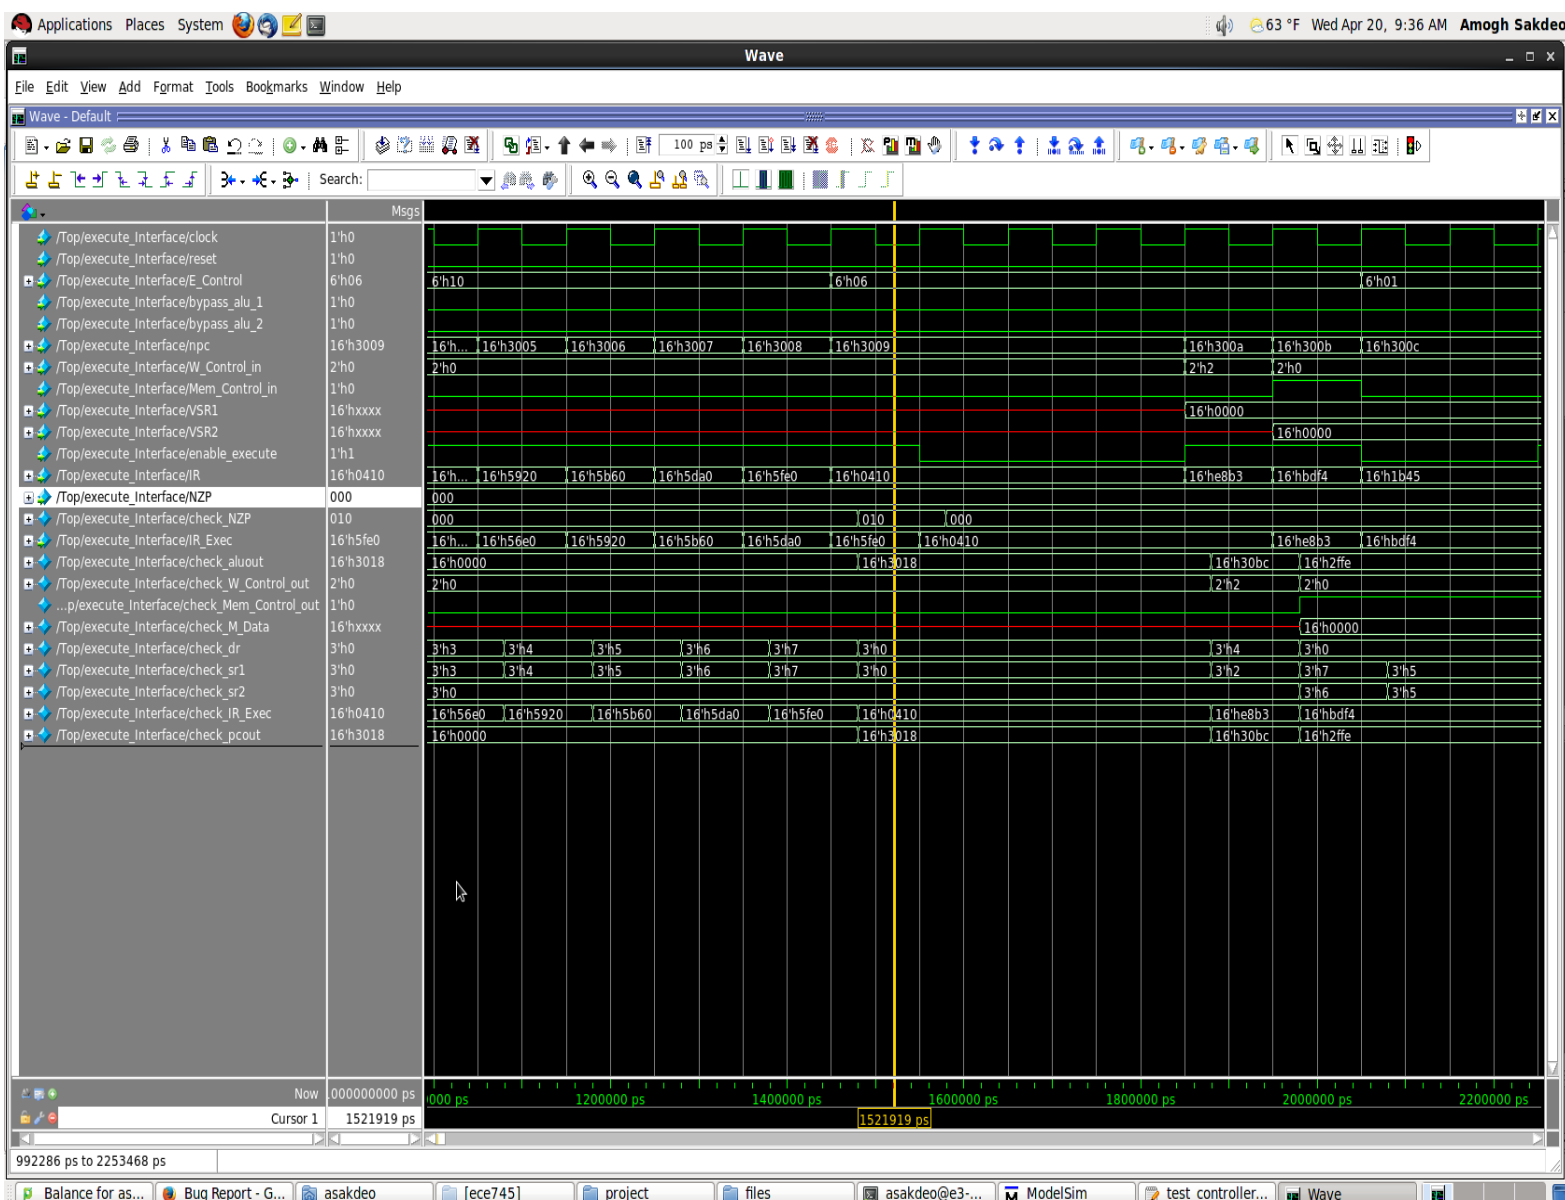
Bug 5 (data_defs_bug5.vp) Z flag of NZP status register stuck at 0

This bug has been found in the execute block of the LC3 DUT. For a branch, every-time the NZP is calculated based on the value of Instruction register. IR[11:9] has the value of NZP associated with the branch instruction. For a JMP instruction the value of NZP is 3'b111, the DUT models this behaviour. For rest of the instructions, the value of NZP is 3'b000 which is also being modelled by the DUT. However for a branch instruction with IR[11:9] as 3'b010, 3'b000 is getting modelled by the DUT while for rest of the flags (3'b001, 3'b100), DUT works as expected. Thus NZP[1] is stuck at 0 implying that the zero flag of NZP is stuck at 0.
