Rear End Repair

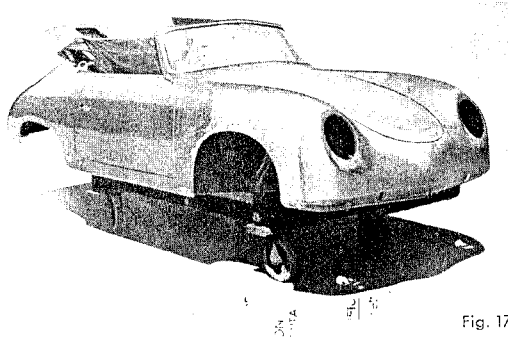
Fig. 176

Body with new front section.

The interior section is tacked in place and spot welded with calking compound in the seam around the lower edge. The vertical seam is flame welded.

After the body is removed from the alignment jig, the fitting of the skin section is performed with the aid of a new front hood and the two bumper brace holes. The hood serves as a pattern for the hood opening and the two bumper brace slots are used as levelling references. Two 30x5x approx. 300 mm ($\frac{3}{16}$ x $1\frac{3}{16}$ x 12 in.) rods are to be inserted into the bumper brace sockets to serve as reference markers. The headlight sockets must be horizontally on the same level and equidistant from the car center.

The paint near the weld seams must be removed so that the joints can be covered with lead in order to smooth them into the body contours. The hood must then be aligned with the opening so that there is a uniform 3 mm ($\frac{1}{8}$ in.) gap around the entire hood.

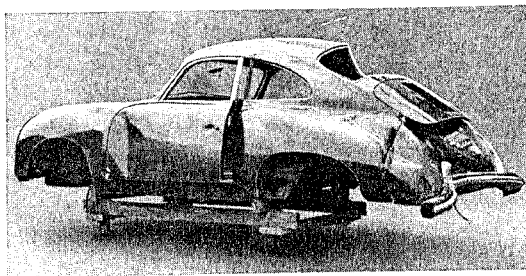
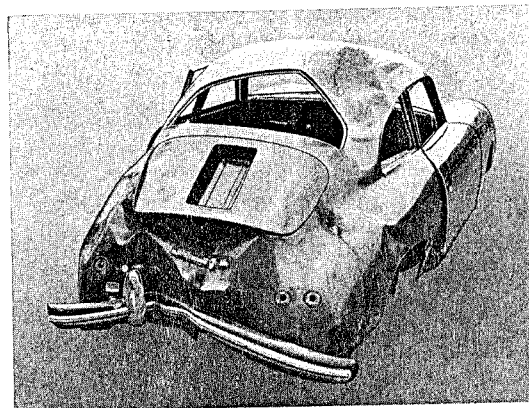
Fig. 177

These two illustrations show the damage to the rear end, the roof and rear fenders. What cannot be seen, is the damage to the interior panels and possible chassis damage.
