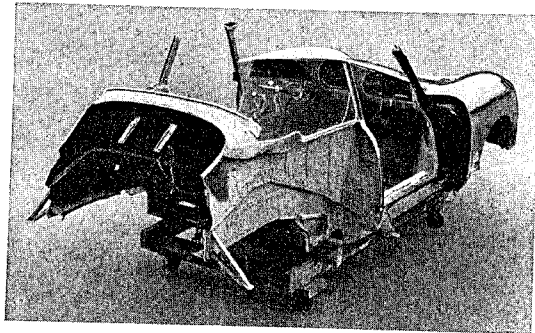
Fig. 179

The body after removal of the damaged parts.

The fenders were completely removed up to the door posts, first with thin shears along the door post and then by heating the metal red hot and removing the spot welded portion from the post, a spot at a time. The inner and outer rear sections were removed similarly. The top is removed best by cutting at the existing weld seams so that the posts are retained.

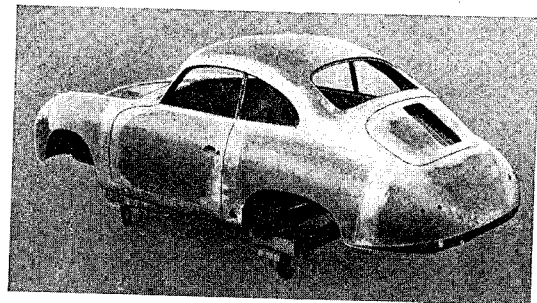
Fig. 181

Reconstructed body.

After completing the welding of the frame sections the top, rear, and fender sections are spot welded in place. The rear hood opening is aligned to match the new hood so that a uniform gap of 3 mm ( $1/8$  in.) extends around the entire hood. The skin sections are then welded in place and the seams hammered flat. All skin seams are tinned and filled with lead so that a smooth contour is obtained. These seams are clearly visible in Fig. 181.

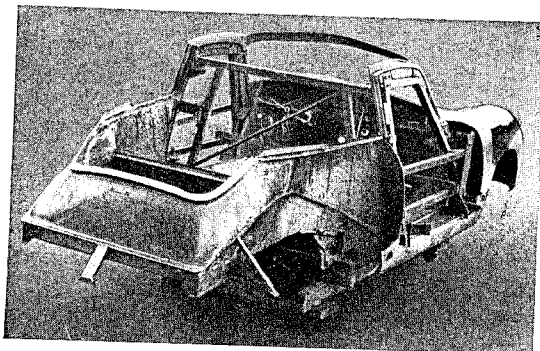
Fig. 180

Installed interior rear section.

The rear cross member has been installed and the rear interior panel spot welded to the body and cross member. The left and right roof frames were rebuilt with the aid of door templates specifically constructed for this purpose. The door post must be held firmly in place as shown in Fig. 180. The roof frame and interior sections are to be installed, spot welded together, and finally welded in place.
