CPT344: COMPUTER VISION AND IMAGE PROCESSING

ASSIGNMENT 2

DETECTION OF INCOMPLETE SOLDERING PROCESS

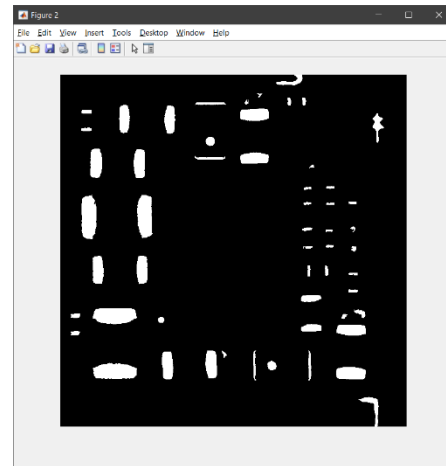
Figure 5 Crop section of test Image 1

We choose to crop a small region to closely check the soldering process of the PCB. From *Figure 5*, we can see that the soldering is quite complete and in proper shape. While in *Figure 7*, we can see that there are many improper shapes and round ended lead to the results of undercooked.

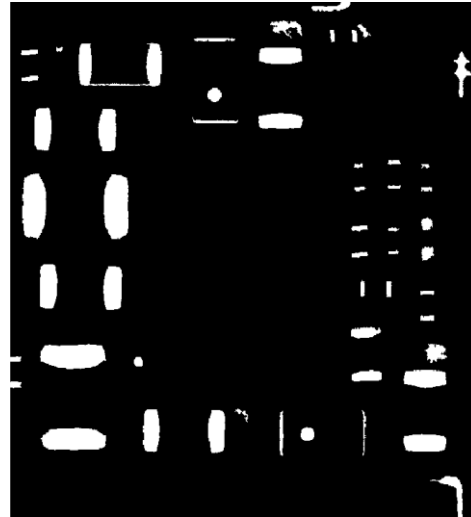
Figure 9 Test Image 2 with crop section 2

In *Figure 9* and *Figure 11*, the soldering is in rectangular (proper) shape which considered as fully cooked solder. In *Figure 8* and *Figure 10*, the soldering shape is round ended (improper) which is considered as undercooked and incomplete soldering.

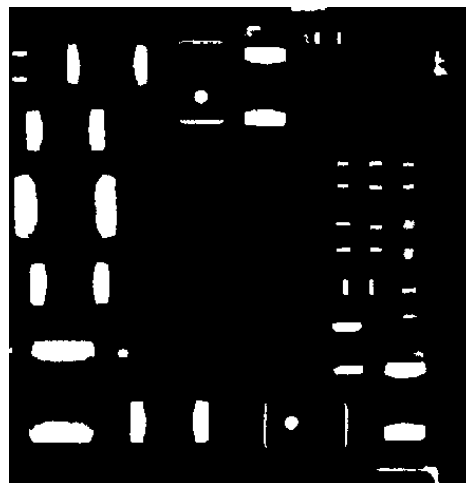
Figure 12 Test image 4 with crop section 1

In *Figure 12* and *Figure 13*, the soldering point is complete and there is no redundant part, which is considered as good soldering. In *Figure 14* and *Figure 15*, some parts of the soldering points are missing or inappropriate soldering methods, which are considered as incomplete soldering.
