Grounding Caption

Medical Report

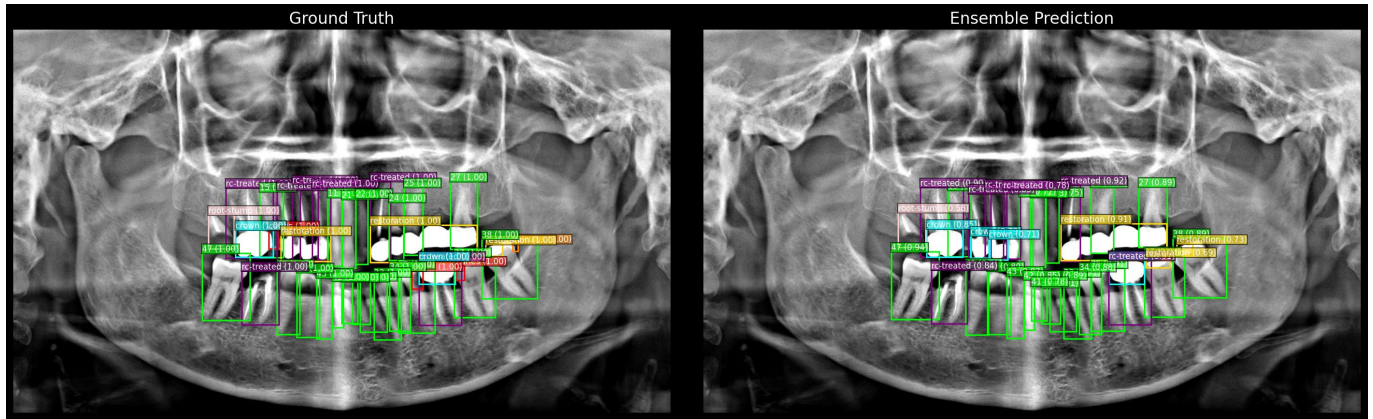
- A total of 19 teeth are visualized within the panoramic field.
- Wisdom teeth status: Tooth #38 (left lower third molar) is fully erupted and non-impacted. No evidence of impaction or other wisdom teeth (e.g., #18, #28, #48) is observed.

- **Suspicious for a root fragment or residual root stump** near tooth #15 (left upper second premolar). This finding requires further clinical correlation to confirm the nature of the radiopaque structure.

- **Evidence of a crown** adjacent to tooth #35 (right lower first molar).
- **Root canal-treated teeth** noted near #22 (left upper first premolar), #35 (right lower first molar), #15 (left upper second premolar), and #45 (left lower second molar).
- **Restorations** documented near #25 (left lower second premolar), #38 (left lower third molar), and #37 (right lower second molar).
- **Crown-related structures** observed near #15 (left upper second premolar), #11 (left upper central incisor), and #35 (right lower first molar).

- **Suspicious root fragment near #15:** Requires clinical examination and possibly CBCT imaging to confirm diagnosis and rule out periapical pathology.

- Reinforce meticulous oral hygiene, particularly around #15 and adjacent teeth with prior restorations.
- Monitor radiopaque structures near #11 and #15 for signs of recurrent caries or secondary infection.

- **6-month recall** for radiographic reassessment of the suspicious root fragment near #15.
- **Referral to endodontist** for further evaluation of root-treated teeth (#22, #35, #15, #45) to confirm treatment outcomes.
- **Dentist consultation** for functional assessment of crowns near #35, #15, and #11.
