Status Antonio Cooled Feed Fab & Testing

2015-08-13, Matt Fleming

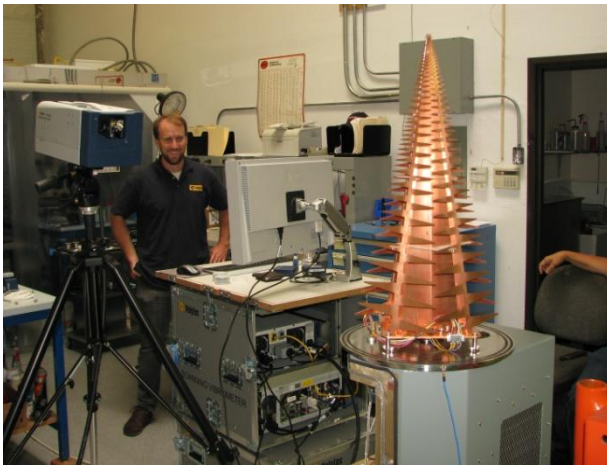
Feed 001 during vibration testing

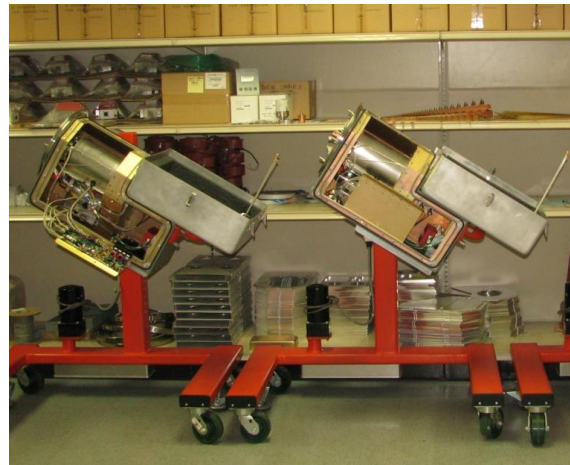
SN-002 & SN-003 on stands.

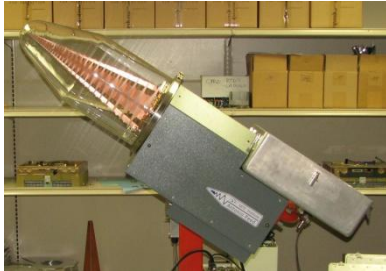
Feed 001 on stand. (testing)

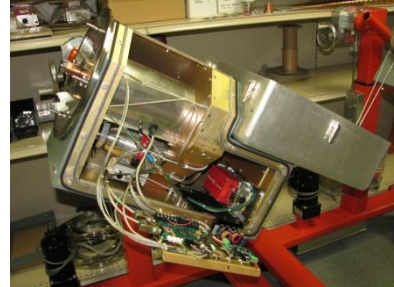
Feed 003 on stand. (hold)

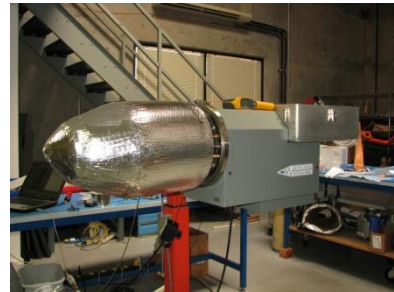
Bake out blanket.

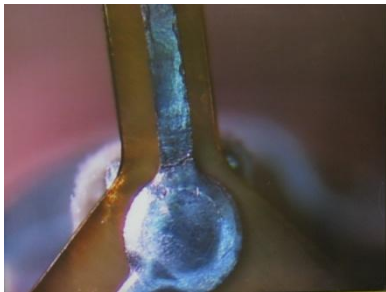
SN-001-B typ crack visible.

- Correct Design of Tip Circuit for Durability: (Improvements) A very successful low vibration cooler mount has been designed and prototyped. An improved design which will prevent premature failure of the feed tip circuit has been designed and all parts have been rushed through manufacturing and are now in stock at Minex.
- Improved Screen Room Test Facilities: (no change) Improved lighting is still needed. New coax cables have been identified but the cost is outside our current budget, waiting.
- Feed Tip Assembly Fixture & Testing: About 90% complete. (up from 30%) The assembly fixture is very useful, but a microscope vision system is needed.
- Software: Some final improvements to software are needed. Rob Ackermann is scheduled to complete this soon.

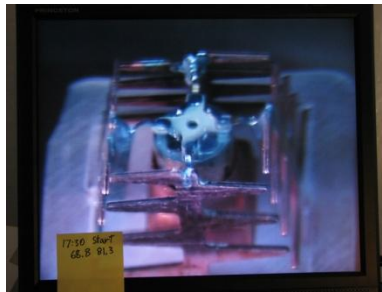
SN-002-A New BeCu Tip Links.

Tip Design with Beryllium Copper traces for better fagique resistance.

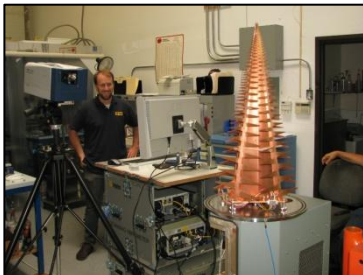
Laser Vibrometer Testing.

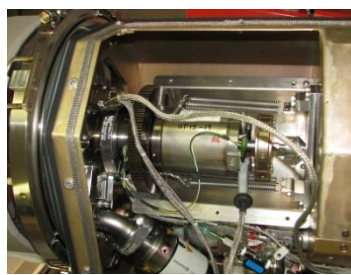
Installed low vibration mount.

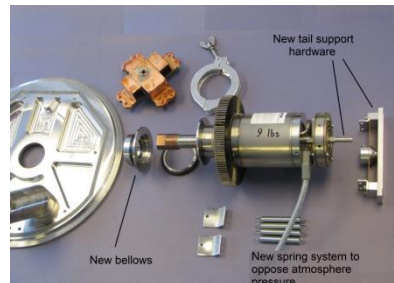
Components low vibration mount.
