Glider Deployment Report: calanus (June 17, 2025)

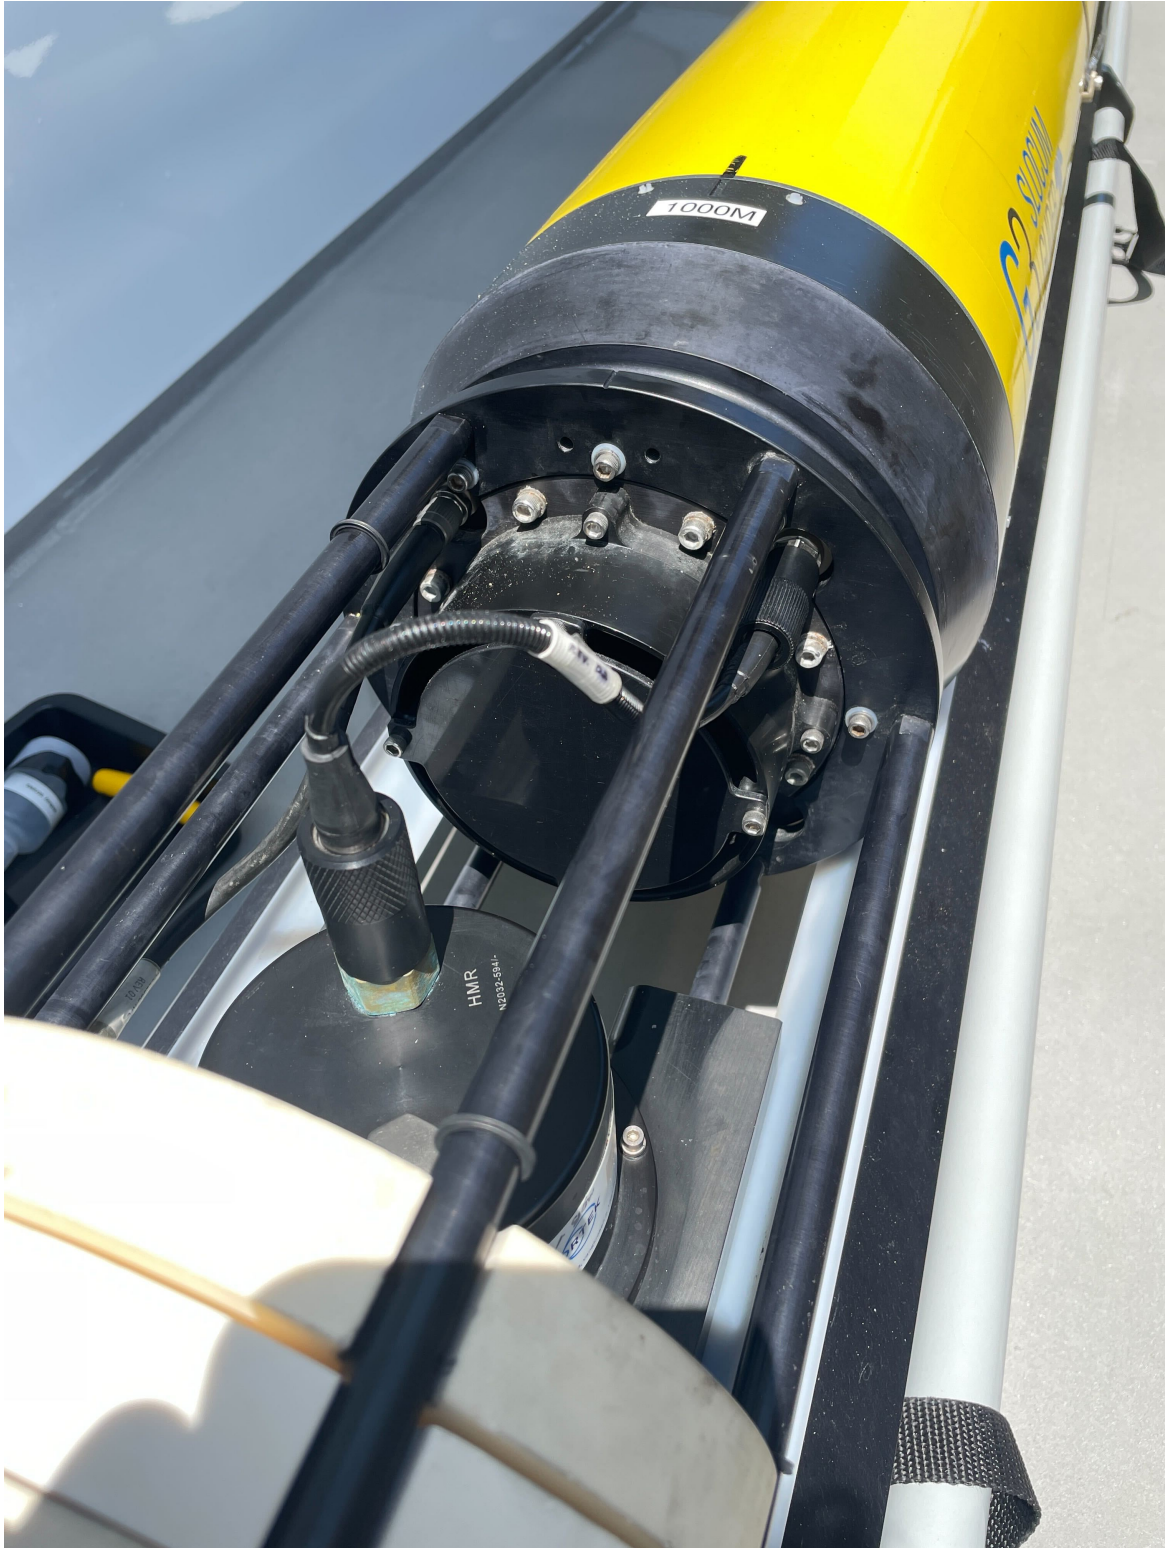
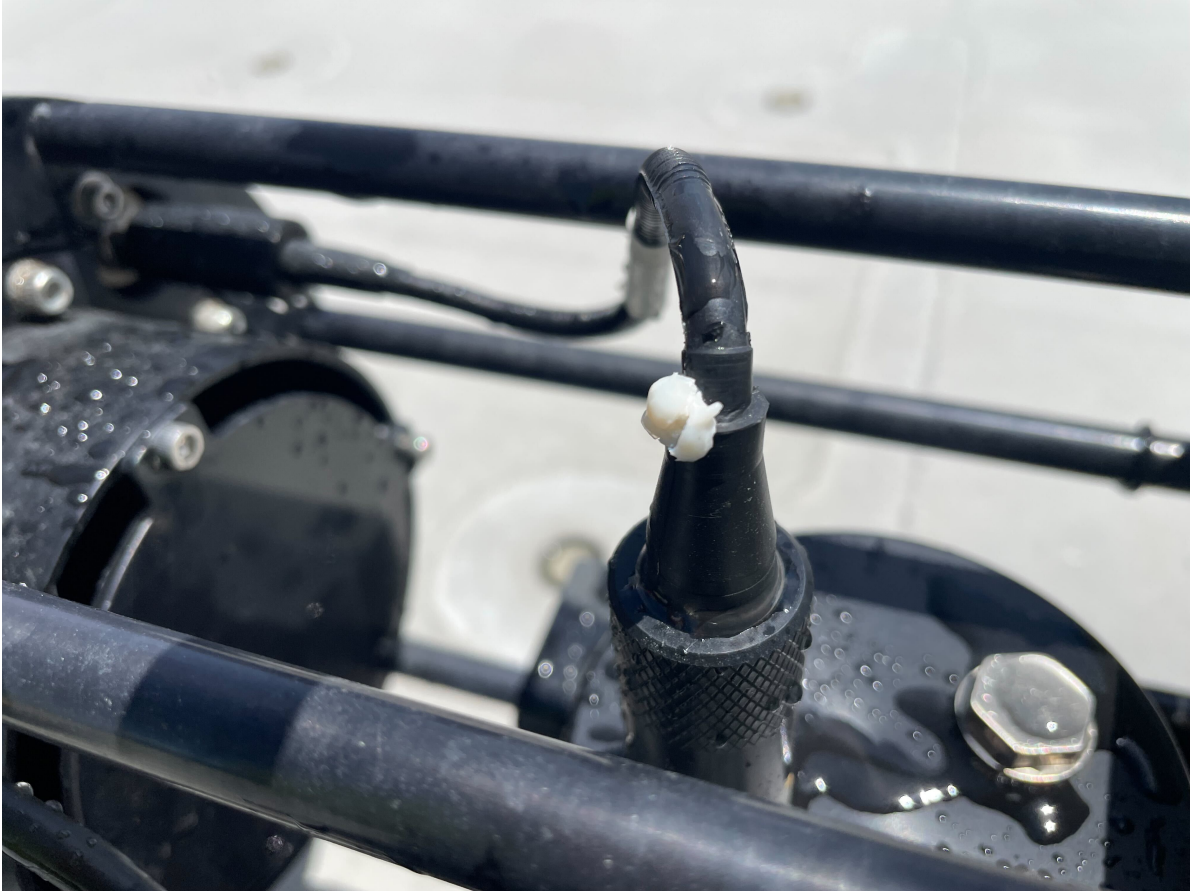
No obvious signs of damage or corrosion were evident upon recovery, although some barnacle growth was apparent. Back in the laboratory, pilots discovered that the cable connecting the acoustic sensor to the glider showed signs of significant corrosion. Pilots suspect that because the cable has to be bent at approximately a 90-degree angle when connected, it may have split, allowing salt water intrusion. However, the sensor itself and the glider appear to be undamaged. Pilots were able to communicate with the sensor back in the laboratory and confirmed that it collected more than 1 GB data while deployed. A shorter cable that does not require bending in order to reach its connection points may prevent this issue in the future; however, we will need to discuss the possibility of fabricating a different cable with the sensor's manufacturer (Nortek). Pilots attempted rotating the sensor on its mount to see if a more desirable angle could be achieved, but rotating the sensor caused an even bigger bend in the cable. Until a different cable is produced, it is possible that this problem may occur again if we continue to deploy this sensor in its current configuration.

Damage to the Nortek unit on “calanus.” Because of the proximity of the Nortek unit to the nose of the glider and the length of the cable connecting the unit to the glider, the cable is bent at a severe angle. The cable likely split, allowing saltwater intrusion and resulting in the sensor’s failure.
