Rockchip_CameraHAL1_FAQ

文件状态: Status: [] 草稿 [] Draft [] 正在修改 [] Modifying [√] 正式发布 [√] Released	文件标识: File No.:	RK-PC-YF-255
	当前版本: Current Version:	V1.0
	作 者: Author:	王潘祯撰/温定贤 Randy Wang/Shawn Wen
	完成日期: Finish Date:	2020-02-14
	审 核: Auditor:	
	审核日期: Finish Date:

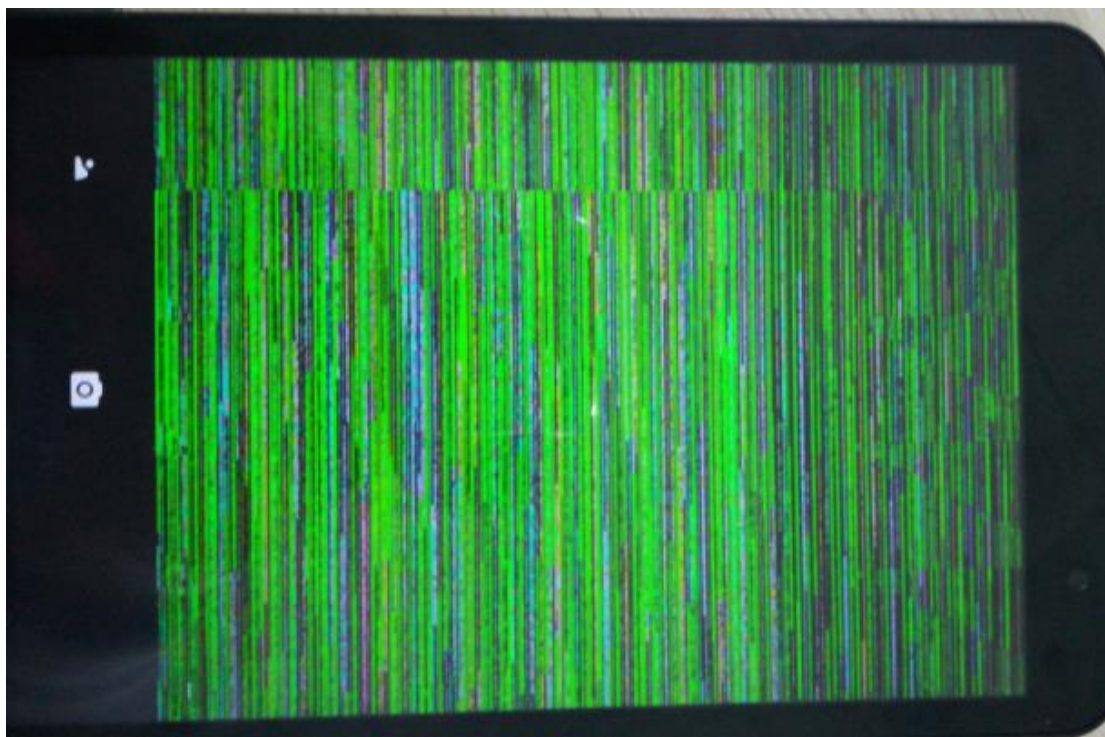
RK3126C-8.1 调试 GC2145+GC0312，GC2145 预览正常，GC0312 预览是花屏如图：

With RK3126C-8.1 debugging GC2145+GC0312, GC2145 preview is normal, but GC0312 preview is abnormal as below picture:

图 10 预览花屏

Picture 10 Preview screen abnormal

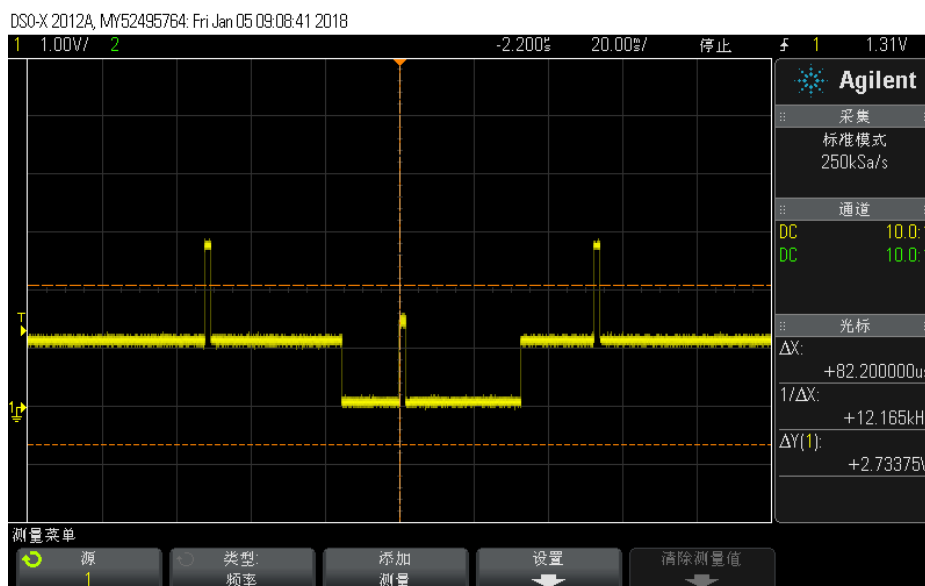
图 11 GC0312 的 VSYNC 图

Picture 11 VSYNC of GC0312

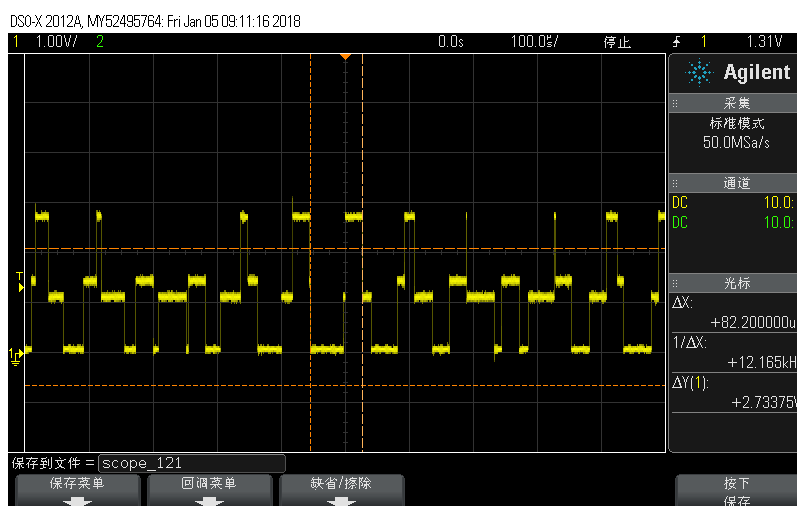
图 12 GC0312 的 HSYNC 图

Picture HSYNC of GC0312

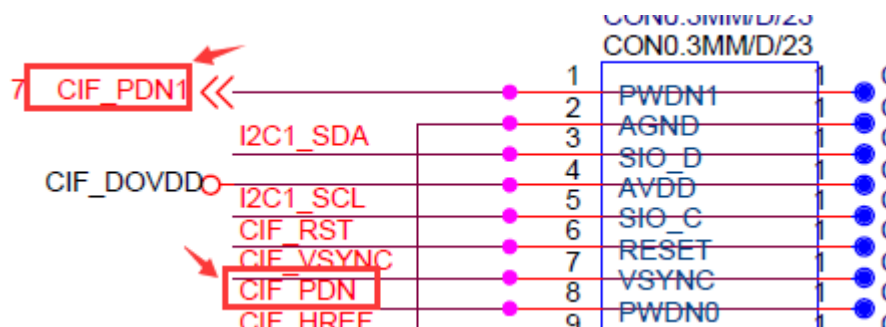
CIF_PDN 对应 GPIO3_B3 即 GC0312 的 PWDN 引脚

CIF_PDN corresponds to GPIO3_B3 which is PWDN pin of GC0312.

图 15 PDN 原理图位置

Picture 15 PDN schematic location

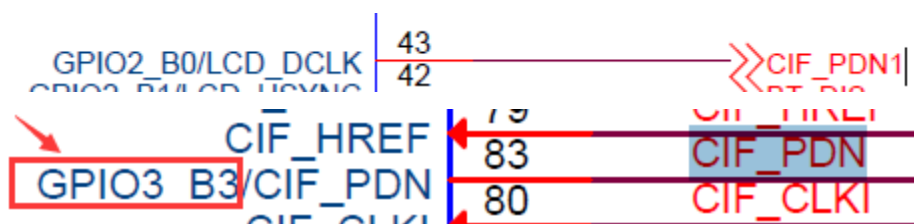
测量确认 GC2145 正常工作的时候: CIF_PDN1 为 0; CIF_PDN 为 1;

When GC2145 is working normally: CIF_PDN1 is 0, CIF_PDN is 1.

图 16 PDN 对应 GPIO

Picture 16 Corresponding GPIO of PDN

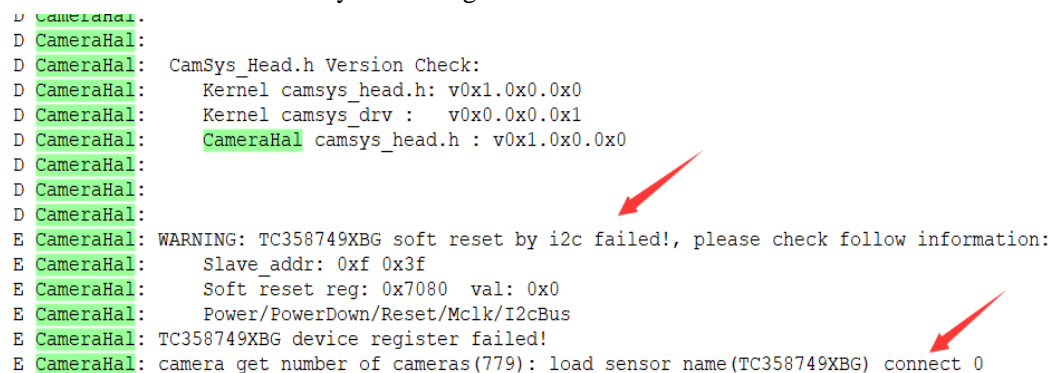
Camera 无法正常使用，查询 logcat 发现，i2c failed 报错。

Camera cannot work normally. Check logcat and find there is i2c failed error.

图 18 I2C 通讯异常 log 示例

Picture 18 I2C communication abnormal log example

Here we mainly introduce the moment and method to measure the power supply and control signal for debugging I2C abnormality. To make Camera module work normally, need to register after camera service is started after power on, and only with successful registration it can normally open to preview. Generally, the camera module without constant power supply will power down after the registration is ended abnormally or the camera automatically closed due to failure, which is inconvenient for measuring the power supply and control signal. To ensure the module is in working state all the time, need to add the following patch:

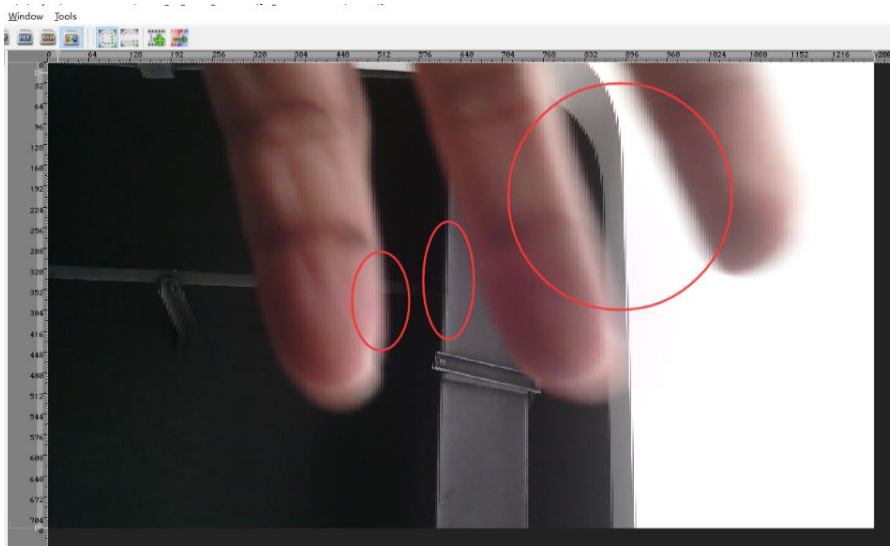
Rk3326 android 8.1 平台 OV5640 接收图像出现模糊马赛克状，如下：

RK3326 android8.1 platform OV5640 occurs blur and mask issue while receiving image as below:

图 32 OV5640 模糊图像

Picture 32 OV5640 image blur

Capture yuv image output by isp, confirm there is also blur existing, and there is no other error in logcat. So it is analyzed that may be related with image format. Check cam_bard.xml configuration, and it is found that format configuration is wrong. The camera module outputting yuv format is mistakenly configured as CamSys_Fmt_Raw_10b in sensorFmt.
