## SECTION : 501-25D Body Repairs — Water Leaks

VEHICLE APPLICATION : 2008.0 Falcon

### Water Leaks

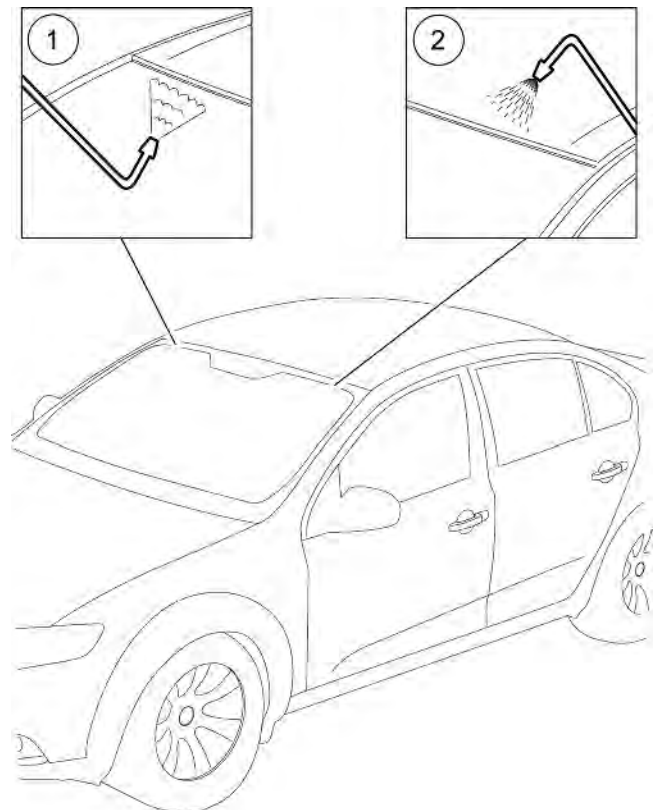
### Diagnosis of a water leak

- **Diagnosis:**
  - Ingress of water into A-pillar area or instrument cluster area
- **Cause:**
  - Breaks in adhesive beads
- **Corrective action:**
  - Breaks in adhesive beads can be located from inside by using compressed air. The leak can be identified from outside by the escaping air.
  - A second test method is by means of a water test.

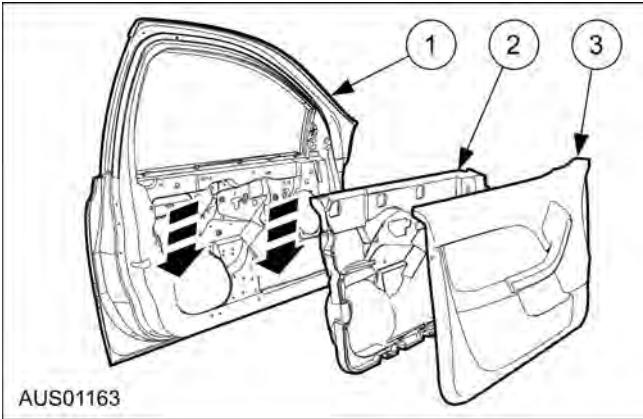
Door seal

- Diagnosis:
  - Water ingress in the lower part of the interior door trim or in the rocker panel area.
- Cause:
  - The foam watershield fitted behind the interior door trim exists to drain off water that has entered the door via the drainage holes, either downwards or outwards. If the foam watershield is damaged or has been fitted incorrectly, then water can get into the passenger compartment.
  - In addition to this, the drainage holes can become clogged with leaves, dirt or excess cavity protection agents. Water gathers in the door and ingresses into the passenger compartment.
  - Check foam watershield for damage or correct fitting.

- Check clamping load: Refer to Chalk Test.
- Adjust the clamping load:
  - The clamping load is normally adjusted using the striker. When doing so, the edge alignment from the door to the side panel, or from the front door to the rear door must be taken into account.
  - Another setting method is to realign the panel flange for the seal mounting. The clamping load is increased by moving the flange towards the door.
- Check the bearing surface:
  - Apply chalk evenly to the surface of the seal. Evenly coat the bearing surface of the door with vaseline.
  - Close the door fully, the lock must engage. Open the door. The imprint of the chalk (bearing surface) can be identified in the film of grease.
  - The bearing surface should be at least 5mm across at all points.

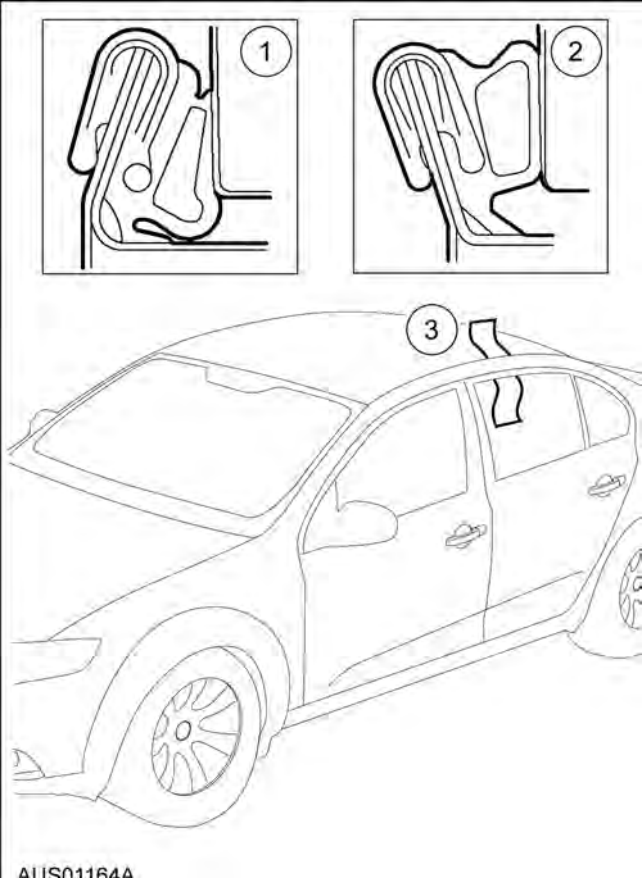
Checking the seal

- Diagnosis:
  - Ingress of water into the rocker panel area
- Cause:
  - Insufficient clamping load between seal footprint and sealing surface.
- Corrective action:

Item	Description
1	Panel flange bent too far inwards: small bearing surface

Item	Description
2	Panel flange adjusted correctly: correct bearing surface
3	Check clamping load with a strip of paper

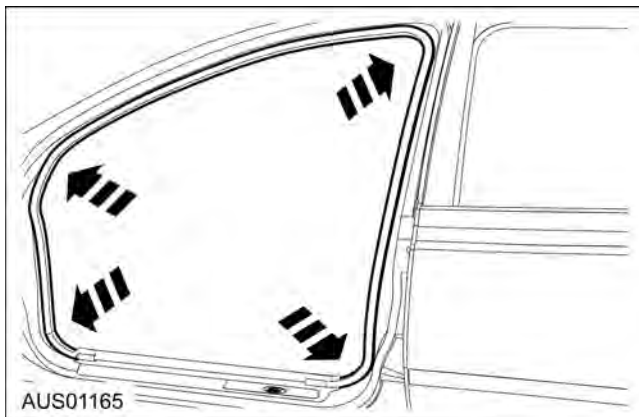
### Correct installation of the door seal

- Other cause:
  - The door seal is attached to the welded flange all the way round. If this welded flange is uneven or damaged at any point (usually in areas with narrow radii) then this point could be subject to leaks.
  - A stretched seal carrier can also cause a leak.
  - In both cases, water gets into the vehicle interior under the seal carrier.
- Corrective action:
  - Align the deformed welded flange using a hammer and anvil block, prevent and if necessary repair any paint damage.

- A stretched seal carrier must be realigned by hand. If this is no longer possible, the seal must be renewed.

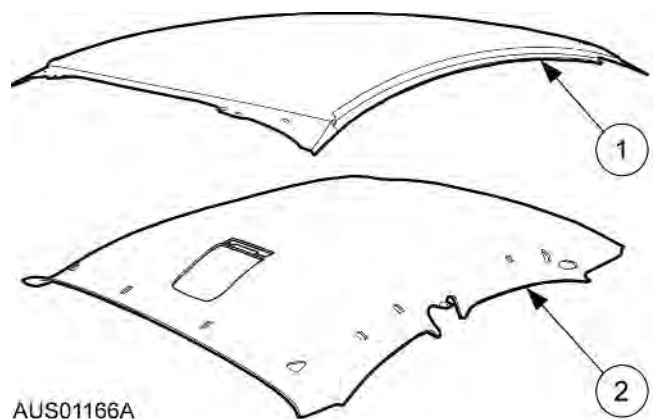
- Diagnosis:
  - Ingress of water at sliding roof aperture
- Cause:
  - The sliding roof/tilting roof is installed in a water trap. The water drains off via the water trap, water drain holes and drain hoses. The drain hoses lead downwards on both sides via the A-pillar and C-pillar.
  - The drain holes or drain hoses can become clogged with leaves, dirt, underbody protection and so on.
- Corrective action:
  - Check the water trap for leaks.
  - Check the drain hoses for leaks and for correct connection to the water trap.
  - Check the drainage system for unhindered flow, and blow out with compressed air if necessary.
  - Check the external seal and the correct adjustment of the sliding roof.

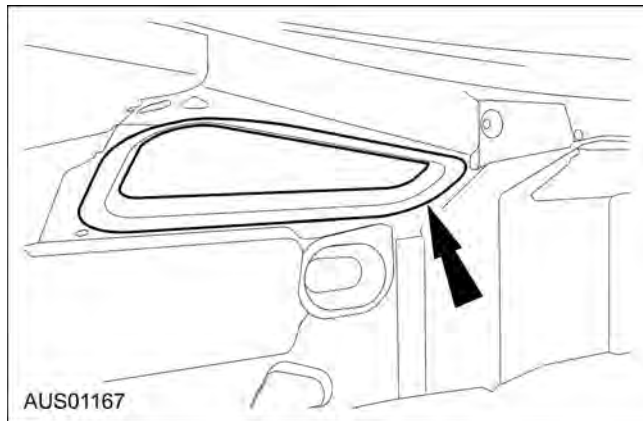
### Heater and ventilation housing seal

- The heater and ventilation housing is attached to the apron panel. The pass through area is sealed with a foam watershield that is fixed to the housing.
- The housing has drain holes to allow the water to drain off.
- If the foam watershield is defective or the drain hole is clogged, water can ingress into the front footwell area.

- Corrective action:
  - Seal the broken seal welds.
  - If a leak is found in the heater or ventilation housing, the drain holes must be checked first.
  - The housing may have to be removed to check the foam watershield and its bearing surface for damage.

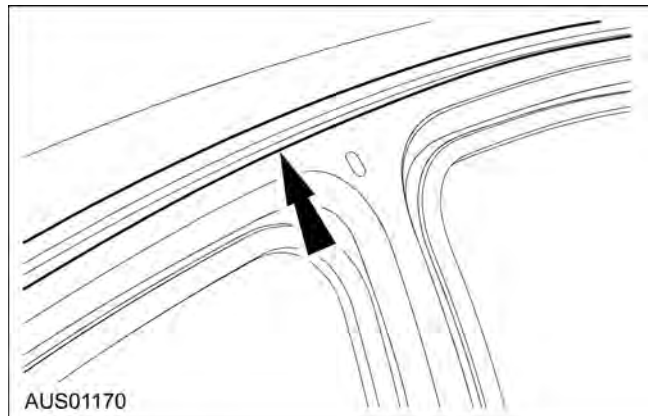
### Drip rail seal

- Diagnosis:
  - Ingress of water into side headlining area
- Cause:
  - The roof outer panel is sealed with a seal weld at the connection point to the side panel. This seal weld can be concealed with a bezel or trim strip.
  - In the case of estate and hatchback vehicles, there is an additional seal to the rear roof crossmember.
  - Water can enter here if there is a break in the seal weld.
- Corrective action:
  - Remove trim strip or bezel. Check and re-seal the seal weld.

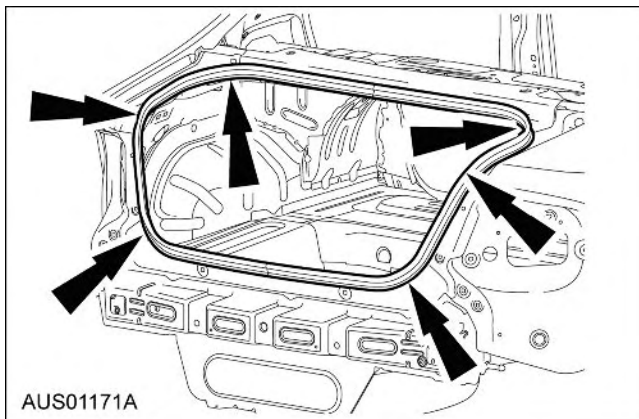
### Check the seal for correct installation position

- Cause:
  - The luggage compartment lid seal corresponds to the door seal.
  - If there is a water leak, the seal must be checked for damage and the seal carrier must be checked for correct seating.
  - The clamping load and the bearing surface of the lid must also be checked for leaks.
- Corrective action:
  - The adjustment of the lid is made using the lock striker or the lock.
  - Rubber bump stops are attached to both sides of the luggage compartment opening. These are normally adjustable, and the clamping load can be modified.
  - The narrow radii of the luggage compartment lid seal are also problem areas.

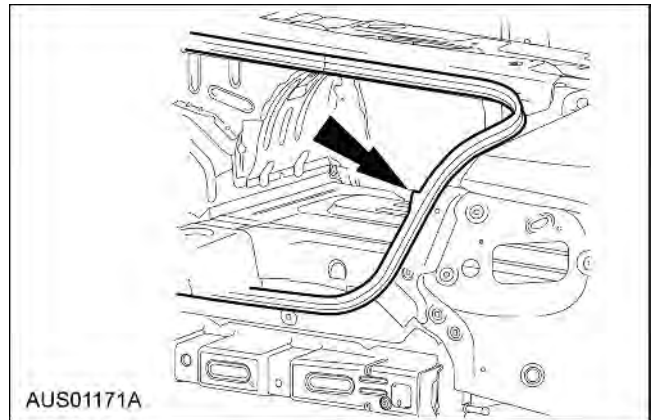
### Uneven welded flange.

- Other cause:
  - The seal is not attached evenly around the lid because of a deformed or uneven welded flange.
- Corrective action:
  - Check the seal and bearing surface.
  - Re-align a deformed or uneven welded flange.

**NOTE:** The seal carrier covers a defective weld.

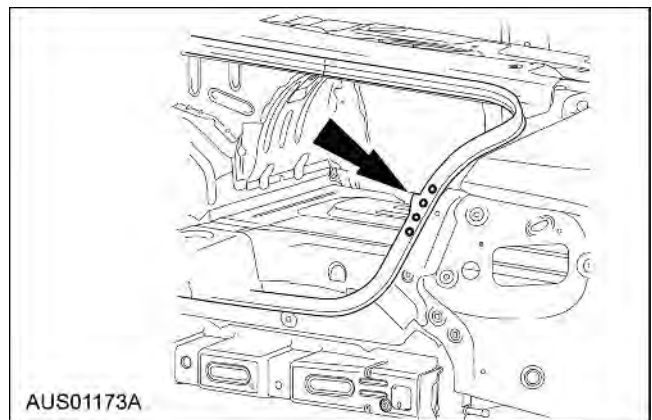
### Welds melted through

- Other cause:
  - Leaking weld on welded flange (melted through). Water can ingress into the luggage compartment under the seal carrier.
- Corrective action:
  - Pull the seal from the seal carrier.
  - Seal the leaking weld using sealing compound.

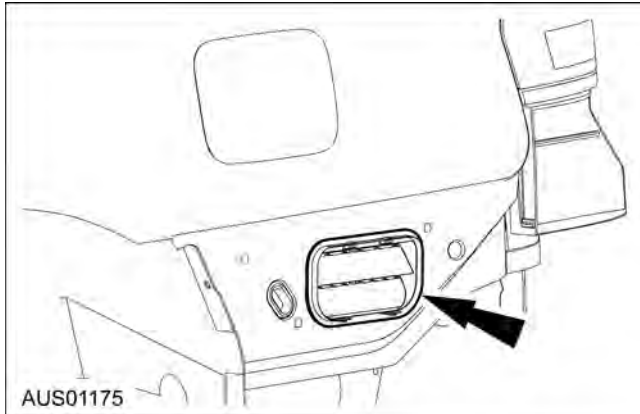
**Check the seal for the forced air extraction.**

- Diagnosis:
  - Ingress of water into side luggage compartment area
- Cause:
  - The forced air extraction for the vehicle interior is located in the lower side panel area of the luggage compartment. The ventilation housing is sealed with a rubber watershield on the bodywork side.
  - The rubber flap of the forced air extraction must be able to move freely and not be warped.

- Corrective action:
  - Remove the forced air extraction. Detach the bumper if required.
  - Check the seal area between the bodywork and housing, as well as the rubber flap.
  - If rubber flaps are warped, reposition by lifting/fixing.
  - Replace damaged air extractor as necessary.
