Major Issue with Lilygo-T-A7670 on Battery: Everytime "Brownout detector was triggered" once connected on battery and devices get hanged and need manual reset #232

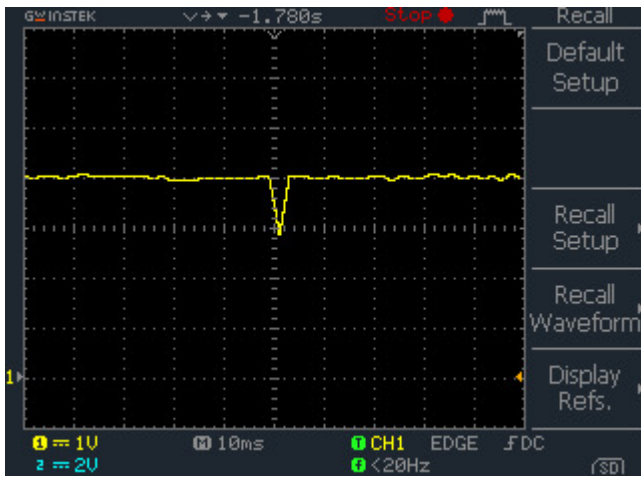
There is major issues in this board. Whenever tries to connect it with battery Li-Ion or Lipo every time it output "Brownout detector was triggered". I have disable brownout detection but our devices get failed/hanged on this stage. There are lot of devices we have procured and whole project has been messed up. When we have connected FTDI adapter to save log, this is the state when device get hangs anytime and we have to go for manual reset. There is lot of unreliability with this product. This log is just got by programming your own example MQTTClient without doing any change just connecting the module on battery.

And facing issues. There is an issue with hardware. I am not sure if that could be resolve by using a capacitor to stabilized the voltage.

Here is the battery voltage waveform captured using oscilloscope. The battery voltage is 4.0 and when modem tried to power up then it drop below 3.0 V

If you enable it after setup, it may cause power failure!

7. Known issues, ESP32 (V1.2) version of [T-A7670](#), [T-A7608](#), when using battery power supply mode, BOARD_POWERON_PIN (IO12) must be set to high level after esp32 starts, otherwise a reset will occur.

This problem is a known issue and can only be solved by calling GOIO12 to set the high level at the beginning of setup. This problem has been discussed in another post.
