Design Assignment 3

Zurizadae Soto Maya [1010229548]

Zarah Mathew [1009961720]

November 14th, 2025

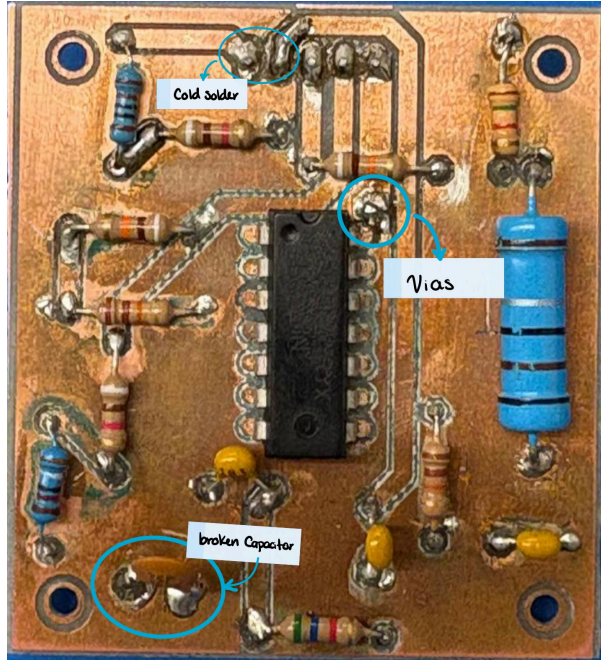
Description of main issues	Annotated PCB
<ul style="list-style-type: none"> • The I_{sense} and V_{out1} pins had cold solder joints, preventing current from flowing through these connections. This was resolved to restore proper electrical continuity. • The capacitor on the lower left broke while testing. Repairs were made by soldering additional legs to extend its lead and then reinstalled securely on the PCB.

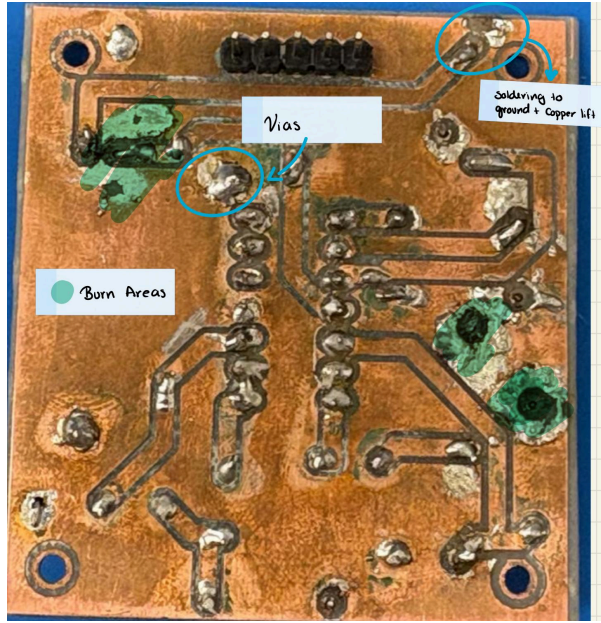
<p>This image shows the top side of the PCB with various components. Annotations include: 'Cold solder' pointing to a joint at the top; 'Via' pointing to a through-hole connection in the center; and 'broken Capacitor' pointing to a capacitor on the lower left with additional leads soldered to it.</p>
<ul style="list-style-type: none"> • Some areas on the bottom side of the PCB were overheated during soldering, thus, got burned. This caused the copper pour to lift and prevent soldering. While this did not affect the majority of the PCB because no critical traces were connected in this region, one trace on the top left was affected. The component lead was bent to reach an intact trace and soldered to restore connectivity. • Several bridges were found on the PCB, creating short circuits and prevented V_{out1} to receive the signal. These bridges were removed with a solder wick and pump.
