TP-9789

Carriers, Transmissions and Clutch Core Inspection Deduction Examples

Revised 10-05

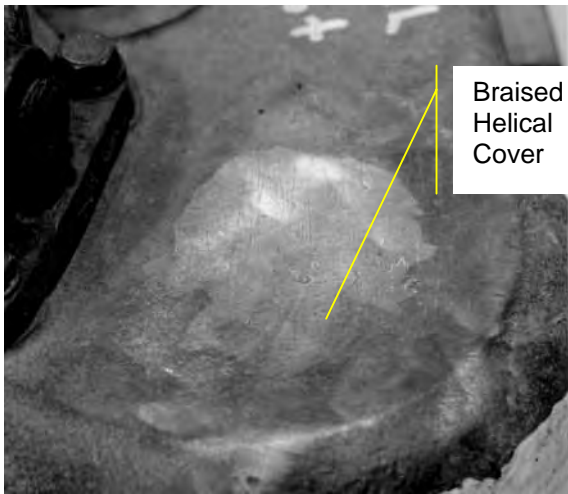
Braised
Helical
Cover

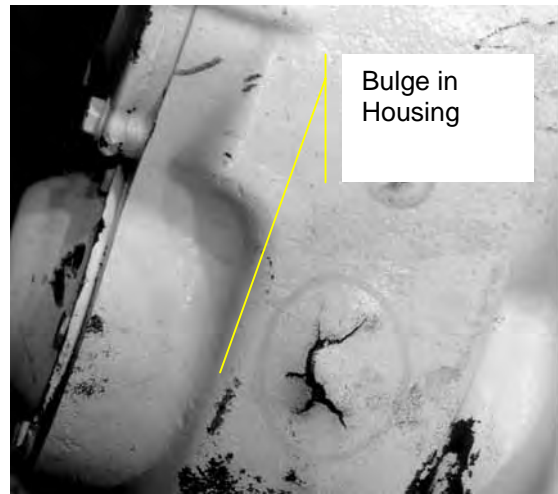
Bulge in
Housing

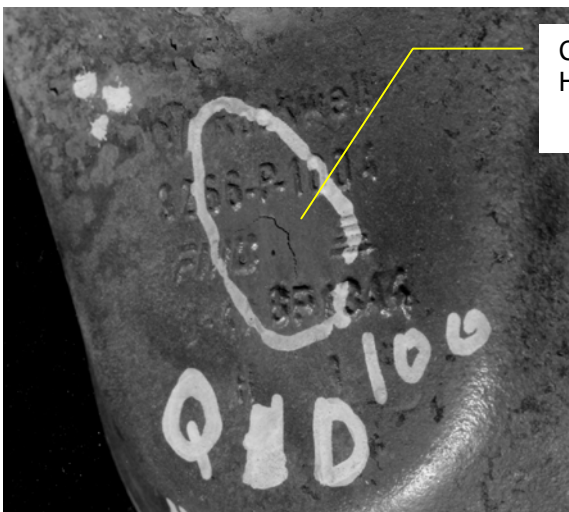
Cracked
Helical Gear

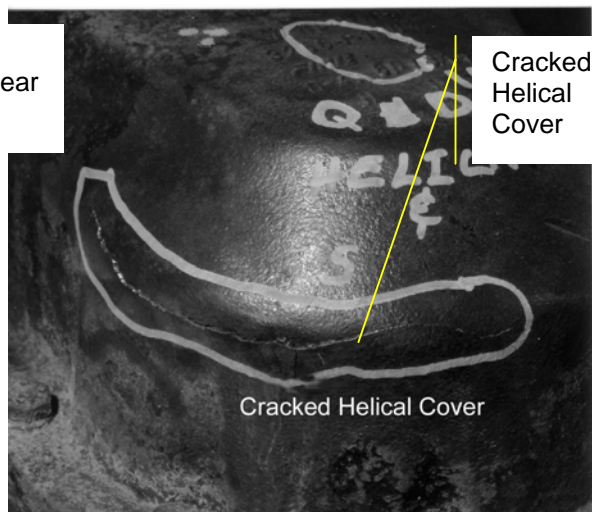
Cracked
Helical
Cover

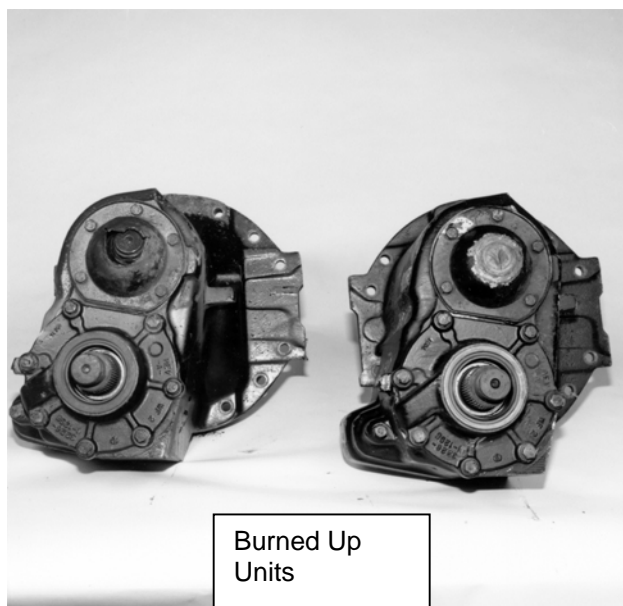
- The models affected are the SHDA, SHDB, SHRA, and SHRB. The number of teeth on the shafts can identify the old design SSHD's. The old design has ten (10) teeth and the newer designs have forty-five (45) splines. SSHD cores with fine toothed splines and casting numbers 3200 R 1162 and 3200 P 1420 are acceptable for core credit.

Coarse Splined SSHD (Old
Style)
