C O R E A C C E P T A N C E C R I T E R I A

Turbocharger – Groups and Cartridges (NACD & LACD Only)

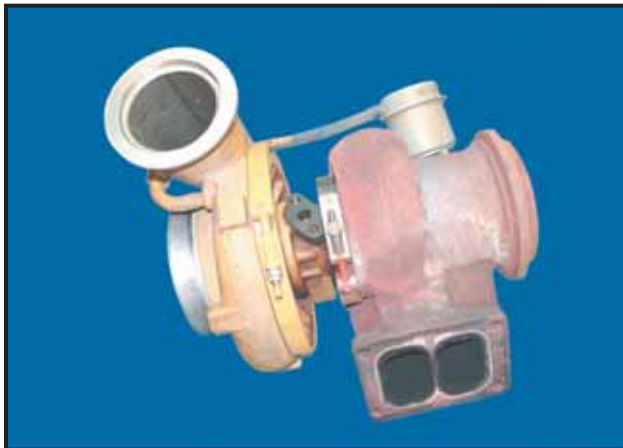
Figure 1

Full Core Refund

Fully assembled and complete

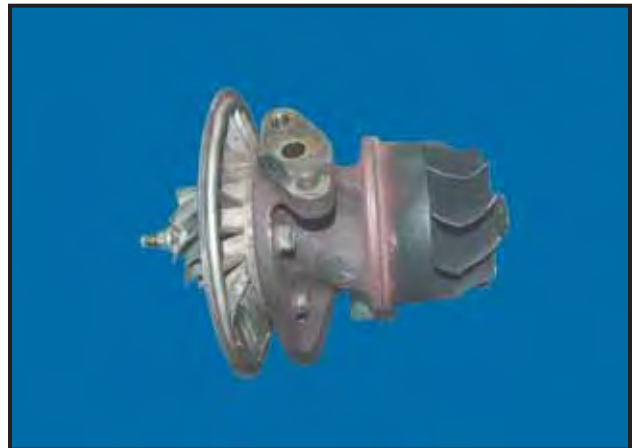
Figure 2

Full Core Refund

Fully assembled and complete

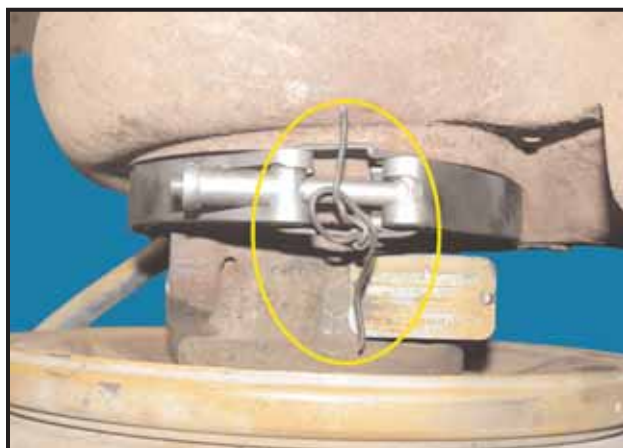
Figure 3 **Full Core Refund**

Fully assembled and complete
(band clamp wired together if broken)

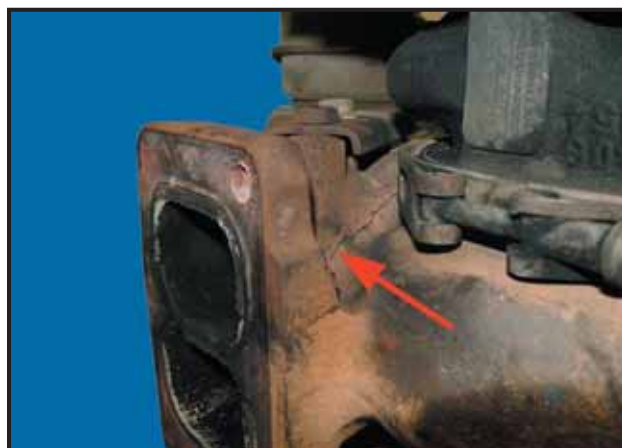
Figure 4 **Full Core Refund**

Operational damage — crack

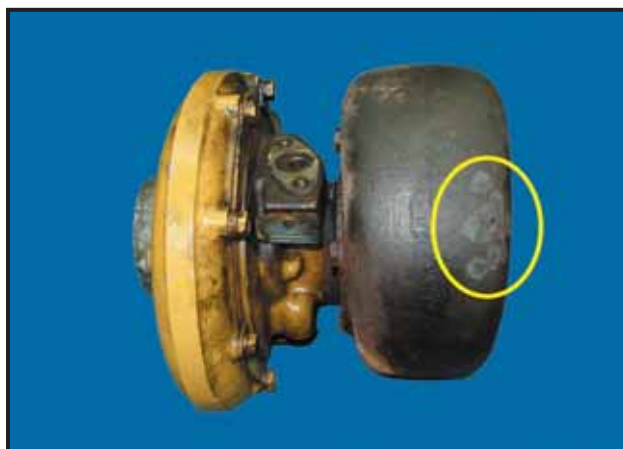
Figure 5 **Full Core Refund**

Turbo with hammer marks/blows

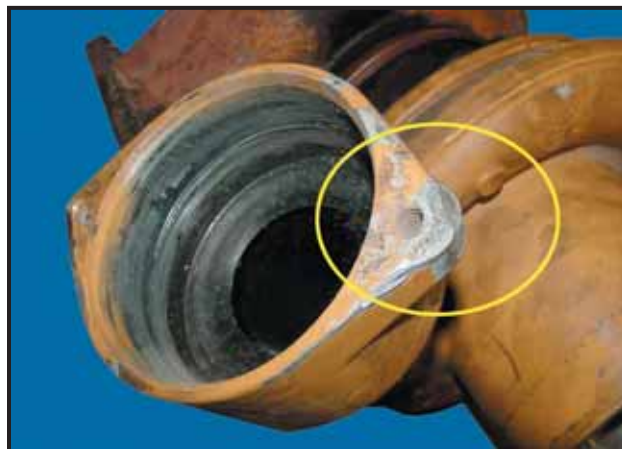
Figure 6 **Full Core Refund**

Turbo with hammer marks/blows

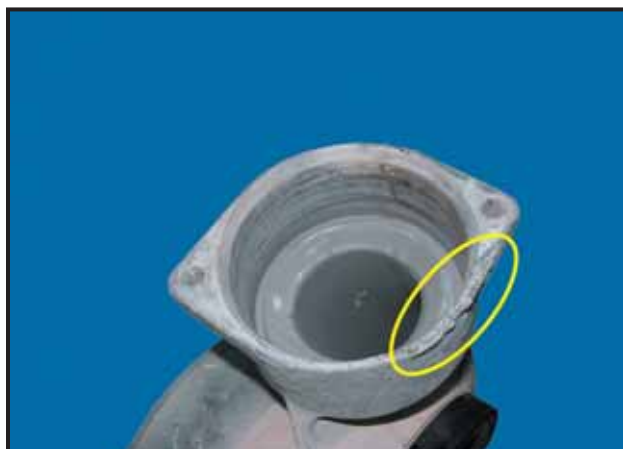
Figure 7 **Full Core Refund**

Damage — chipped cold housing

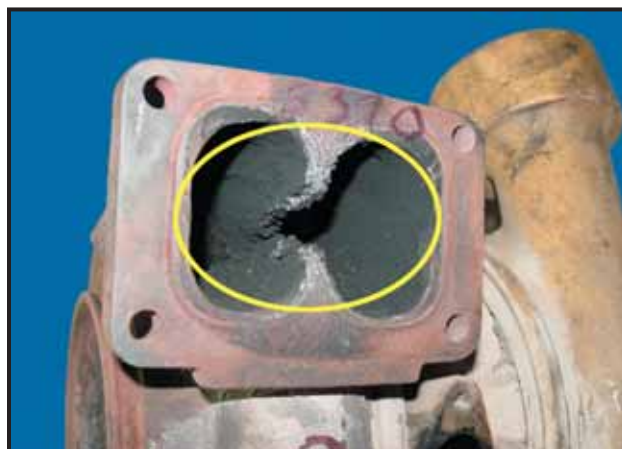
Figure 8 **Full Core Refund**

Divider wall burned out

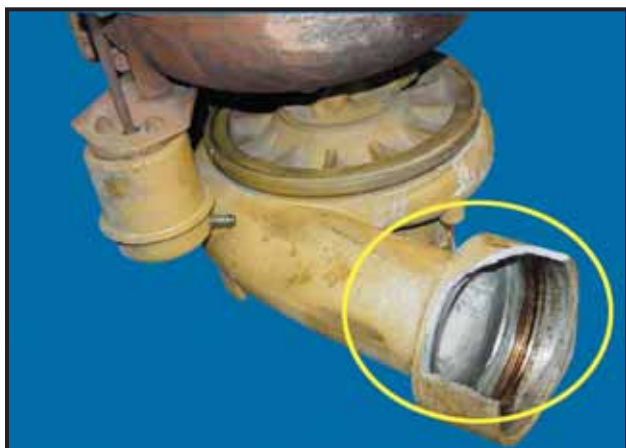
Figure 9 **No Core Refund**
Broken housing resulting from mishandling

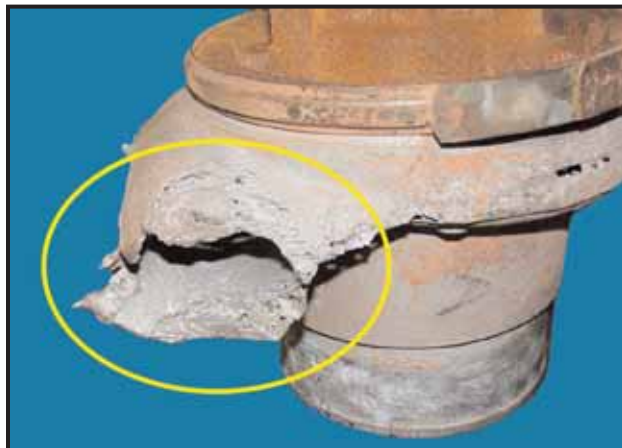
Figure 10 **No Core Refund**
Turbocharger damaged by fire

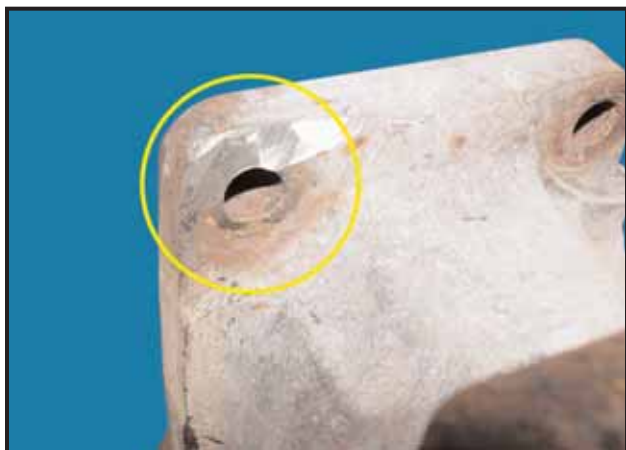
Figure 11 **No Core Refund**
Non-operational damage — grinder marks

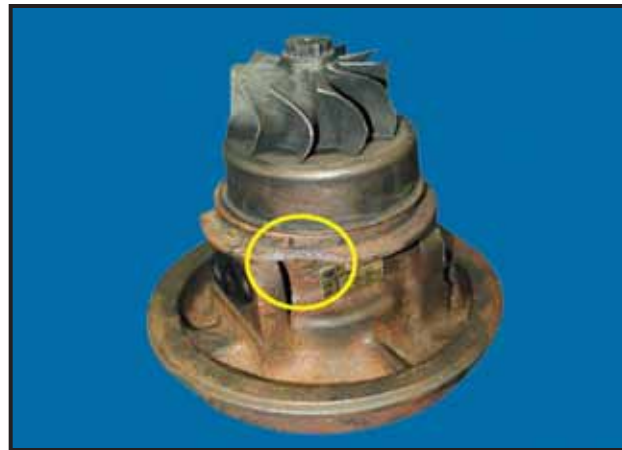
Figure 12 **No Core Refund**
Non-operational damage — broken center housing

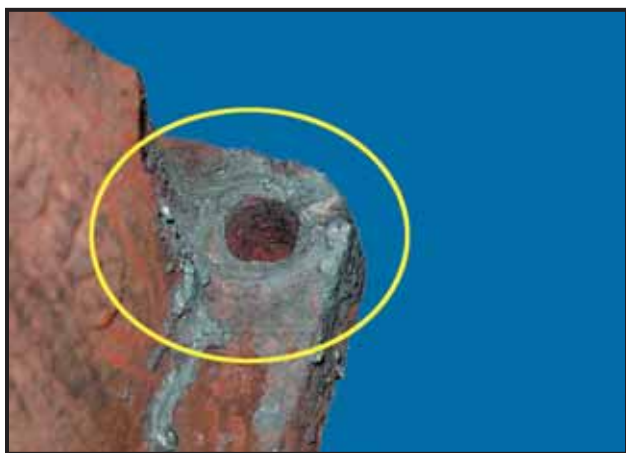
Figure 13 **No Core Refund**
Non-operational damage — melted by torch

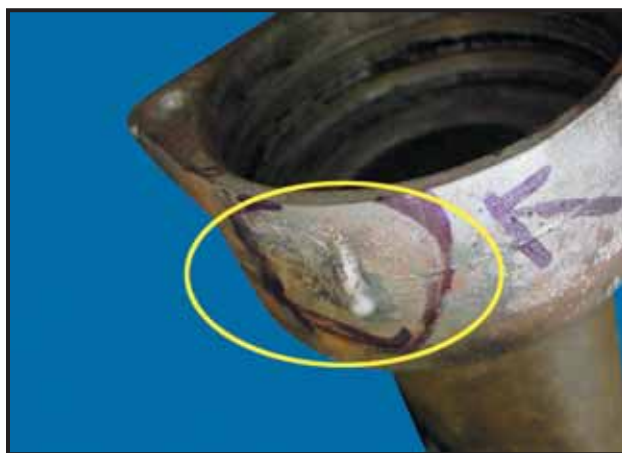
Figure 14 **No Core Refund**
Non-operational damage — melted by torch

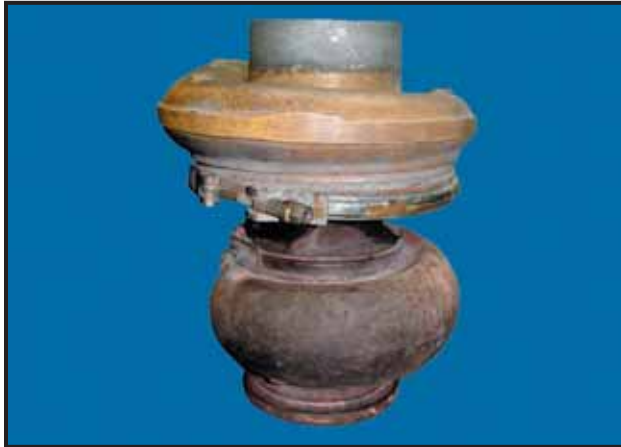
Figure 15

No Core Refund

Band clamps loose

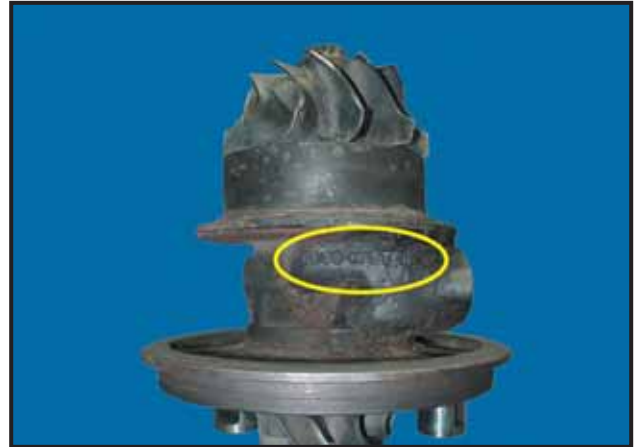
Figure 16

No Core Refund

Rotomaster — not acceptable turbo model
