# Roadranger®

## Eaton® Fuller® Clutches

Failure Analysis Guide  
All Clutch Models

Troubleshooting Guide CLTS-1271 June 2003

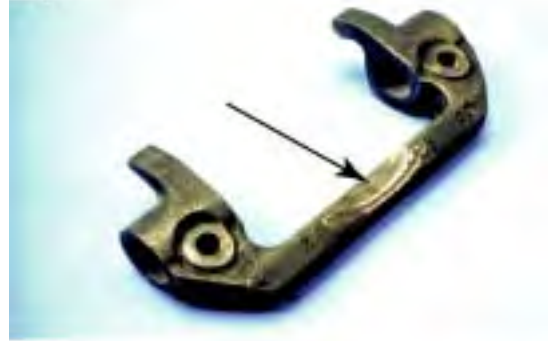
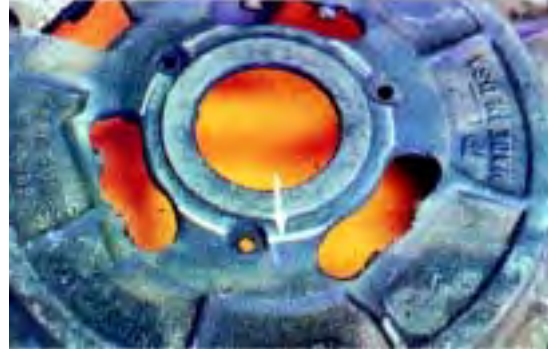
The arrows in Figures 1 and 2 show the areas of contact between the release yoke bridge and the clutch cover. Overstroking of the yoke, in an attempt to obtain the required 1/2" - 1" clutch brake squeeze, is a typical cause of this failure.

- Worn clutch brake
- Broken or missing clutch brake
- Worn or incorrect transmission bearing retainer cap (refer to Figure 3)
- Excessive wear on release bearing wearing pads and/or the fingers of the yoke (refer to Figure 1)
- Improper set up of the linkage system. Consult your OEM service manual
- Incorrect yoke installed

**Note:** The clutch cover can be reused if the above items are corrected, a new yoke is installed, and there are no broken or cracked parts on the cover. The above failure is typically preceded by a noise complaint and/or vibrating clutch pedal at the point where the clutch pedal is fully depressed. Depending upon the amount of wear (at the bearing cap and/or yoke fingers/wear pads), it may be possible to adjust the linkage to eliminate the noise complaint.

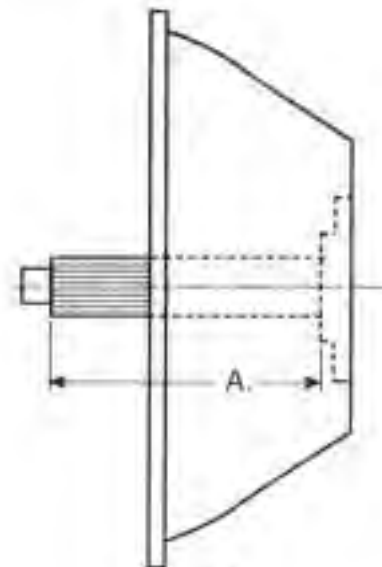
Figure 3

Dimension A, based on SAE standards, is 8.657" (219.9 mm) nominal, and should not be greater than 8.71" (221.5 mm) Ref. 1990 S.A.E. handbook 4:36.106

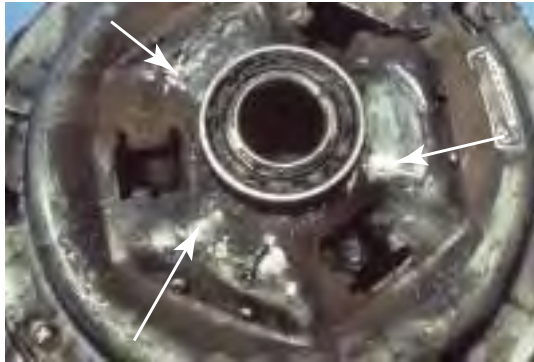
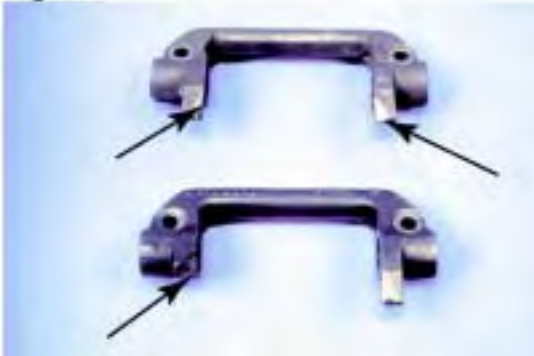
Figures 4 - 5 show the damage that results when the release yoke contacts the clutch cover. More specifically, the fingers have become pinched between the clutch cover and release bearing, resulting in one or more of the following:

- A broken /cracked release bearing housing (not shown)
- Damage to the clutch cover (see arrows, Figure 4)
- Wear to the backside of the yoke fingers (see arrows in Figure 5, top yoke)
- Broken yoke finger(s) (see arrow in Figure 5 bottom yoke)

- Linkage system broke, allowing the loose yoke to contact cover
- Linkage system was improperly reinstalled (example: forgetting to reinstall the cotter key, allowing the clevis pin to come out)
- Adjusting the clutch with the linkage instead of internally using the adjusting ring
- Rotating the ring the wrong direction (counterclockwise instead of clockwise) when adjusting for clutch wear

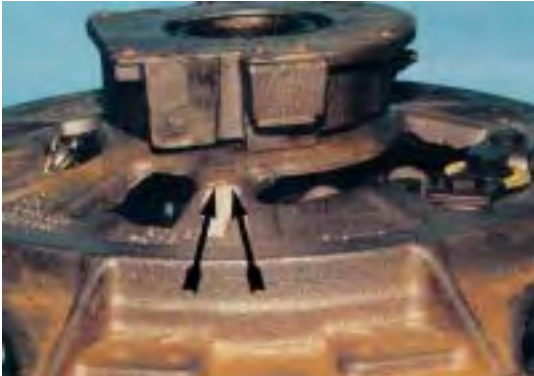
Fig 6

Referring to the arrow in Figure 6, this brand new clutch (Easy-Pedal 1402 S.D.) was damaged during transmission installation. More specifically, the release yoke "fingers" were elevated to the "straight out position" and were allowed to jam into the clutch cover. Subsequent damage might be a broken finger(s)(Figure 5) or bent release yoke / cross shafts. As a result, it is important that these parts be inspected for damage (and replaced if damaged) before installing a new clutch.

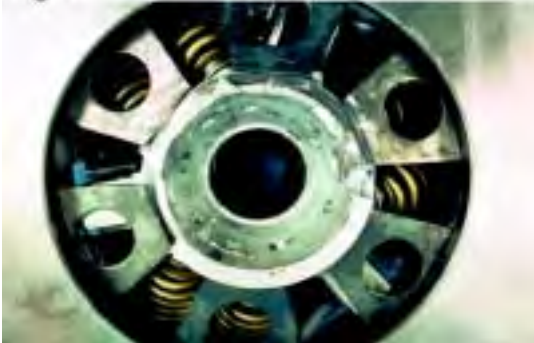
Fig 7

Figure 7 shows what can happen when the levers break through the retainer's nose. The primary cause of this failure is allowing the transmission to hang unsupported in the driven disc during transmission installation.

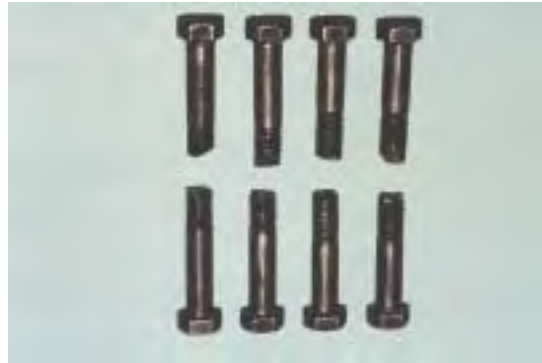
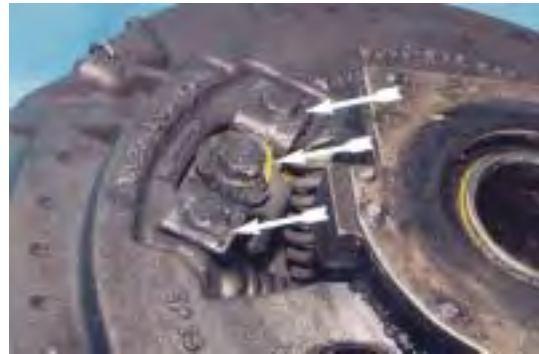
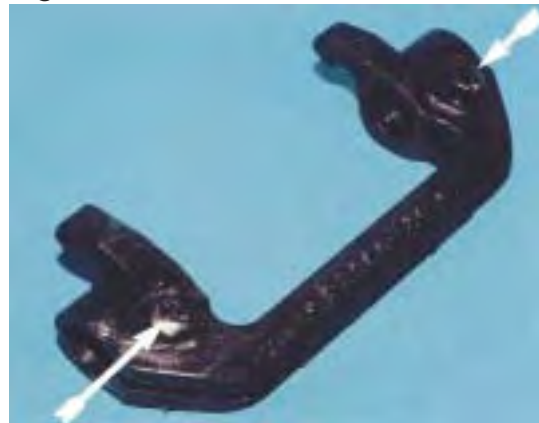
The broken mounting bolts, show in Figure 8, are the direct result of insufficient torquing of these (8) bolts to the flywheel. More specifically, these bolts were loose enough to allow the clutch cover to hammer back and forth against each bolt until they broke. Also, the (8) mounting bolt holes in the clutch cover were "egg-shaped" as a result of the constant hammering.

Additional damage occurred to both the clutch cover and the release yoke as a result of their interference with each other (refer to the arrows in Figures 9 and 10). It is worth noting that this service clutch had accumulated 50,000+ miles before it failed.

Another potential cause of the above failure would be the over-torquing of the mounting bolts. Doing so can cause the bolts to fracture and eventually separate from the flywheel. Combining this scenario with low grade mounting bolts will increase the chances of failure.

**Note:** Refer to the Eaton Installation Instructions (packaged with each clutch) to determine the proper mounting bolt torque, minimum grade of bolt, etc., for the specific Eaton Fuller Clutch model you are installing.

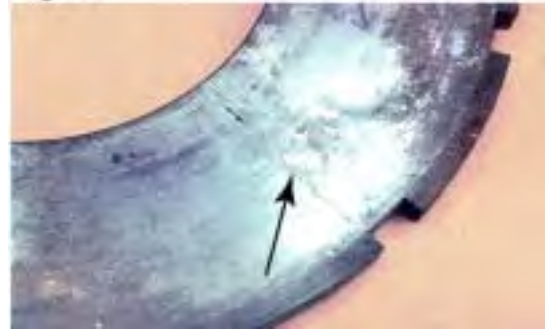
Fig 14

Figure 14 shows a broken intermediate plate. As in the previous example, the heat flow was so intense that the metal could not disperse the heat quickly enough.

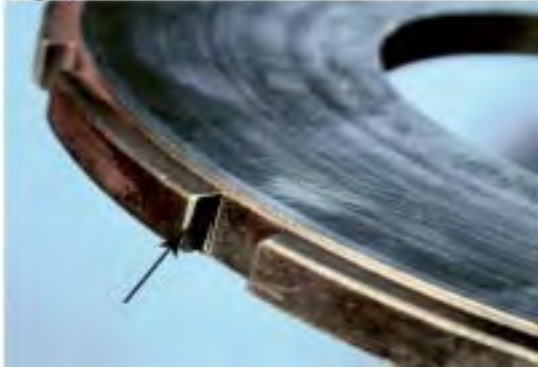
Fig 18

The groove worn in the face of the drive pin slots are on the upper section of the face on one side of the slot (see arrow in Figure 18) and on the lower section on the opposite side of the slot. This indicates that the drive pins were cocked and causing the intermediate plate to hang-up. This will cause release problems and therefore hard shifting. Do not file the slots of the intermediate plate to correct the problem. Instead, you must reset the drive pin(s) until they are square to the flywheel.

**Note:** Always install new Eaton drive pins when installing a new Eaton Fuller 14" Heavy Duty Clutch. This is important because worn drive pins (against the new intermediate plate slots) can prevent the clutch from releasing cleanly. Also, ensure that the drive pins are set squarely to the flywheel's friction surface (refer to the Eaton Installation Instructions packaged with each Eaton Fuller Clutch). Failure to set each drive pin squarely is the most prevalent reason for a "poor release complaint" on a recently installed clutch (Angle Spring and Easy-Pedal Plus 1402).

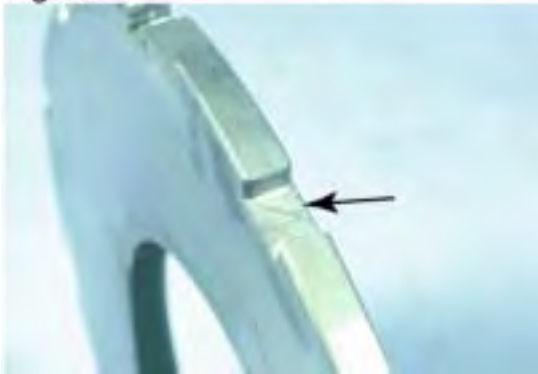
Fig 19

As indicated by the shiny areas on the drive slots, (see arrow Figure 19) the slots of this intermediate plate were hand filed. Eaton does not recommend this practice since it can cause unequal loading on the drive pins in the flywheel. Instead, Eaton recommends that the drive pins be checked for squareness to the flywheel friction surface and reset if necessary (see Eaton Installation Instructions).

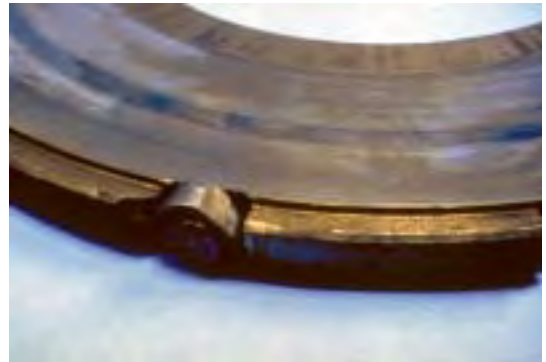
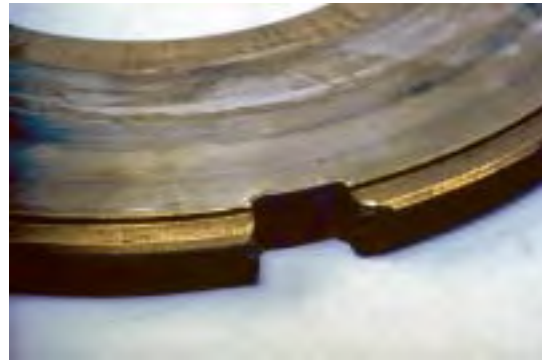
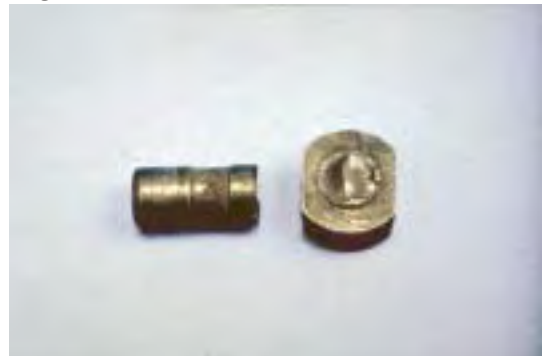
Figure 20 shows a broken drive pin head that has become wedged into the intermediate plate's drive slot. Figure 21 is the same intermediate plate but with excessively worn and broken drive slots. Figure 22 shows a broken drive pin. The above failures can be caused by one or more of the following:

- Failure to use the anti-rattle springs packaged with each super-duty clutch
- Misapplication of the clutch
- Unequal loading on the drive pins as a result of filing the drive slots.

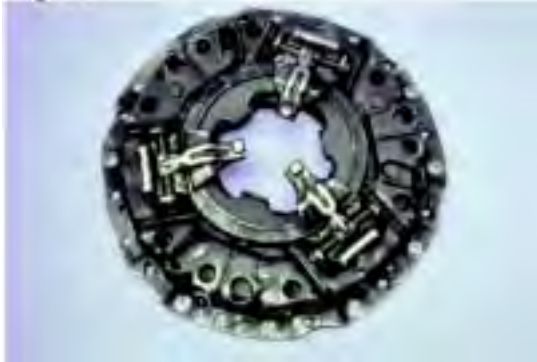
Fig 30

A leaking transmission or a leaky rear main engine seal can coat the clutch cover with oil, as indicated in Figure 30. Figure 41 shows the disc which was run with this cover.

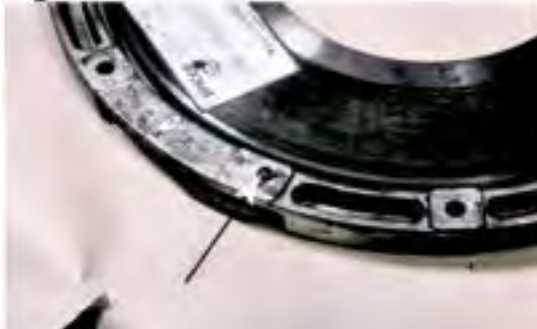
Fig 31

The separator pin shown in Figure 31 became damaged (bent) when it was dropped during clutch installation. To prevent this from occurring, Eaton recommends the use of two (2) guide studs when mounting the intermediate plate and clutch cover to the flywheel (refer to the Eaton Installation Instructions).

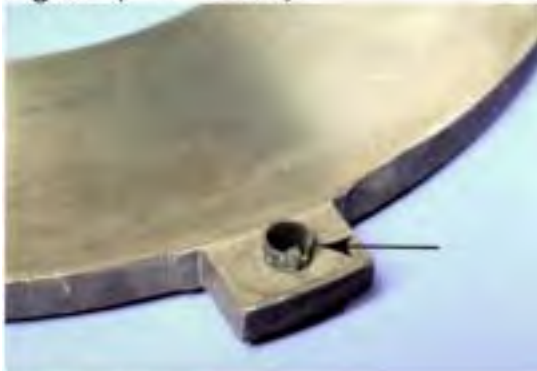
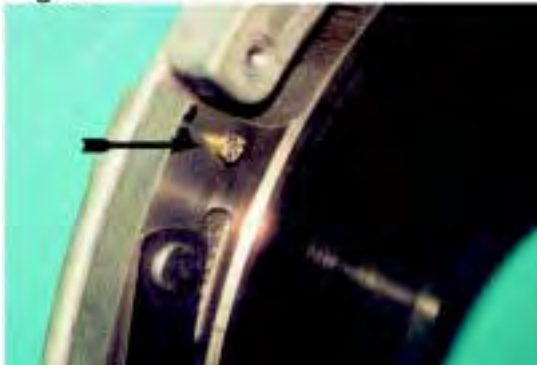
The damage done to the separator pins in Figures 32 and 33 (see arrows) is the result of using the wrong tool combined with excessive force. All four pins (on each intermediate plate) were damaged. When "setting" the four (4) roll pins, the proper tool would be a 1/4" flat nose punch used in conjunction with a small hammer (to help ensure light taps).

A damaged pin(s) can prevent the intermediate plate from retracting evenly when the clutch is disengaged, leading to a "poor release" complaint from the driver. The same complaint can also occur if the mechanic forgets to "set" the four (4) positive separator pins upon installation of the clutch. In you forgot to set the separator pins before installing the transmission, you can still set them through the inspection opening of the transmission.

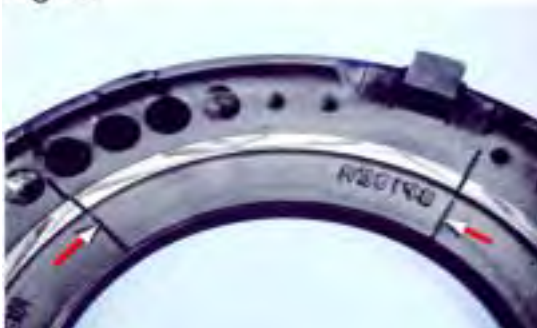
Fig 39

Figure 39 shows the back of the pressure plate. This clutch has been properly adjusted (internally, using the adjusting ring) because each of the 6 levers has more than one witness mark (or lever fulcrum point).

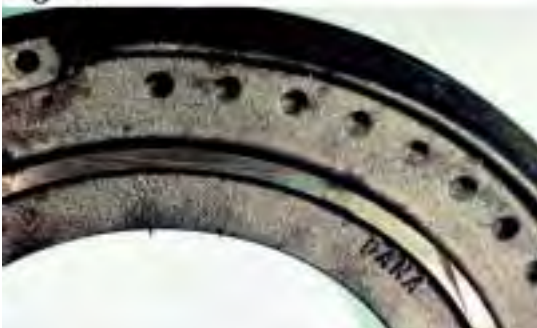
Fig 40

Figure 40 depicts a clutch that has not been adjusted properly. As shown, there is only one witness mark per lever indicating that the clutch was improperly adjusted using the linkage.

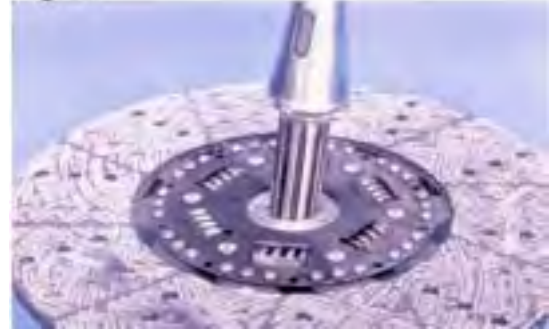
Fig 47

Shown in Figure 47 is a brand new driven disc which was warped during transmission installation (as indicated by the dummy input shaft which is not perpendicular to the disc's hub). More specifically, the transmission was allowed to hang unsupported in the driven disc hub. A driven disc which has become bent due to improper installation techniques should not be reused because of the potential for a "poor release" complaint.

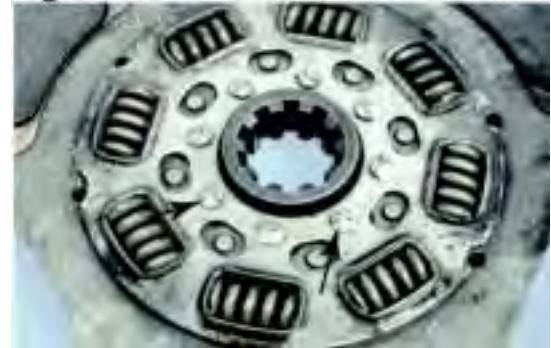
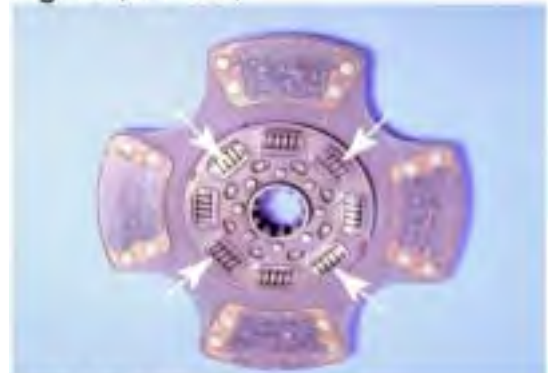
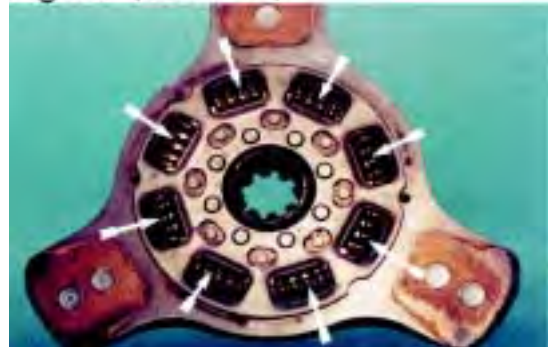
- The rivets of the disc (Figure 48) have been contacting the flywheel's mounting bolts. Some potential causes of this particular interference are as follows:
  - a. Loose flywheel mounting bolt(s) due to inadequate torquing.
  - b. Forgetting to tighten one or more of the mounting bolts when reinstalling the flywheel.
  - c. Installing an extra washer under the flywheel mounting bolt.
  - d. A flywheel which has been resurfaced too many times.
- The damper springs (see arrows, Figure 49 and 50) have been contacting the flywheel mounting bolts because the front driven disc was installed backwards. The driven disc (in Figure 49) had been wearing for a period of time before the interference occurred (as indicated by the full wear pattern on the ceramic buttons) while the one in Figure 50 was run for a very short period.

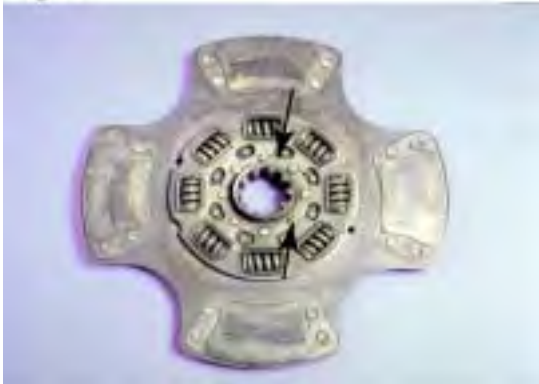
Fig 51

- A disintegrating pilot bearing which is interfering with both the hub and rivets of the driven disc (Figure 51).

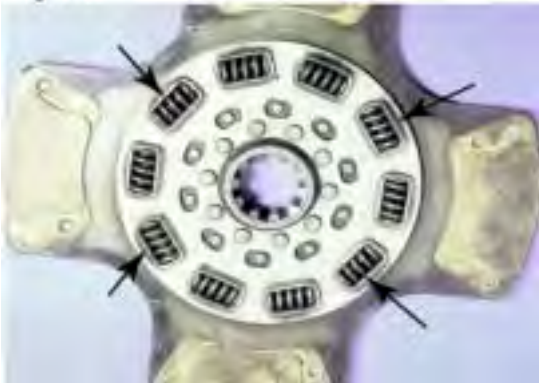
Fig 52

- Installation of the wrong clutch. Figure 52 (see arrows) shows the points of interference that resulted when a 10-spring driven disc was installed where an 8-spring was previously being run. In other words, the recessed area of the flywheel (mounting bolt cavity) was too small for the 10-spring driven disc. Before you mount the new clutch, consult the Eaton Installation Instructions (packaged with each Eaton Fuller Clutch) concerning "potential damper interference". A driver complaint, resulting from the above failure, can be:
  - a. The clutch does not release
  - b. The clutch is noisy during operation

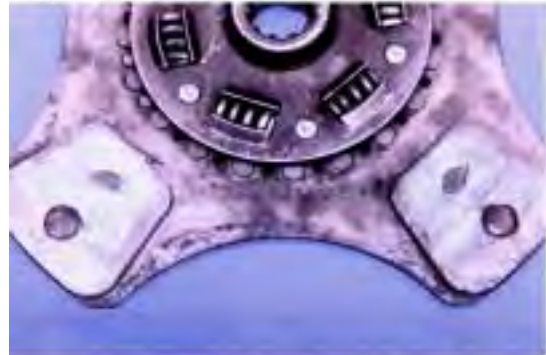
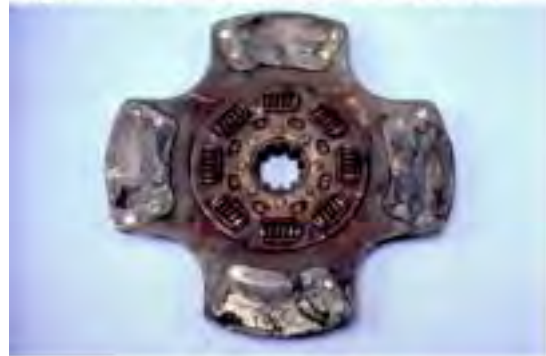
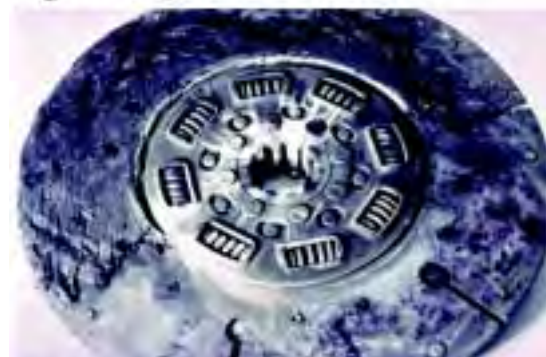
- Lack of free pedal
- Constantly riding the clutch pedal
- Utilizing a slipping clutch as a brake on an incline
- Partial unloading of a clutch due to a binding linkage system, interference, etc.
- Installation and use of improper clutch (wrong application)
- Worn driven disc facings

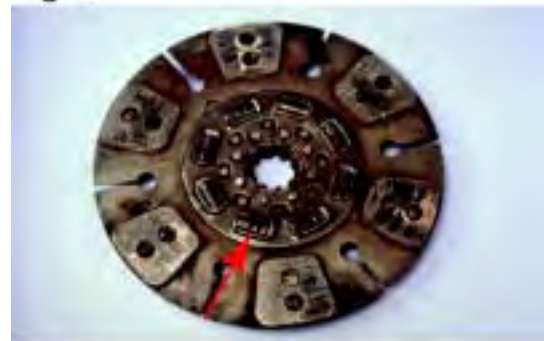
Fig 63

Figure 63 is the disc of a non-Eaton rebuilt clutch. It is an old disc that was rebuilt, as indicated by the presence of dampener springs encased in rubber (see arrow). Consequently, the rubber covered springs can make the disc act as a rigid disc, thus increasing wear to the input shaft and the disc itself. As shown by an arrow in Figure 64, parts of this disc have broken. Also, the springs are wrapped in rubber to prevent any worn ones from falling out after the disc is put into service. Contrast this with the Eaton Fuller Reman Clutches in which only new discs are used.

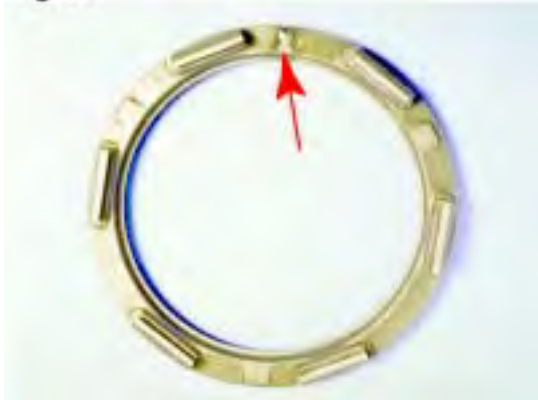
Fig 65

Note also the adjusting ring pictured in Figure 65. It was removed from a non-Eaton rebuilt clutch. This ring was cut open on one side, spread apart, and then welded (see arrow) at a larger diameter to prevent the adjusting ring from becoming loose once it was reinstalled. (Eaton Clutch does not weld adjusting rings, but rather discards any rings that are too loose.)

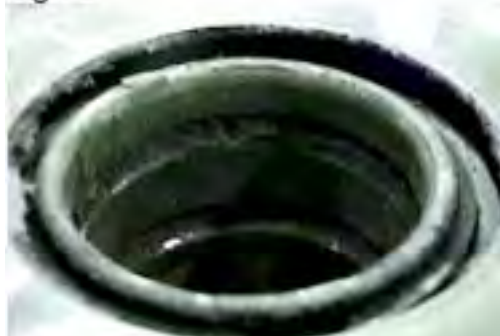
Fig 78

As shown in Figures 77 and 78, incorrect lube or not enough lube can cause a failure. External contamination will also cause wear to the bushing. The transmission input shaft may be rough and require replacement. Use approved/compatible lube. (High quality N.L.G.I #2 or #3 lithium soap grease with E.P. additives 325 degree operating temperature). Apply ample lube and let it flow out of the opening from the bearing housing. Apply additional lube onto the transmission shaft to ensure the bushing will have proper lube. Apply lube to the tips of the release yoke.
