■ Maximizing Durability and Longevity of Microirrigation Tubing

June 26, 2015
Grange Network Webinar

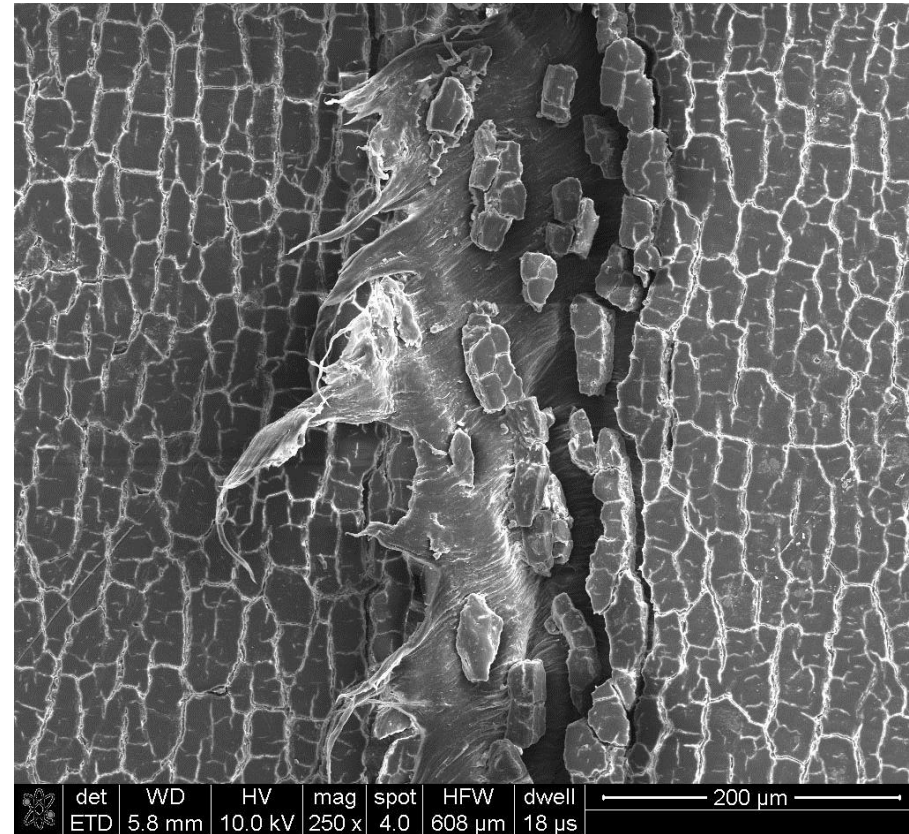
Scanning Electron Microscope Image of Degraded Surface and subsequent failure of Microirrigation Tube Taken at The Dow Chemical Company Laboratories in Freeport, Texas

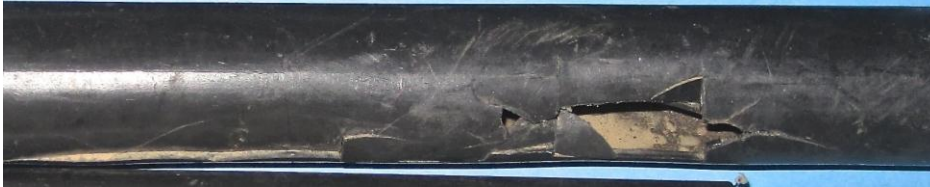
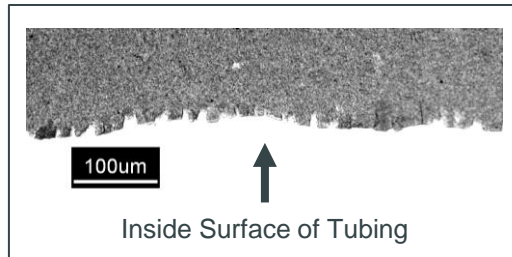
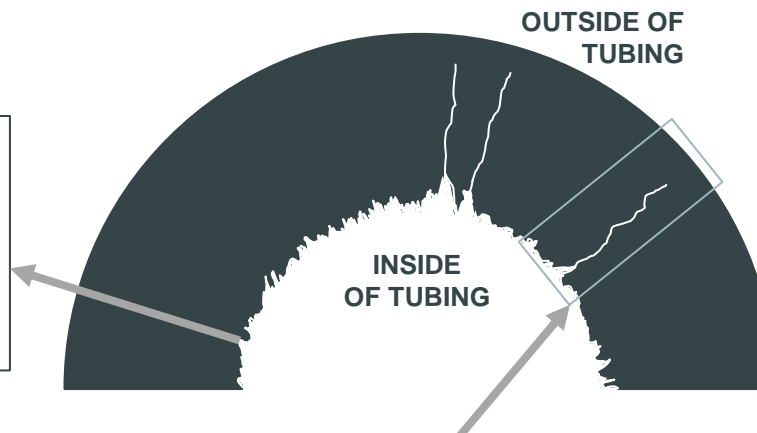
Photo of Tubing Sample, Less than 5 years In Use

Tubing Failure: Inside-Out

- Thin layer of higher quality material on the surface will prolong, but not eliminate, cracking when thick layers of poor quality materials are used in the core
- Oxidized polyethylene on inside of tube was brittle leaving thin layer of high quality material to hold all the pressure

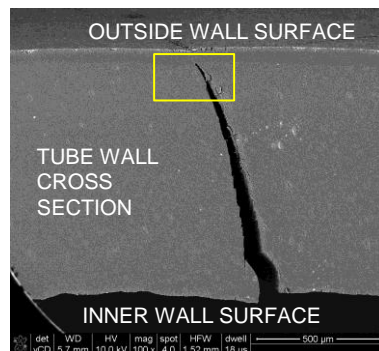
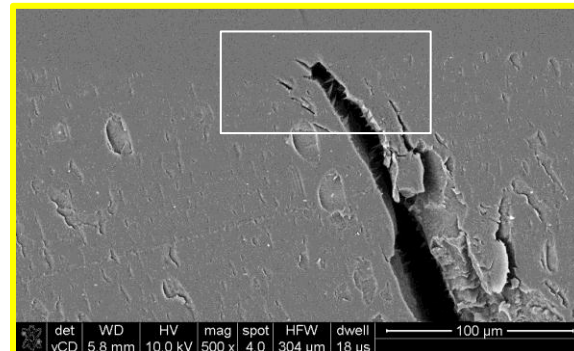
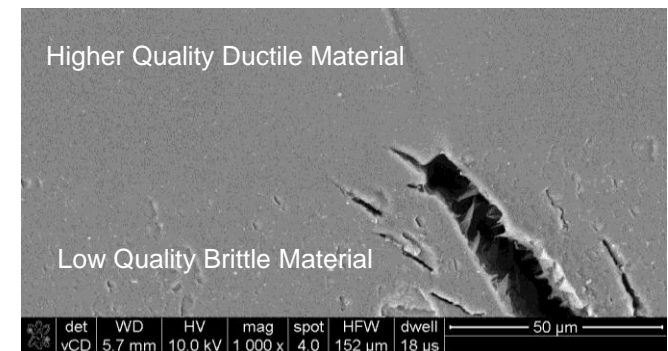
Cracks Initiated from Inner Wall Surface

Scanning Electron Microscope (SEM) Images taken at The Dow Chemical Company Laboratories in Freeport, Texas to determine the cause of a Drip Tubing Failure

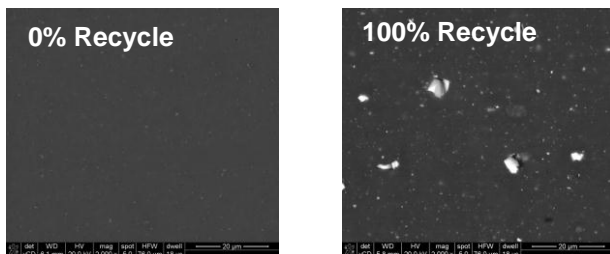
Backscatter Electron Images
(Lighter Colors Indicate Inorganic Contaminants)

Backscatter Electron Images taken at The Dow Chemical Company Laboratories in Freeport, Texas

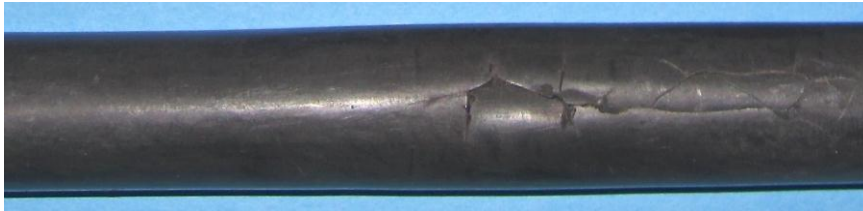
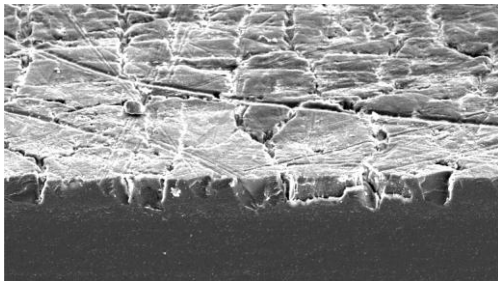
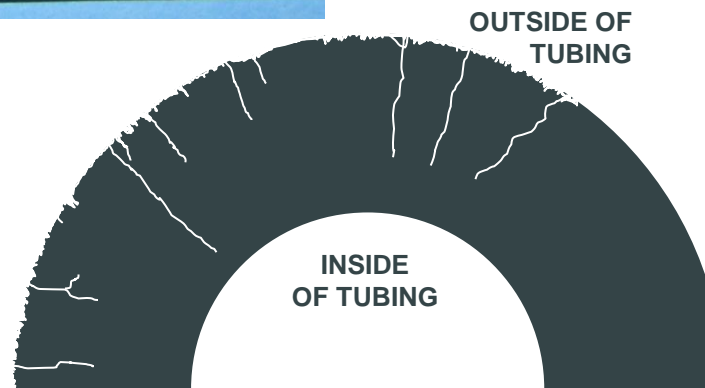
Photo of Tubing Sample, Less than 5 years In Use

Tubing Failure: Outside-In

- Inappropriate stabilization of polyethylene leads to accelerated degradation and cracking
- Undispersed carbon black leads to accelerated degradation and cracking
- The materials used and fabrication methods impact tubing performance

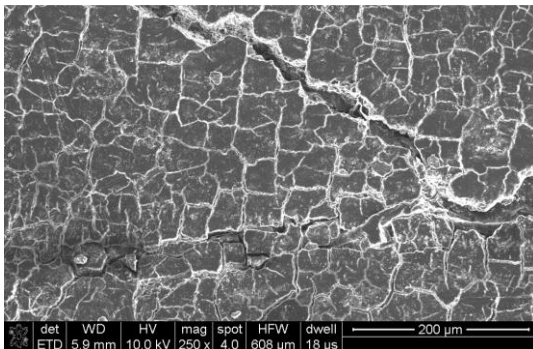
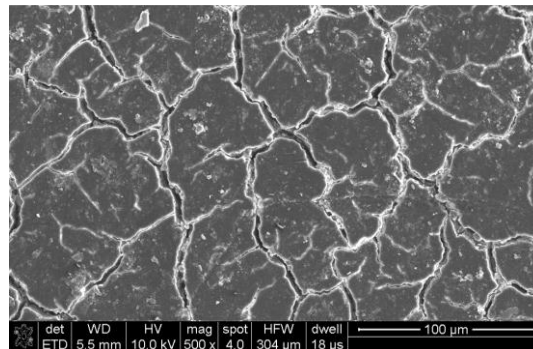
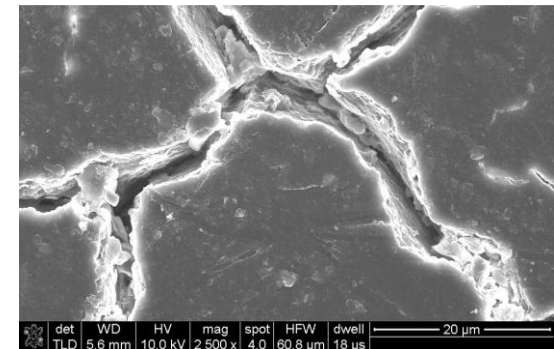
Images Show Outside Surface of Polyethylene Microirrigation Tube That has Significantly Degraded

Scanning Electron Microscope (SEM) Images taken at The Dow Chemical Company Laboratories in Freeport, Texas to determine the cause of a Drip Tubing Failure
