## Sidel Defect Troubleshooting Guide CSD Bottles

## Sidel Defect Troubleshooting Guide CSD Bottle

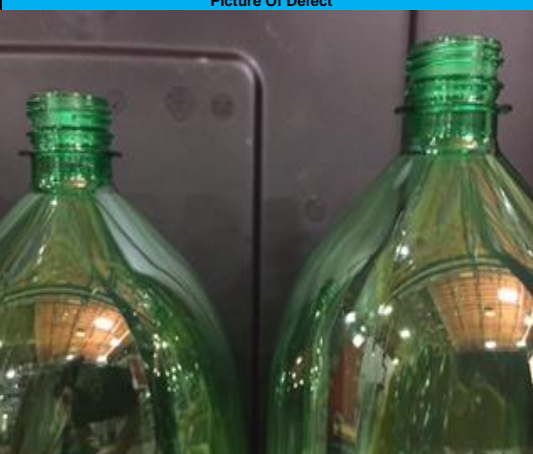
Problem	Cause	Suggested Remedy	Picture Of Defect
<b>Short Bottle/Low Volume</b>	1. Height gauge improperly calibrated.	1. Recalibrate height gauge.

2. Process too cold.	2. Increase overall process temperature.

3. Loss of mold cooling.	3. Restore mold cooling.	
	4. Loss of high blow pressure.	4. Increase high blow pressure.	
	5. Exhaust cam too far advanced.	5. Retard exhaust cam.

6. Insufficient material viscosity in preform.	6. Remove and replace preforms.	
	7. Not enough high blow time.	7. Increase high blow time.	
<b>Tall Bottle/High Volume</b>	1. Height gauge improperly calibrated.	1. Recalibrate height gauge.

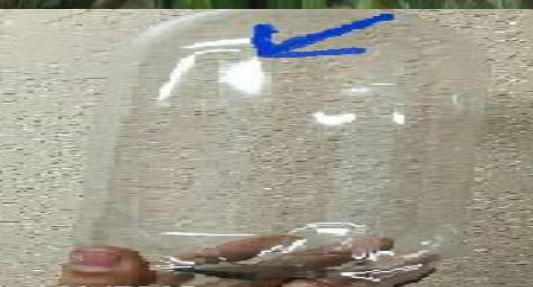
2. Process too hot.	2. Cool overall process.	
	3. Tooling out of specification.	3. Replace tooling.	
	4. Worn out mold or base locking rings.	.	
<b>Flat Sides</b>	1. Mold compensation improperly set.	1. Reset mold compensation.

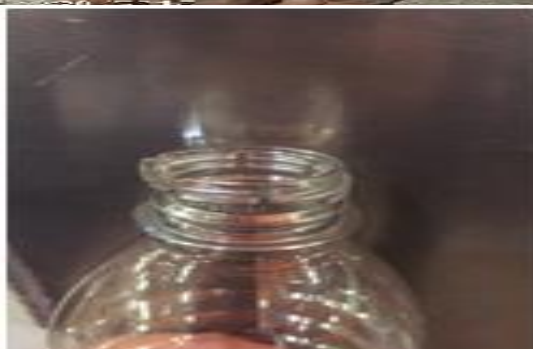
2. Hole in compensation airline.	2. Replace mold compensation airline.	
	3. Blown compensation o-ring.	3. Replace mold compensation o-ring.	
	4. Not enough material in the panel.	4. Add more material to the panel.	
<b>Damaged Finish</b>	1. Off center blow nozzle.	1. Recenter blow nozzle.

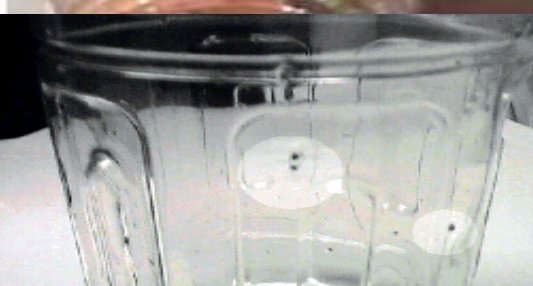
2. Preform loading wheel out of time on oven or mold	2. Reset timing.	
	3. Infeed loading top guide to low/high.	3 Re-adjust top guide.	
	4. Preform transfer arms out of time or adjustment.	4. Retime or reset transfer arms.

5. Preform hopper or feed system damaging finish.	5. Investigate and repair any pinch / jam point on preform feed system.	
	6. Damage occurring during preform manufacture.	6. Inspect preform container for damaged preforms. Replace preforms and notify Supervisor.	
<b>Inclusions</b>	1. Foreign material in regrind like plastic metals rubbers ext.	1. Notify supervisor of the findings and let him decide what to do.

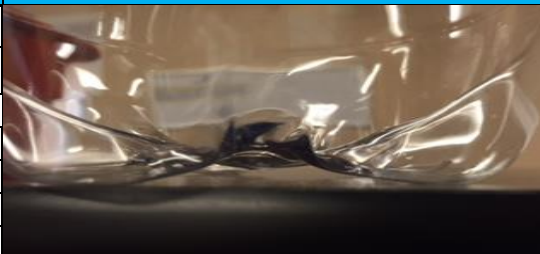
Problem	Cause	Suggested Remedy	Picture Of Defect
<b>Low Base Clearance</b>	1. Base clearance gauge out of calibration.	1. Recalibrate gauge.

2. Too much material in gate.	2. Redistribute material evenly through base.

3. Loss of mold base cooling.	3. Restore base mold cooling.	
	4. Cool jets off or out of position.	4. Reposition cool jets.	
<b>Hole In Feet</b>	1. Foreign material in mold or preform.	1. Remove foreign material from mold or replace preforms.

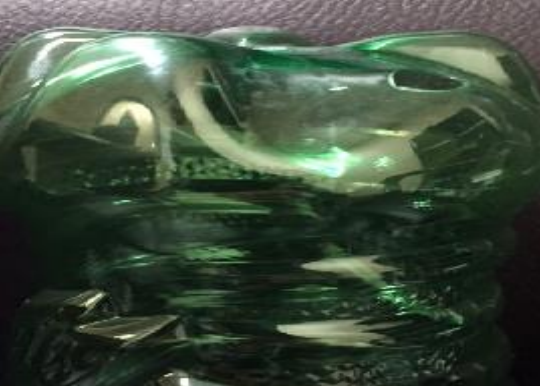
2. Unmelted material in preform.	2. Notify your supervisor.	
	3. Insufficient material distribution (feet too thin).	3. Reprocess and redistribute material.

4. Bent or damaged stretch rod.	4. Replace stretch rod.	
<b>Off Center Gate</b>	1. Stretch rod adjusted too high.	1. Readjust stretch rod gap.

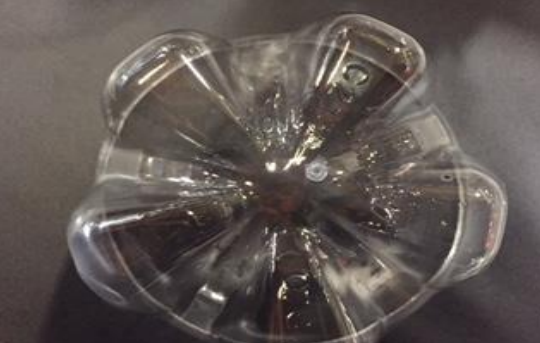
2. Preblow pressure too high or too soon.	2. Reduce preblow pressure or retard preblow cam.

3. Cool process, Verify process with BIC, Verify that auto-correction is activated, verify that camera for preform temperature has not been moved.	
	3. Process too hot.	4. Repair or replace spindle or section of chain.

4. Damage to oven chain or spindle causing loss of rotation.	5. Replace Stretchrod.	
<b>Burst Expansion Too High</b>	1. Make sure the water temp on the Burst tester is between 59 to 62 degrees.	1. Purge water till your with in degrees.

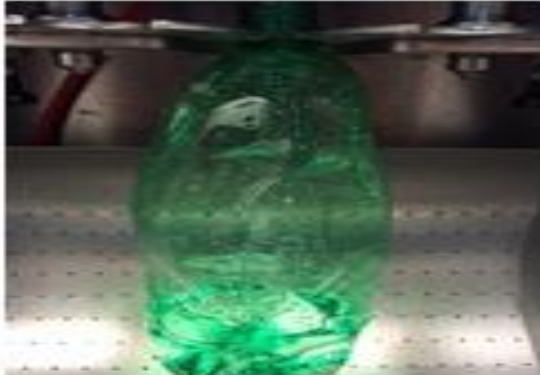
2. Proces Too Hot.	2. Cool off overall Process.	
<b>Bursting In The Gate</b>	1. Gate too cold.	1. Heat up the gate.

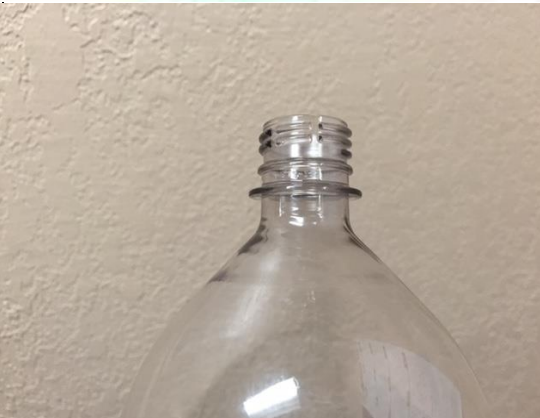
2. Too much material in gate area.	2. Redistribute material to thin out the gate area.

3. Excessive crystallinity in preform gate.	3. Let your supervisor know.	
<b>Drop Neck</b>	1. Too much heat In zone one.	1. cool off zone one.	
	2. Too much material in neck area.	2. Heat up zone one or lower preblow.
