## Remote Assessment Report

## Ground proof Assessment Report

## Mitigation Factors Report

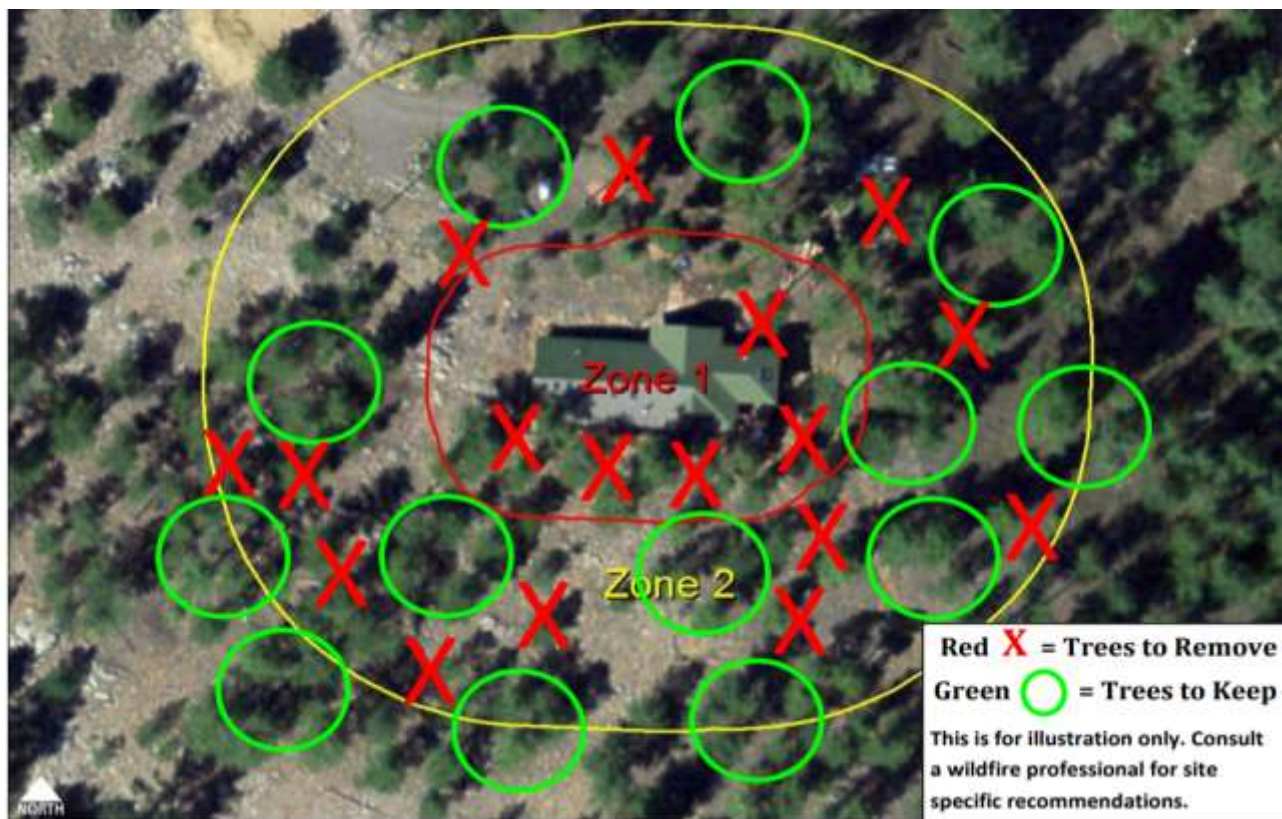
### Satellite view of the site

**Zone 1:** 30ft area around the structure

*Typed information by the SME regarding the X - trees to be removed including the location of the trees*  
*Typed information by the SME regarding the O - trees to be kept including the location of the trees*

**Zone 2:** 100ft area around the structure

*Typed information by the SME regarding the X - trees to be removed including the location of the trees*  
*Typed information by the SME regarding the O - trees to be kept including the location of the trees.*

*\* Please consult ground proof assessment consultant for detailed recommendation*
