ARCHITECTURE REVIEW - MARKABLE ISSUES

Project Title:-
Residence for Mr. Thomas
15 Oak St, Boston

Ground Floor
Layout

AA101

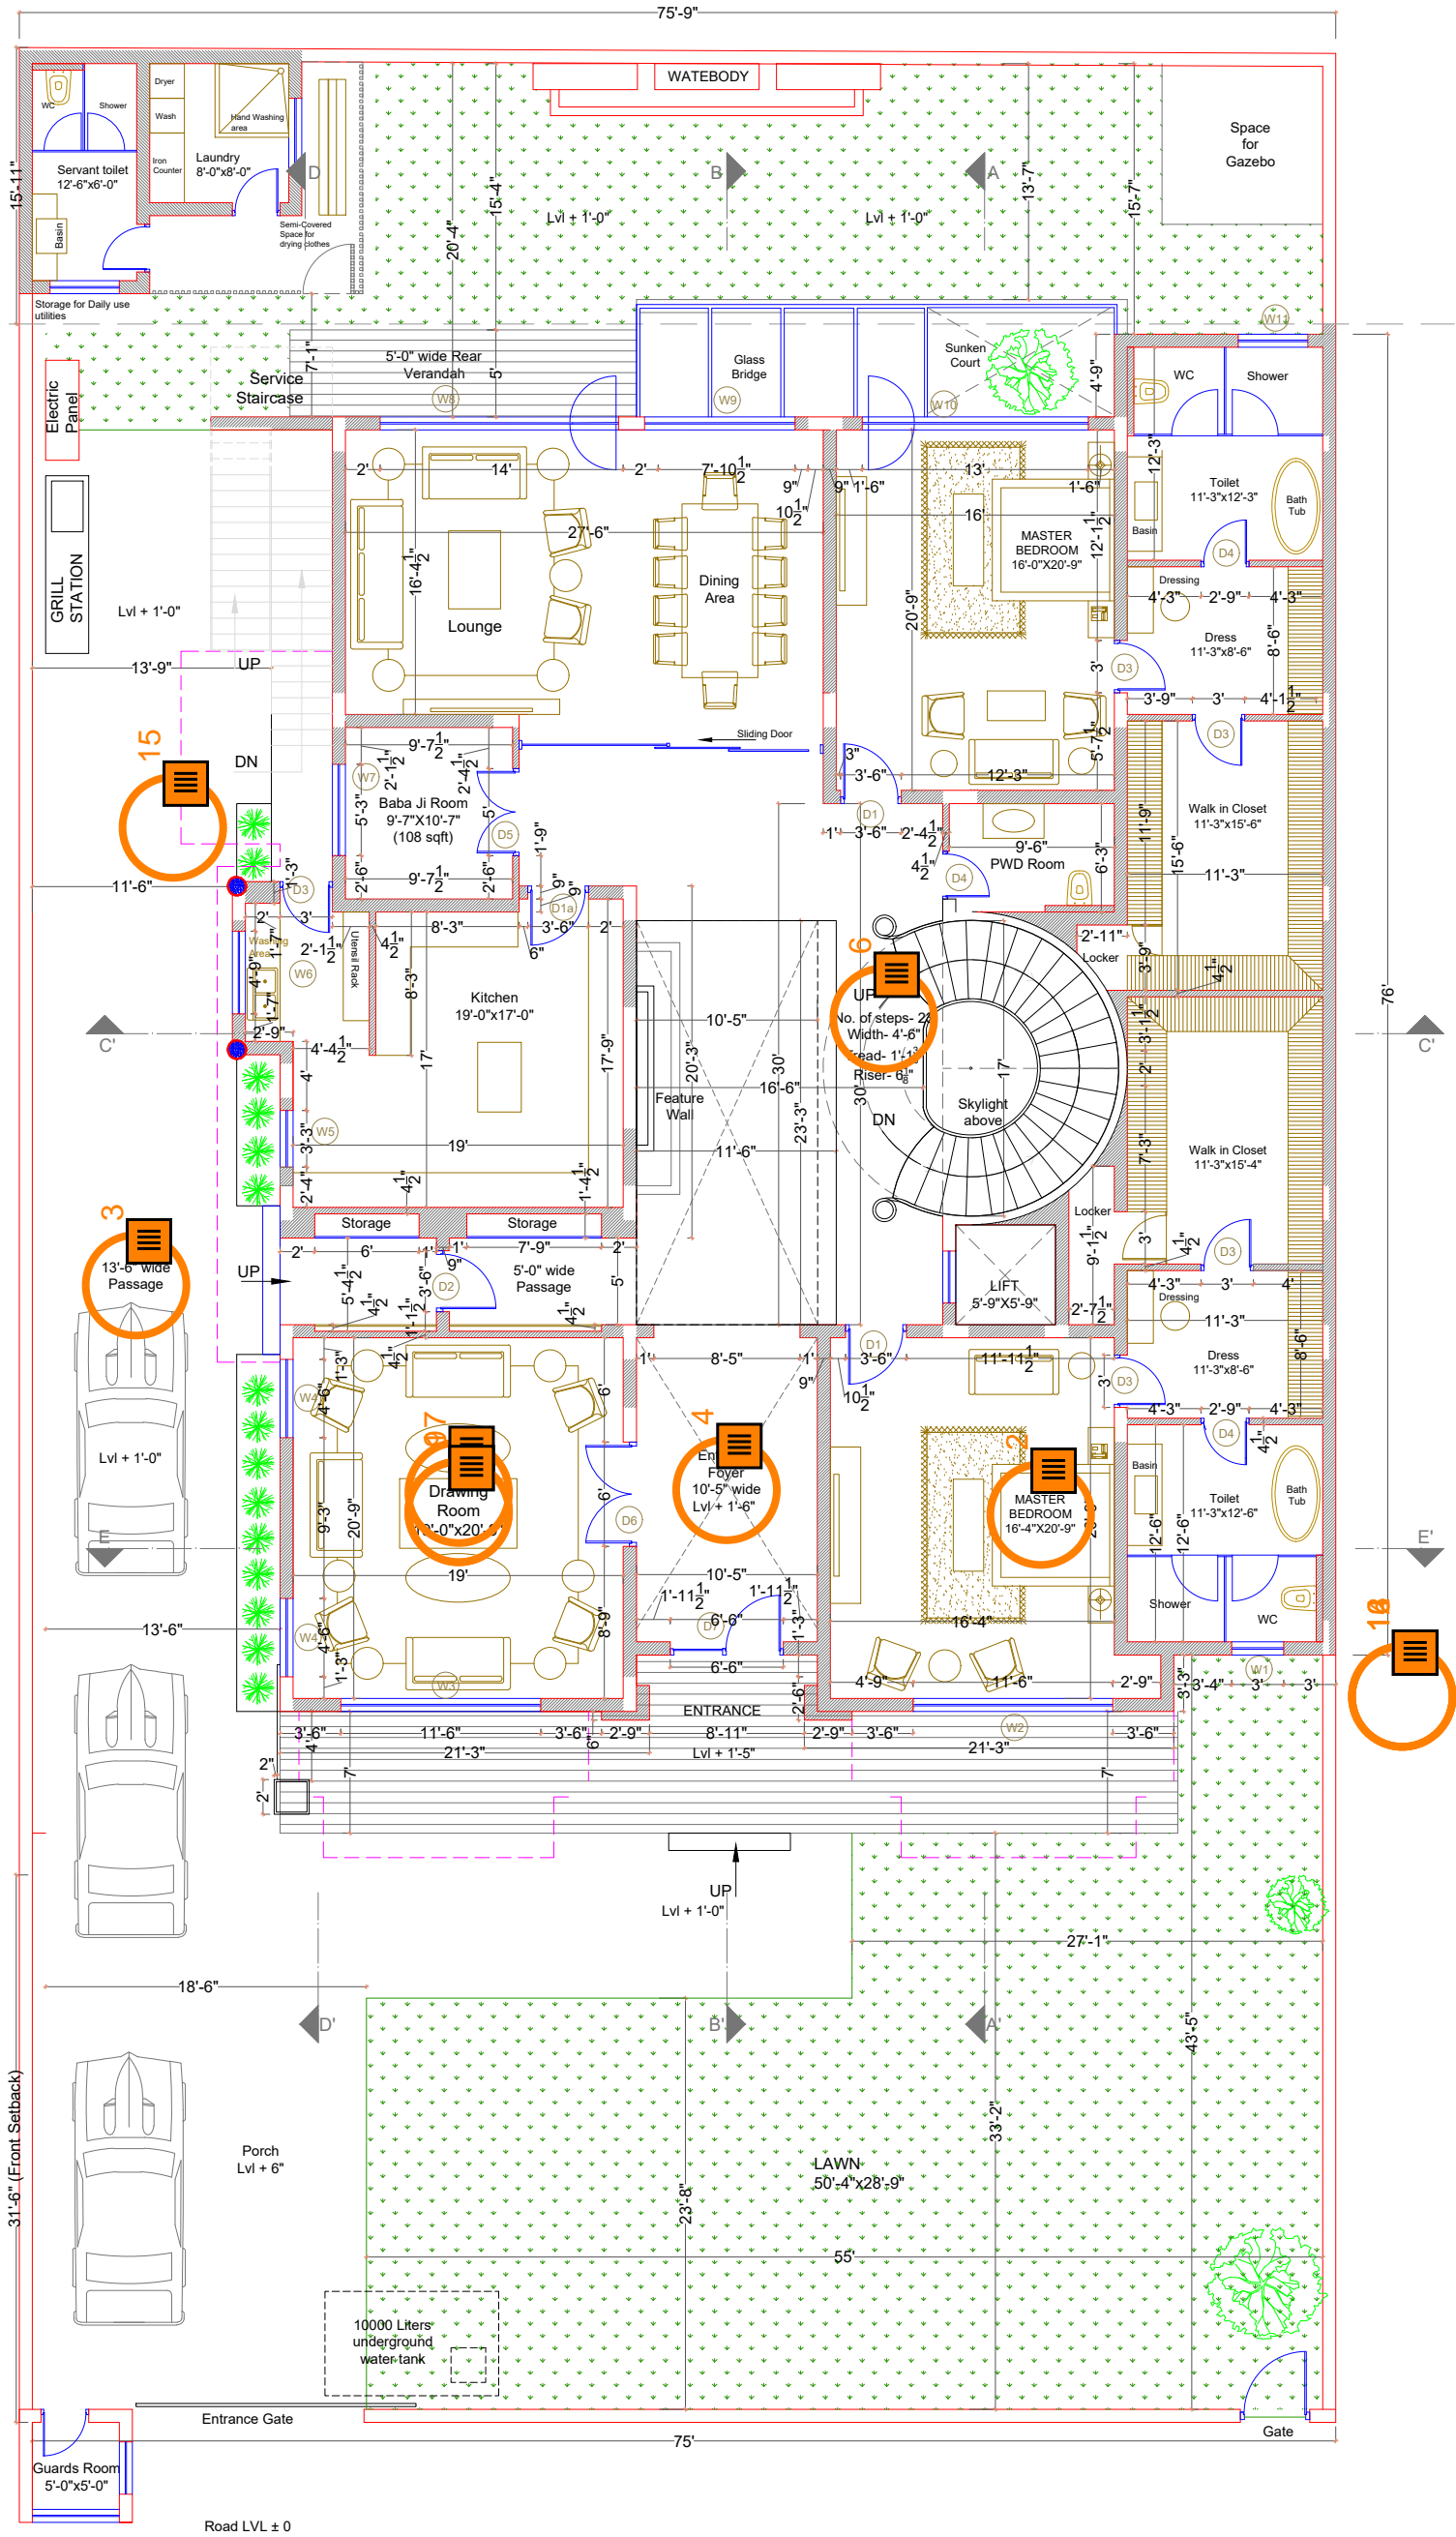
Bedroom dimensions potentially not meeting minimum standards.

Location: 'Baba Ji Room'

Bathroom/toilet sizing and layout may not be optimal for functionality.

Location: Toilet in 'Master Bedroom'

Corridor width seems narrow for functional requirements.

Location: 'Passage'

Door swing into narrow corridor could obstruct movement.

Location: '10'-5" wide'

Text and dimensions overlap, affecting readability.

Staircase rise/run does not appear reasonable.

Location: 'No. of steps- 23'

North arrow missing, affects orientation understanding.

Handrail positions and design potentially incorrect for safety.

Location: 'Staircase'

Room labels overlap furniture and walls.

Staircase location may impact overall circulation.

Review and confirm compliance with NBC recommendations for minimum room sizes.

Verify compliance with space and accessibility guidelines.

Ensure corridors meet minimum width requirements for safe passage.

Change door swing direction or adjust position to prevent obstruction.

Adjust text placement to avoid overlap and improve clarity.

Reevaluate stair dimensions to conform to ergonomic standards.

Add a north arrow to all drawings for clarity.

Review and ensure handrails meet safety requirements.

Adjust placement of room labels for clarity.

Review staircase location in relation to main circulation paths and adjust as needed.
