# Technical Publication

Direction 5831660-1EN

## **Revolution™ Maxima/Revolution™ Ace Application Tips and Work-Arounds**

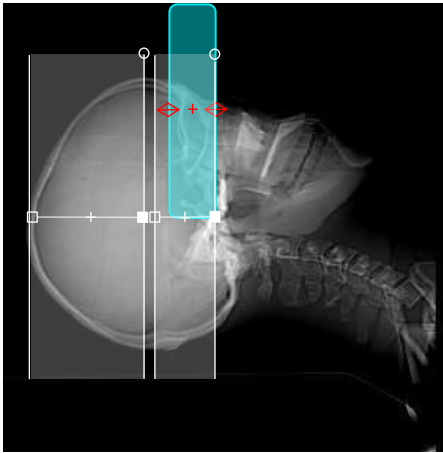
- If the length of the ODM region is less than 2 rotations in an Axial scan, the system will acquire the ODM scan for each full rotation. As shown in below , the ODM region prescribed for the 1st scan group and if the scan group has 2 rotations, the scan group (2 rotations) are acquired with ODM modulation.

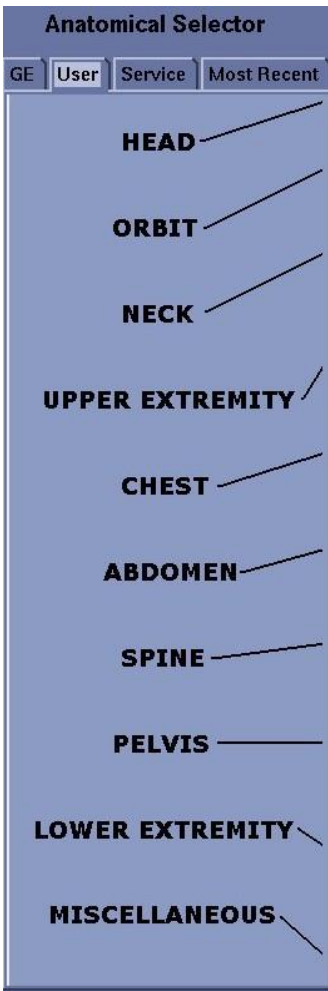
- When the system is configured in a language other than English there are several items that will be displayed in English on the protocol selector. The following table shows the items that will be displayed in English and the translation.

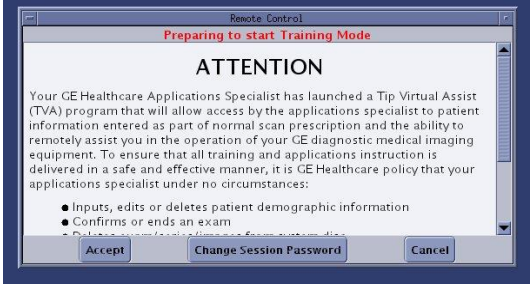
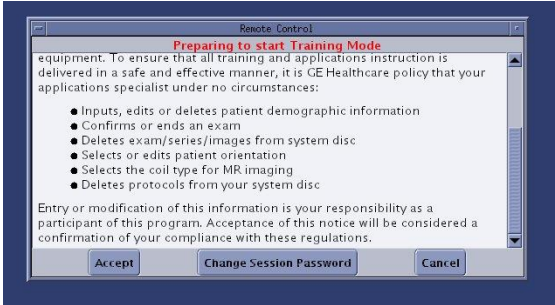
- When the system is configured in a language other than English, the user confirmation screen for the start of Remote Training is not translated. The attention information is translated in the following table.

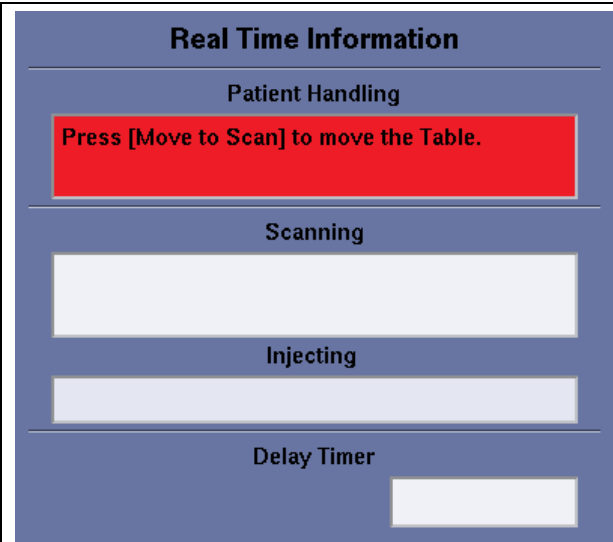
- When the system is configured in Portuguese and Danish languages, the following error message is not translated. The table below shows the English screen capture, English text and the translated text.

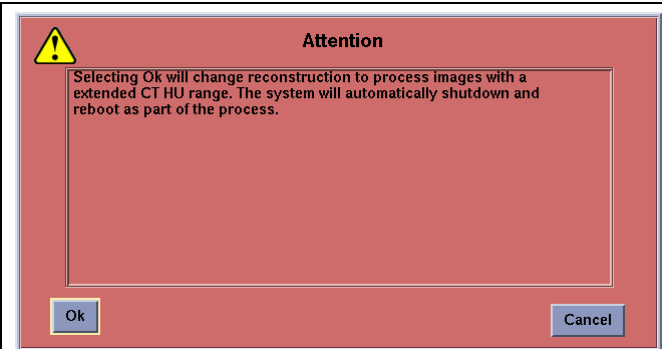
- When the system is configured in Danish language, the following pop-up message for Extended HU Unit is not translated. The table below shows the English screen capture, English text and the translated text.

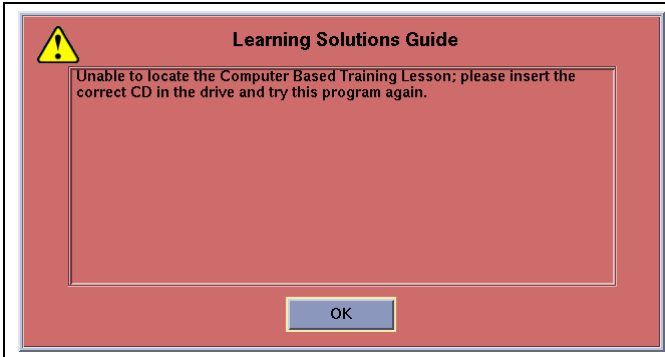
- When the system is configured in Dutch language, the following pop-up message for Learning Solutions is not translated. The table below shows the English screen capture, English text and the translated text.

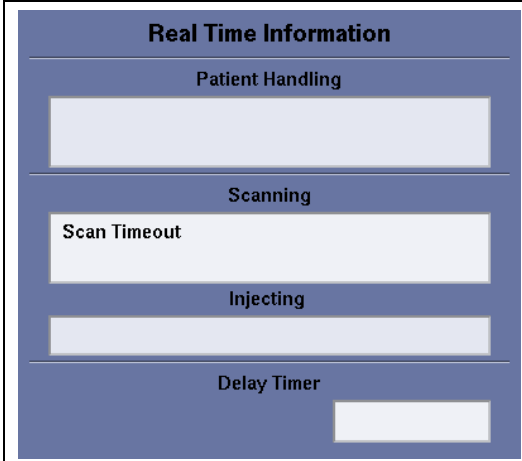
- When the system is configured in Dutch language, the following pop-up message in Real Time Information is not translated. The table below shows the English screen capture, English text and the translated text.

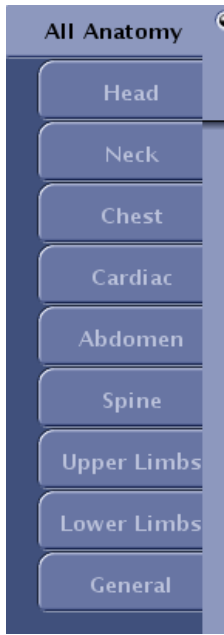
- When the system is configured in Portuguese language, in Volume Viewer the Anatomical Area selection button has text that is truncated. The table below shows the English screen capture, English text and the translated text.

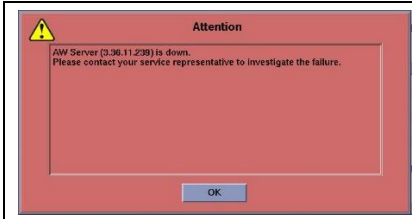
- When the system is configured in Chinese or Japanese language and using Remote AWS Application the following error message pop up is not translated correctly. The table below shows the English screen capture, English text and the translated text.
