Troubleshooting Guide

Related Product	Symptom	Possible Cause
v100/v100GX	LNB/NBD Error	LNB, NBD/FSK unit, Cable between NBD/FSK unit and LNB

Document Number: #2016P2-TG0909-02-V1_1

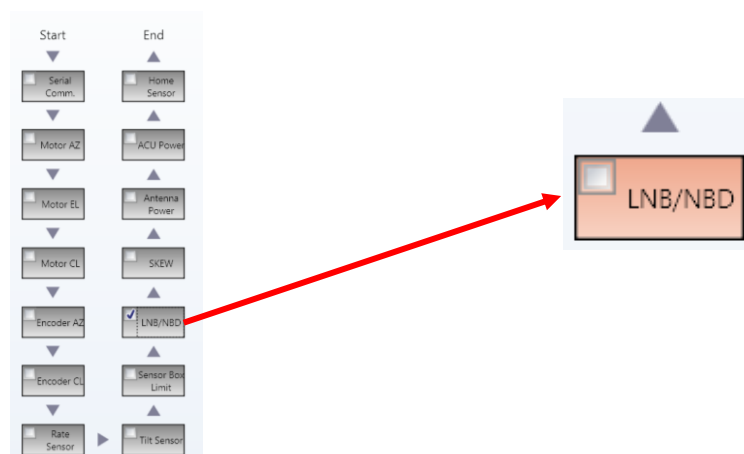
2.2 Aptus

The LNB/NBD Error makes antenna tracking and VSAT service unavailable due to no RX signal from satellite. That error can be detected by Diagnosis test as LNB/NBD error (code 110).

→ LNB/NBD is diagnosed as **GOOD** or **BAD**

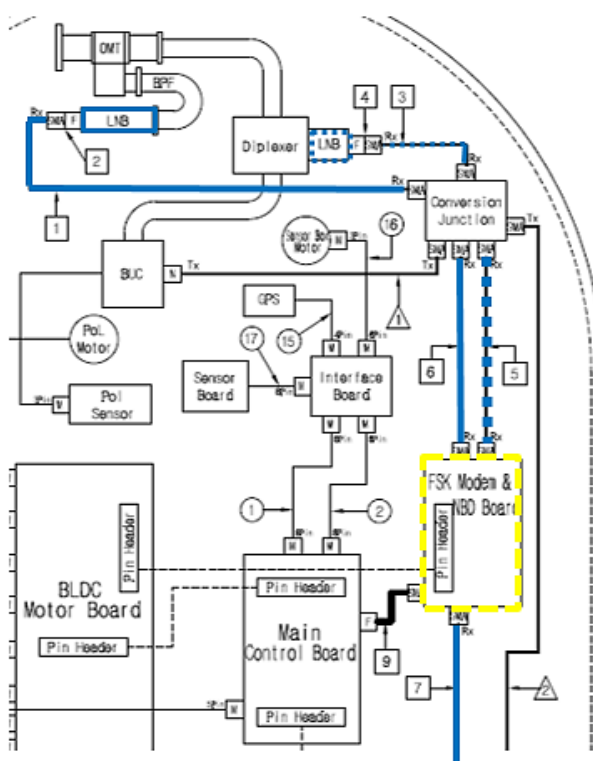
(LNB/NBD System Diagram)

- LNB (Cross pol LNB / Co pol LNB) error
- FSK / NBD board error
- Cable error between LNB & NBD
- Wrong setting of Local Frequency

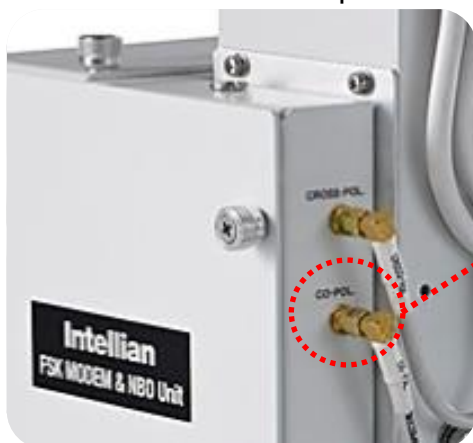
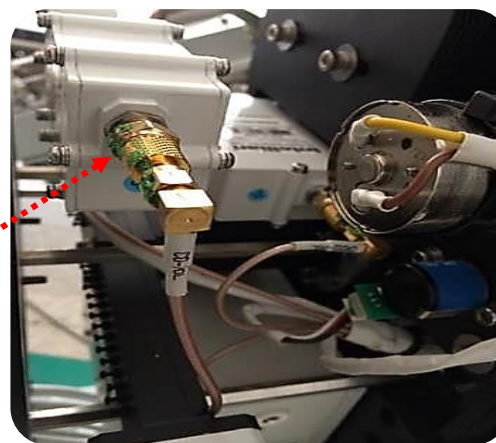
1. Check the Co-Pol LNB input cable.

In case that the voltage is measured normally on output port of NBD but is not measured on the LNB input connector → Check and replace RF cables between the NBD and the LNB.

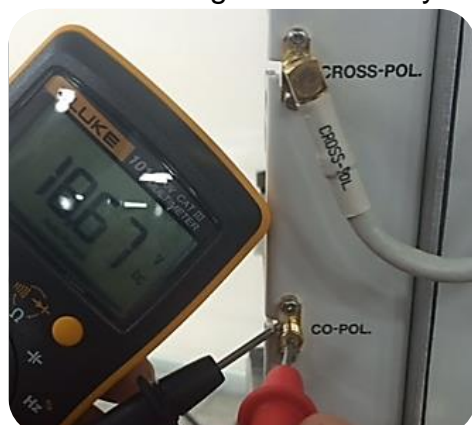
(How to measure the NBD output voltage)

2. Check the existing NBD board by using RF TEST cable.

In case that voltage is not detected on the output port of the Cross or Co Pol NBD.
→ Check and Replace the NBD

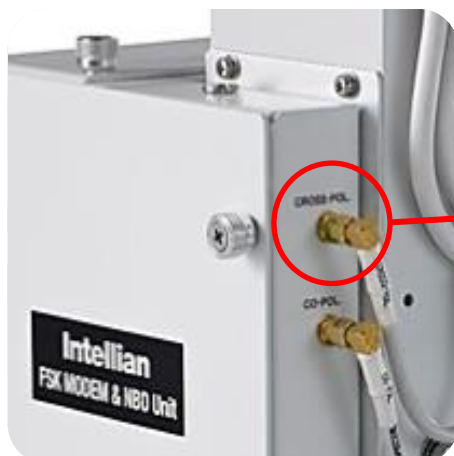
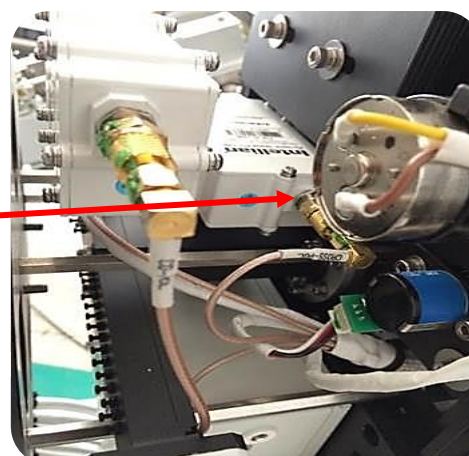
6.3.2 Check the Cross pol LNB voltage

The LNB input power from the FSK/NBD is supplied only for one LNB in operation at one time, not for both Co / Cross pol LNB at the same time.

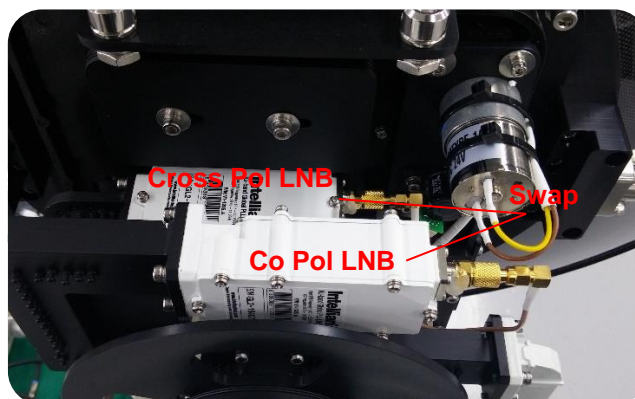
7.1 LNB swap test

LNB/NBD diagnosis test can be conducted by swapping the Cross pol LNB and the Co pol LNB in defect of spare LNB for replacement or test.

- Antenna LNB/NBD test result check
 - NBD Cross pol Pass Check : Pass
 - NBD Co Pol Pass check : Fail**
- Swap the Cross pol LNB and the Co pol LNB. Then run the LNB/NBD diagnosis test again.
 - NBD Cross pol Pass Check : Fail**
 - NBD Co Pol Pass check : Pass
- In that case, the original Co Pol LNB is defective.
