# **XT1225/XT1254 BASEBAND TROUBLESHOOTING GUIDE**

**Sept 18, 2014**

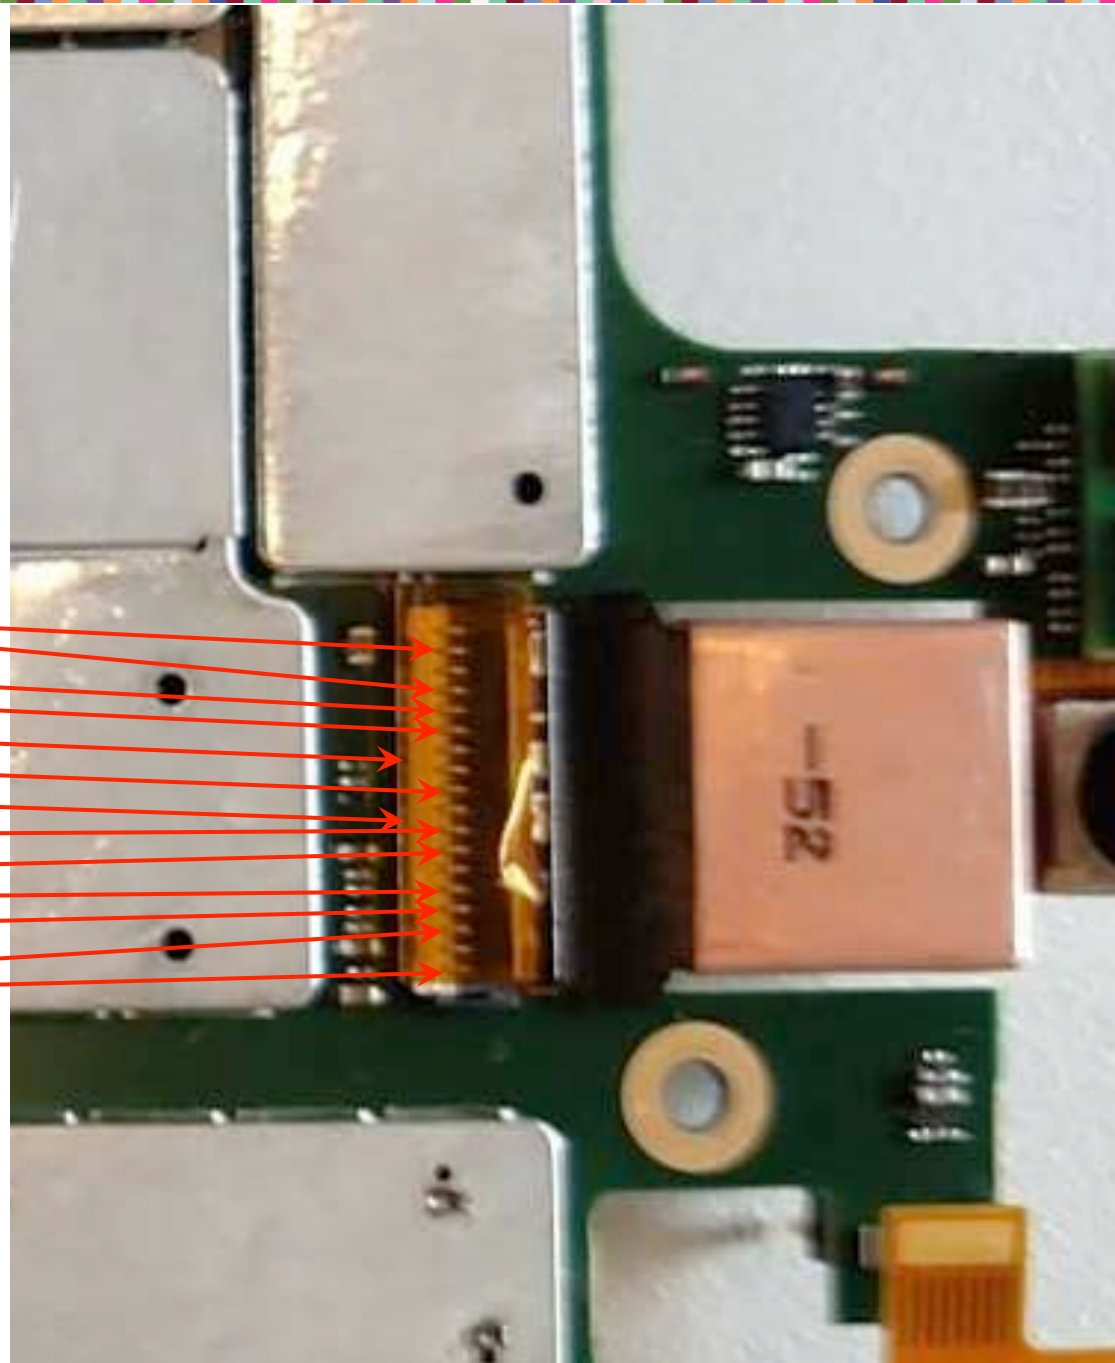
# Rear Camera

- 1) Even pins are available for gentle probing on ZIF connector.
- 2) If the camera is not turning on, the only time you will see these signals is during boot, right before the vibrator turns on. The best way to catch the signal is to set an oscilloscope to single trigger.

- o Test available signals
  - Pin4: AVDD (2.8v)
  - Pin8: DATA3\_N (Check MIPI exist on all MIPI lines)
  - Pin10: MCLK (24MHz @ 1.8v)
  - Pin12: DATA1\_P (Check MIPI exist on all MIPI lines)
  - Pin15: RESET (1.8v) (Odd pin under ZIF door)
  - Pin18: CLK\_N (Check MIPI exist on all MIPI lines)
  - Pin21: I2C\_SCL (1.8v communication present)
  - Pin22: I2C\_SDA (1.8v communication present)
  - Pin24: DATA2\_P (Check MIPI exist on all MIPI lines)
  - Pin28: DVDD (1.0v)
  - Pin30: VIO (1.8v)
  - Pin32: DATA4\_P (Check MIPI exist on all MIPI lines)
  - Pin36: AFVDD (2.7v)

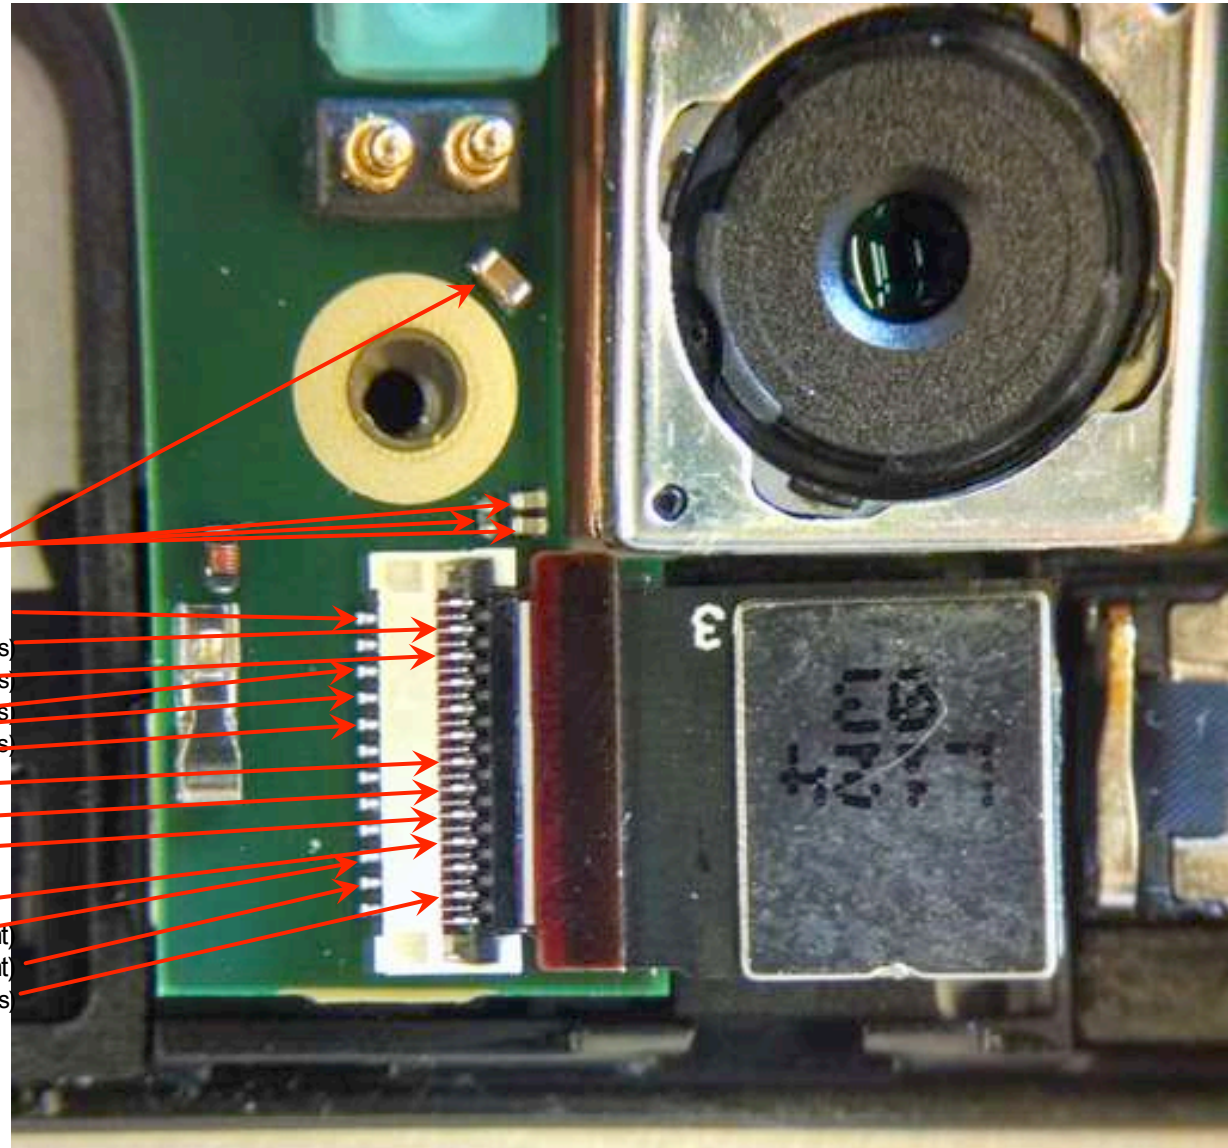
# Front Camera

- 1) Pins are available for gentle probing at ZIF connector.
- 2) If the camera is not turning on, the only time you will see these signals is during boot, right before the vibrator turns on. The best way to catch the signal is to set an oscilloscope to single trigger.

Pin2: DATA1\_P (Check MIPI exist on all MIPI lines)  
Pin3: DATA1\_N (Check MIPI exist on all MIPI lines)  
Pin5: CLK\_P (Check MIPI exist on all MIPI lines)  
Pin6: CLK\_N (Check MIPI exist on all MIPI lines)  
Pin8: MCLK (24MHz @ 1.8v)  
Pin10: VDDIO (1.8v)  
Pin13: AVDD (2.8v)  
Pin15: DVDD (1.2v)  
Pin17: RESET (1.8v)  
Pin19: I2C\_SCL (1.8v communication present)  
Pin20: I2C\_SDA (1.8v communication present)  
Pin22: DATA2\_P (Check MIPI exist on all MIPI lines)  
Pin23: DATA2\_N (Check MIPI exist on all

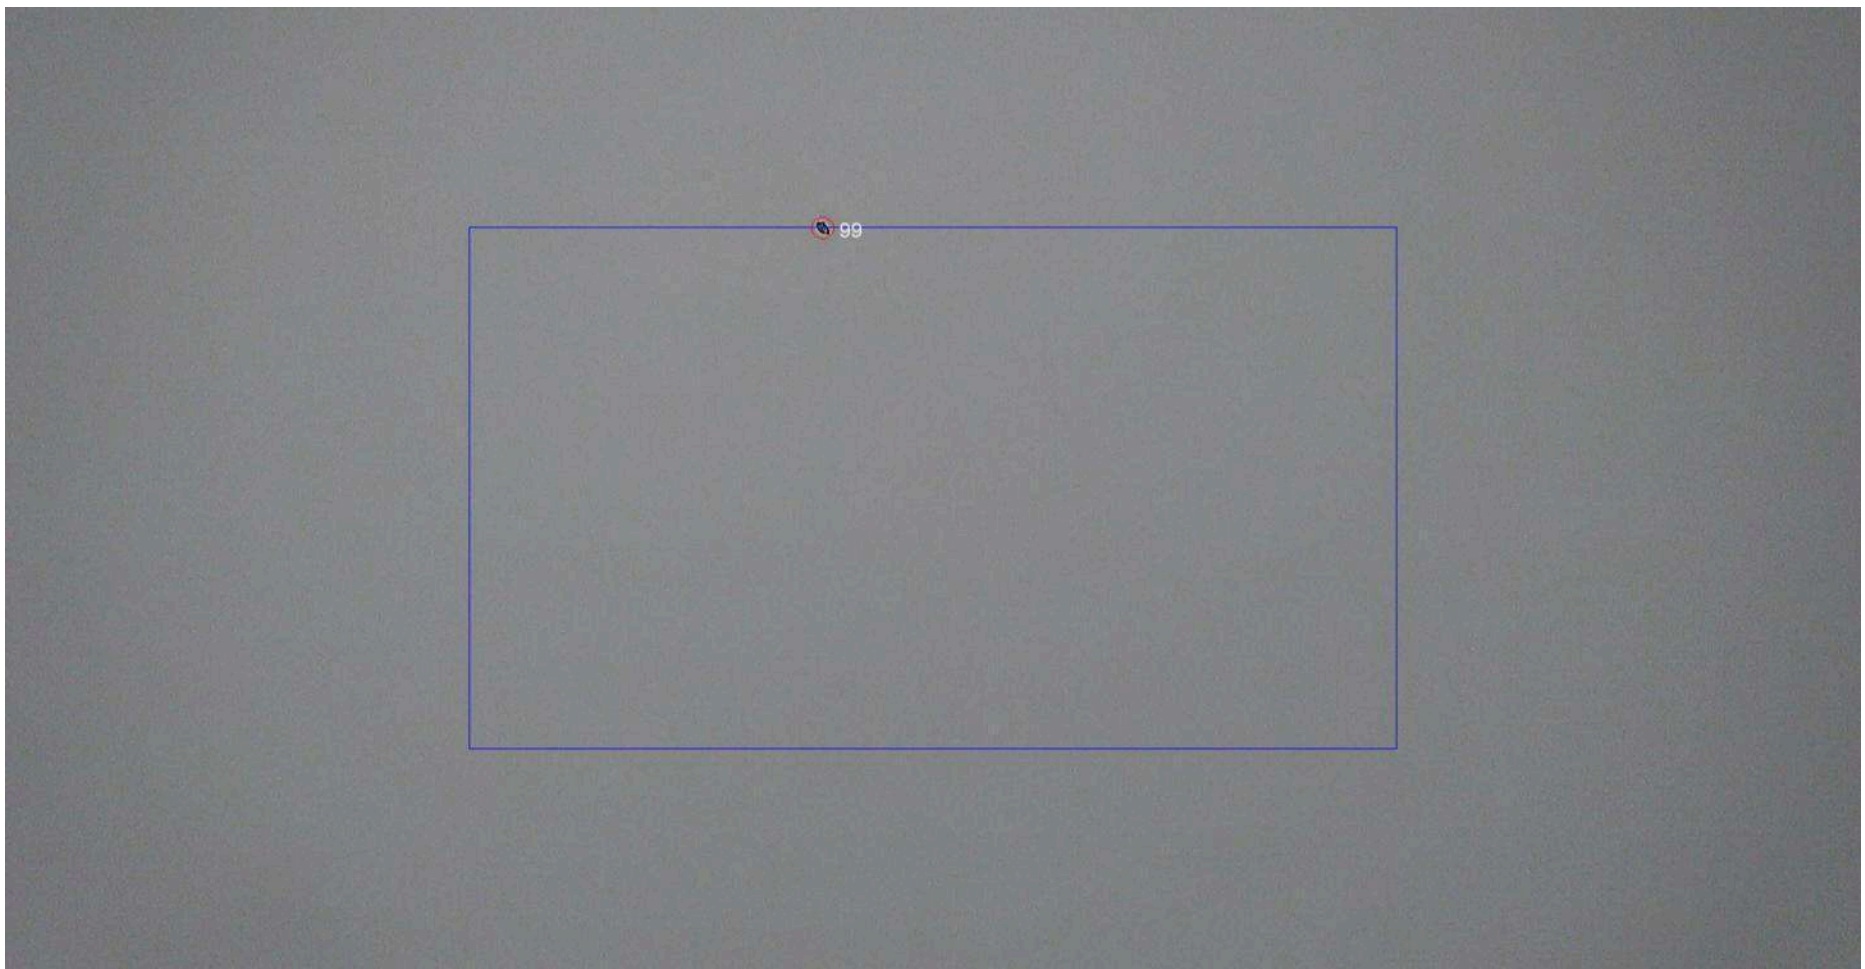
## Blemish Example #2

Blemish failure due to FM. The blue box and red circle are part of the annotated image. Annotated images end with \_BLEMISH in the file name. These annotations are drawn by the analysis software and not part of the real image. The blemish that is circled however is real and indicates FM or a defect in the lens.

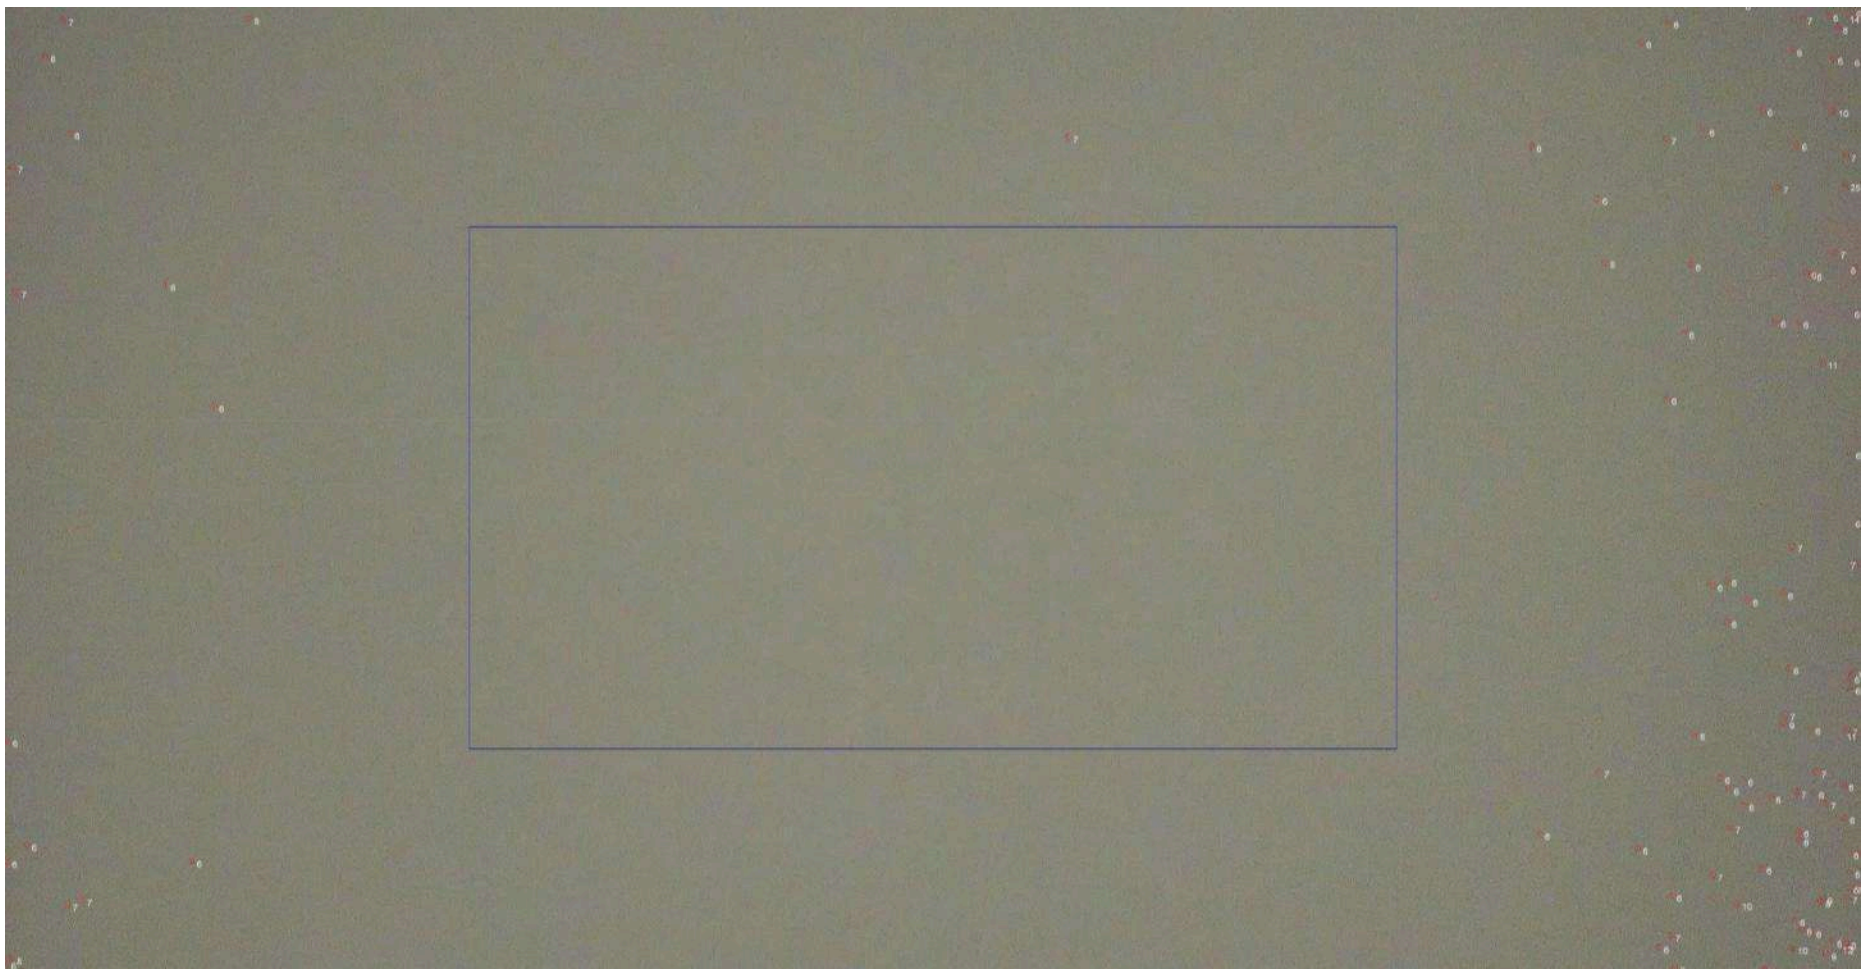
### Blemish Example #3

Blemish failure due to noise. There are no particles or lens defects in this module, but the noise is so bad that it is getting mistaken for blemishes. This is most likely a problem with the sensor.

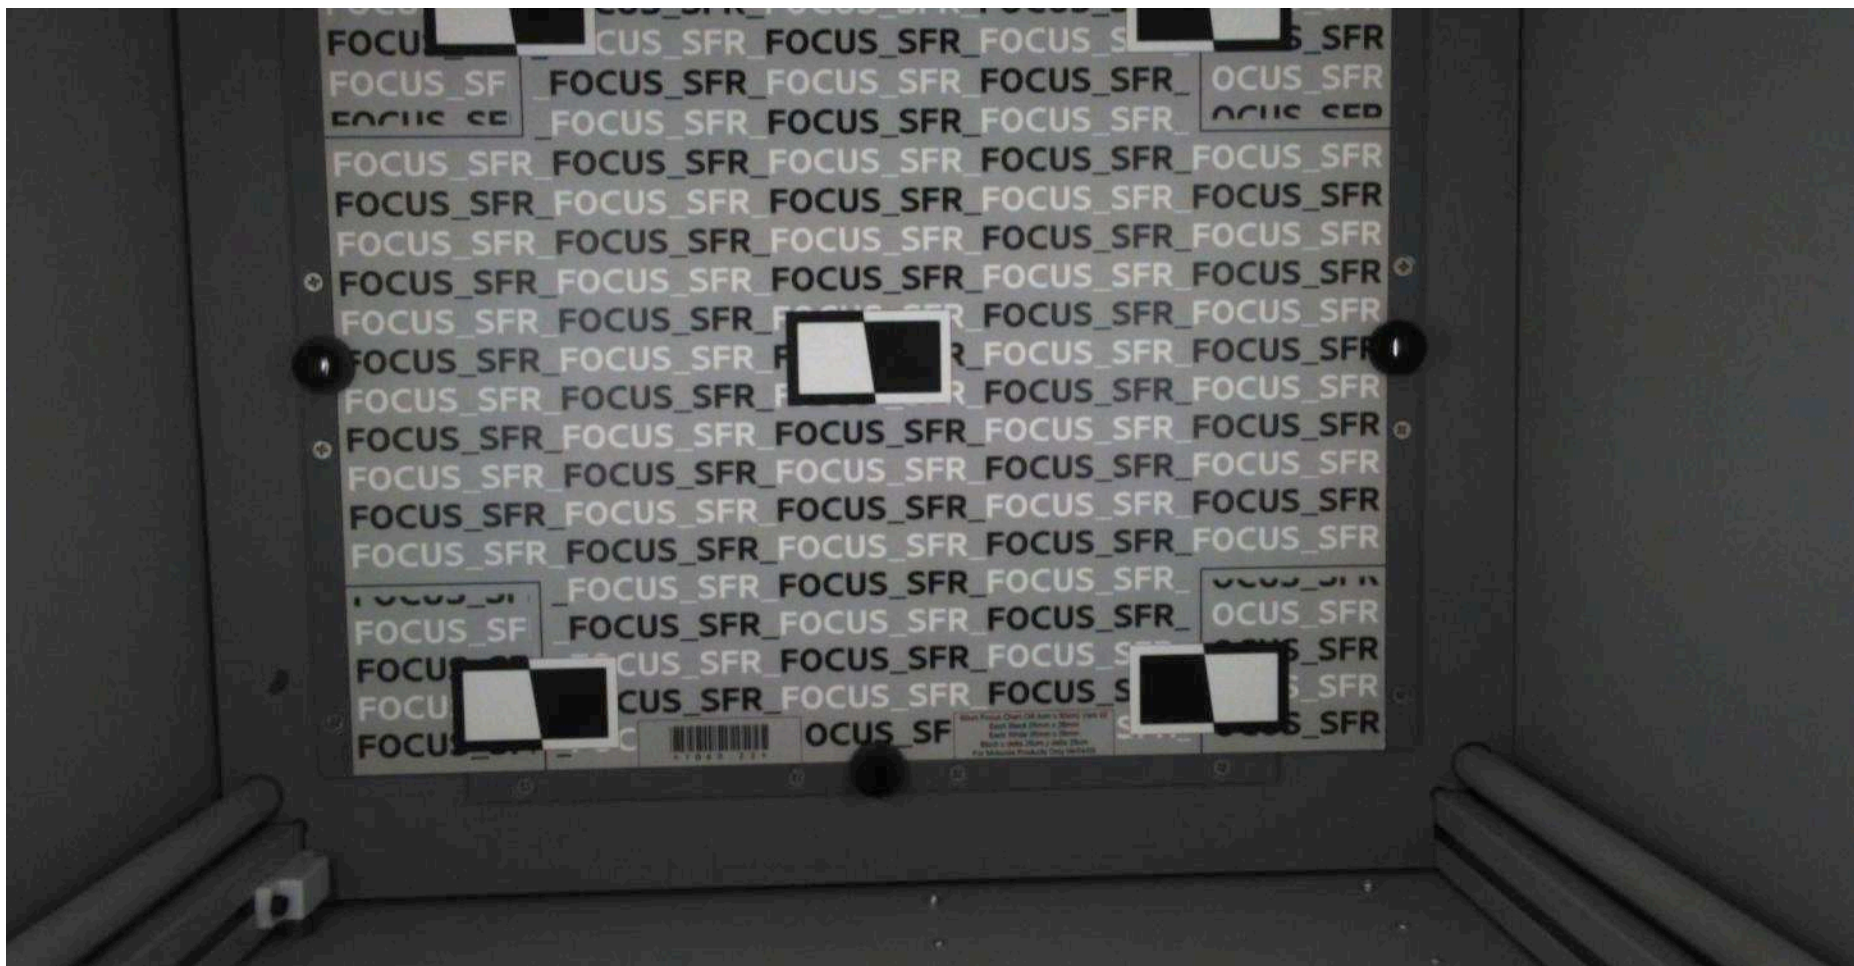
## Placement Error Example

This picture shows a really severe case of the focus chart not being centered within the camera's view. This case is most likely caused by operator error when placing the phone into the test chamber.

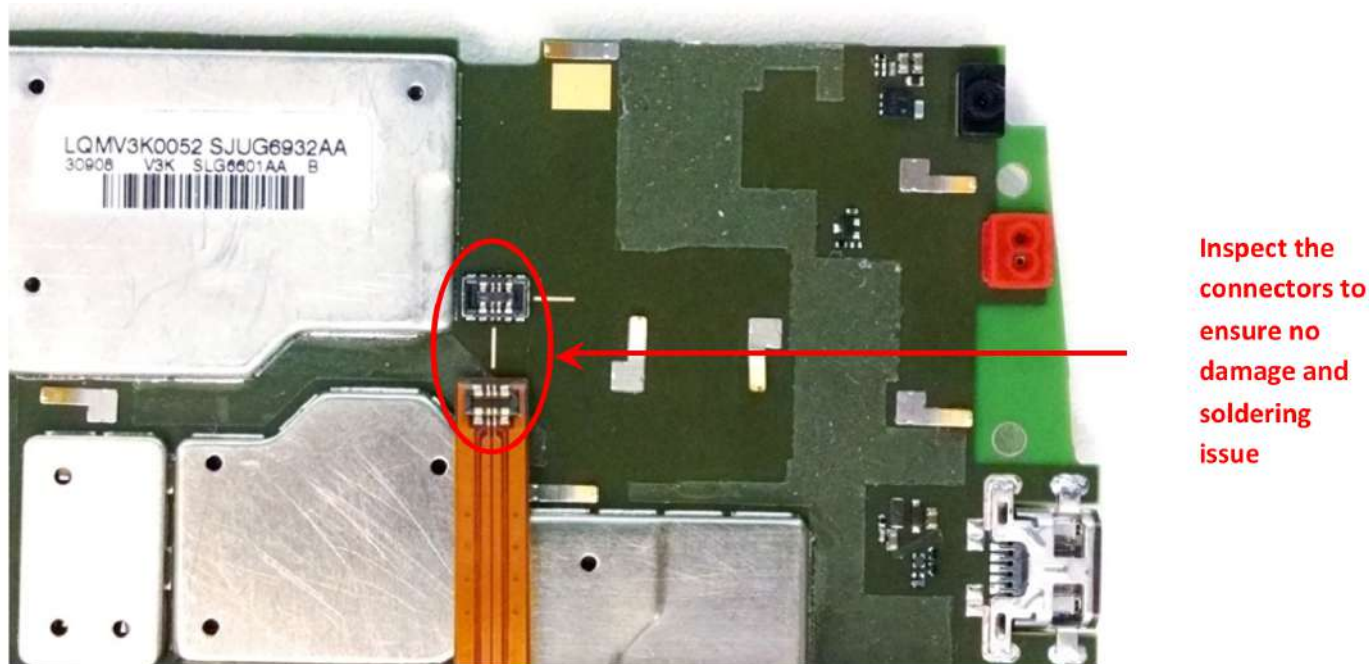
2. Verify NFC antenna connector is not damaged on flex or on PCB. There may be soldering defects, such as shorts, broken pads. There may also be broken pins within the connector. Often broken pins can occur through improper insertion of connector.

3. Replace NFC antenna to see if it follows antenna itself.
4. Ensure NFC antenna matching components are not damaged.
