Paper Jam Error 13.B2.FF

HP LaserJet Enterprise M806/M830MFP

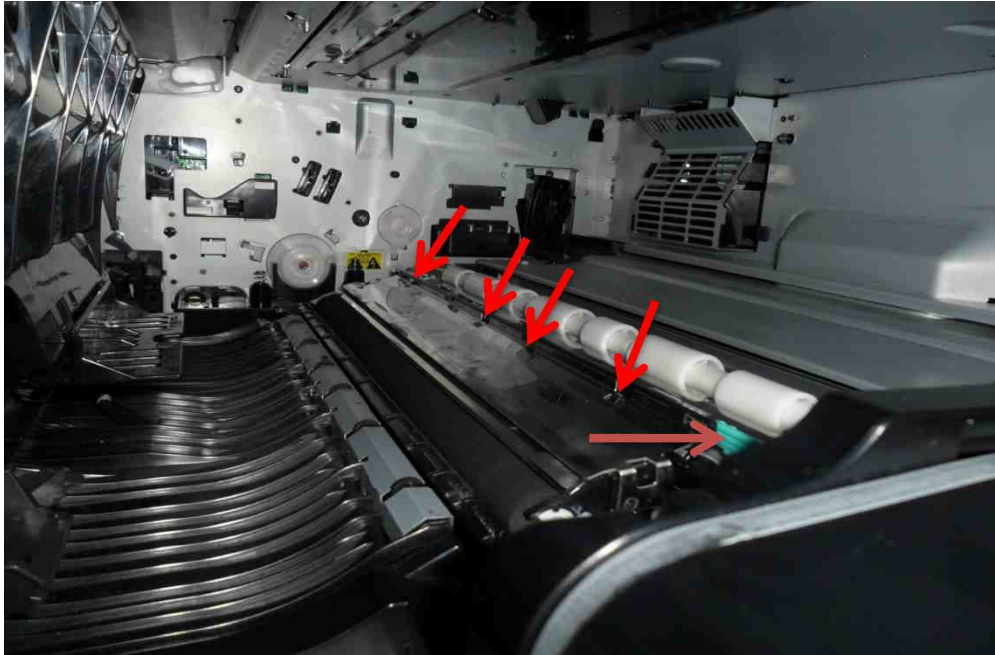
The registration in the M806/M830 series contains 4 paper sensors – three of which are paper width sensors (PS1, PS2 and PS3) and also top of page sensor (PS4). The registration also has an access plate that lifts (green tab) to expose the sensor flags. Any of the 4 flags obstructed at power on will produce 13.B2.FF where the plate would need to be lifted for inspection as any paper obstruction may not be visible otherwise.

Callouts showing four sensor flags and green lift tab.
