59.F0 Error

HP CP4025/CP4525/CM4540/M651/M680MFP

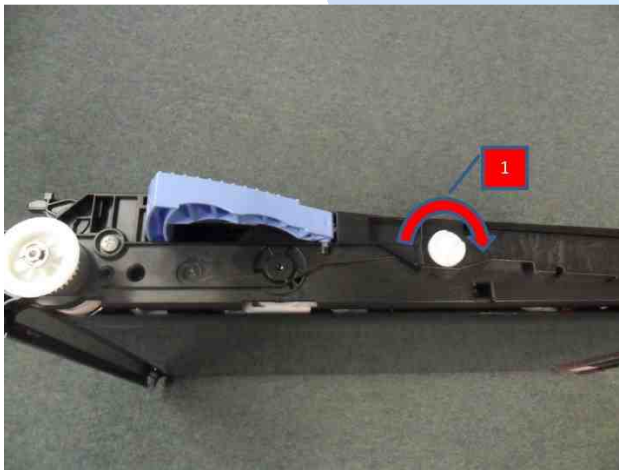
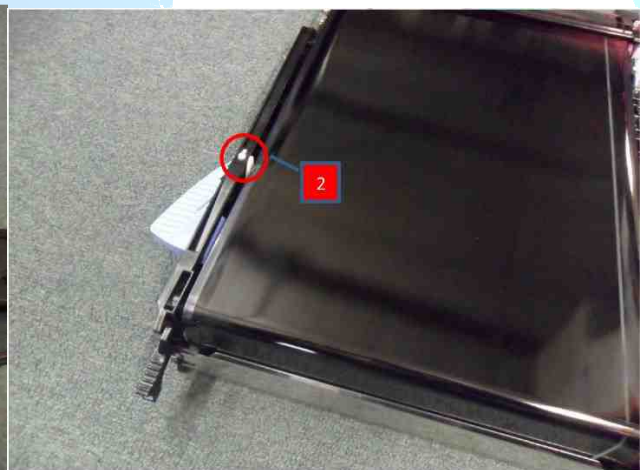
This error is primarily caused by a transfer alienation failure in which the ITB is stuck and unable to rotate, the SR9 sensor (the primary transfer roller disengagement sensor) has gone bad or the fuser drive assembly has failed.

1. Reseat the ITB.
2. If the issue persists, remove the ITB completely from the unit and manually test the ITB gear and flag.
3. Rotate the gear (1) and check that the flag actuates (2) when the white gear is turned.

4. If the ITB flag is broken or damaged, or if the flag does not move, replace the ITB.
5. If the ITB gear and flag are working properly, test the Primary transfer roller disengagement sensor SR9 (Sensor K) by using the MANUAL SENSOR TEST in the TROUBLESHOOTING MENU.
6. Remove the ITB and fuser assembly to locate Sensor SR9 (3) inside the fuser cavity.

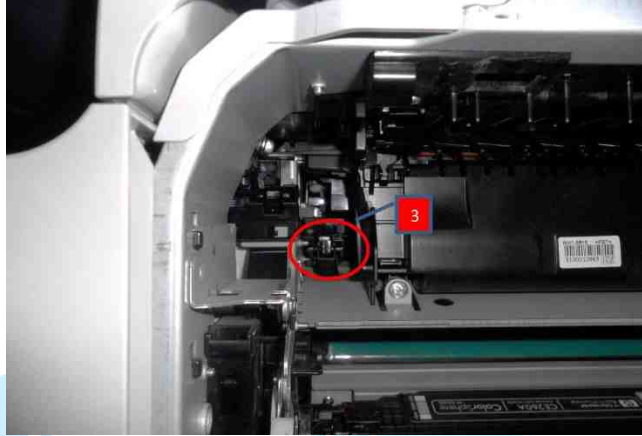
7. From inside the fuser cavity, press and release the SR9 flag to actuate the sensor
8. While pressing and releasing the flag, check the control panel display for sensor response (under K) and confirm the sensor toggles between 0 and 1 (0 is the normal state)
9. If the value does not toggle between 0 and 1, replace the sensor (WG85696000CN)

If Sensor SR9 is working properly, the error would then be the result of the fuser/transfer drive assembly not rotating the belt. Replace the fuser drive assembly.
