## ***HP CLJ 4600/4650 - Blank pages-Disengaging Rod***

**Problem:** Document does not print and no error code is displayed

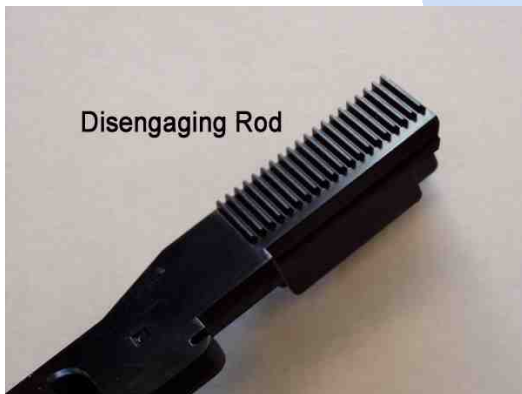
Remove the top and left cover, then put the top cover back on and run a print job. You should hear and see the developing motors start.

The developing disengaging rod will raise approx. an inch, pause for 2 seconds, and then raise a second time.

If on the second lift the disengaging rod skips teeth or does not move, this indicates the disengaging rod needs to be replaced

Note: The disengaging rod along the bottom is a 2" row of teeth that tend to actually break off causing the cartridges not to engage, requiring the rod to be replaced.

1. Remove metal retaining plate (6 screws), exposing the disengaging rod
2. Remove the return spring from the bottom of the disengaging rod
3. Raise the rod to its maximum lift point, and pull upward and outward to remove.
