Baxter	DIVISION OR FUNCTION:	DOCUMENT No.: 35022-SVC	ISSUE DATE: See Stamp
	Service	REVISION: D	EFFECTIVE DATE: SEE STAMP
	OWNING GROUP: Service	DOCUMENT TYPE: ITP	
TITLE: Visual Component Inspection of a SIGMA Model Spectrum Pump			PAGE 1 OF 33

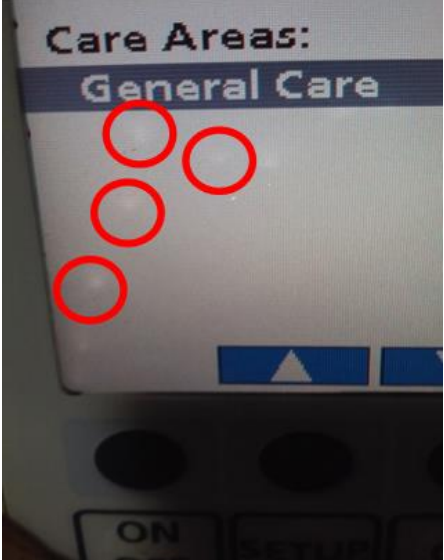
<p>5.1 White/bright colored spots on the screen require a display replacement.</p>

<p>White/bright colored spots</p>
<p>5.2 Significant dark colored areas on the screen require a display replacement.</p>

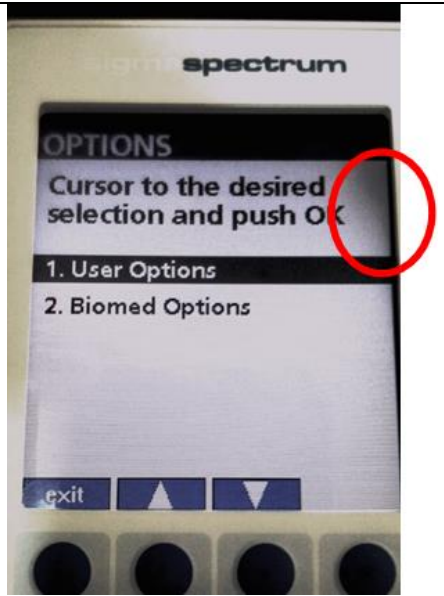
<p>Dark colored area on screen</p>

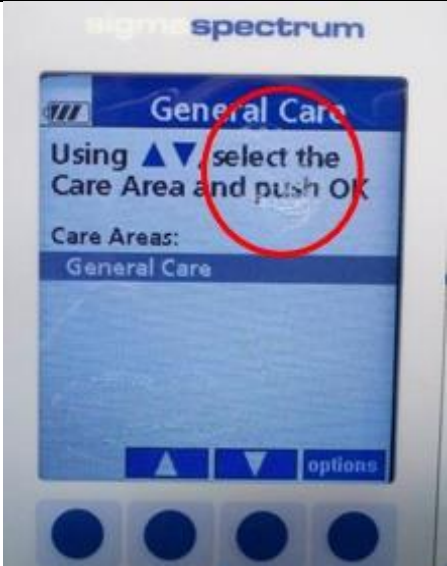
<p>5.1 If screen dents, dings, scratches exist:</p> <p>5.1.1 While in the general care screen, if dents, dings, or scratches do not affect visibility or functionality turn off pump, remove the battery, and proceed to the next step.</p> <p>5.2 If screen foreign material/debris is found:</p> <p>5.2.1 While in the general care area screen, if the <u>debris is minor</u> and <u>does not</u> affect visibility, turn off the pump, remove the battery, and proceed to the next inspection step.</p> <p>5.2.2 Debris such as hair, long fibers, smears, or fingerprints <u>are not</u> acceptable.</p> <p>5.3 Replace or rework the Keypad as required.</p>

<p>Example of a Defective Dented/Scratched Keypad Display</p>
--	---

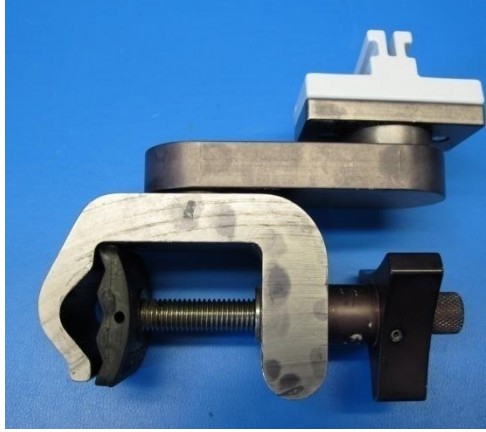
<p>7.1 Inspect the Double Rotating Pole Clamp for discoloration (fading/blotchy spots).</p> <p>7.2 Inform your supervisor or the Materials Manager if discoloration is found, replacement may be required.</p>

<p>Discoloration</p>
<p>7.3 Inspect the Pole Clamp Label for tears and legibility.</p> <p>7.4 Replace label if required.</p>

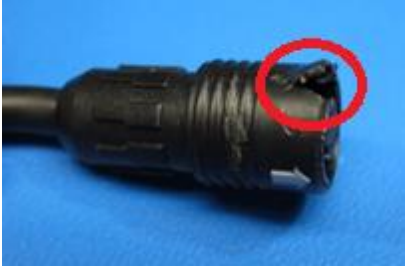
8.1 Discard/replace the AC Power Adapter if the following inspection criteria are not met.	
8.2 Ensure there are no breaks or cracks in the AC Power Adaptor collar and that it connects and disconnects to the rear case properly.

<p>Power Adaptor with damaged collar</p>
8.3 Verify the LED on the AC Power Adaptor Illuminates.

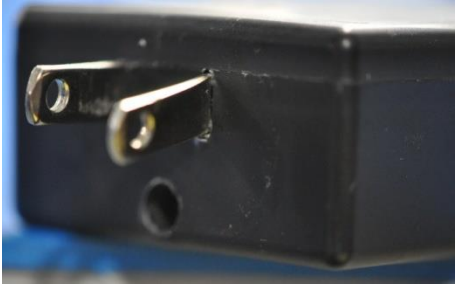
<p>Missing ground prong, bent power prong</p>

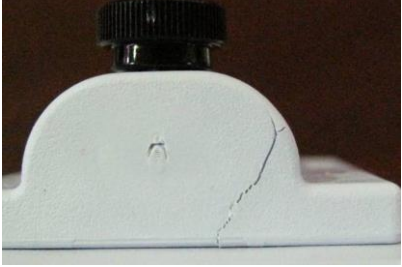
<p>Cracked pump side pole clamp adaptor</p>

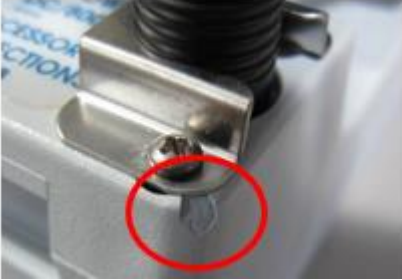
<p>Major case damage</p>

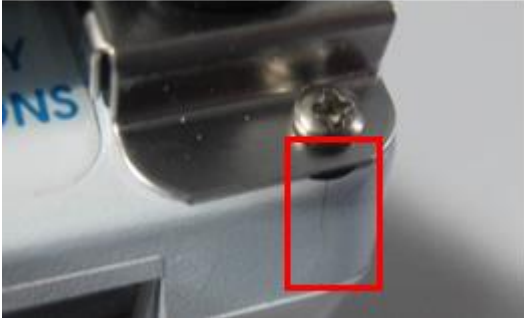
<p>Crack at case screw</p>

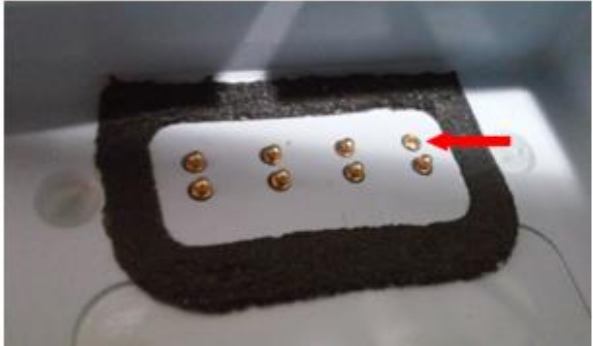
<p>9.15 Ensure the Battery Contact Pins are NOT compressed/Depressed or corroded.</p> <p>9.16 Replace or Rework the Rear Case as required.</p>

<p>Compressed Battery Contact pins</p>
<p>9.17 Consult your supervisor if the Rear case plastic has severe discoloration or markings, a replacement may be warranted.</p>

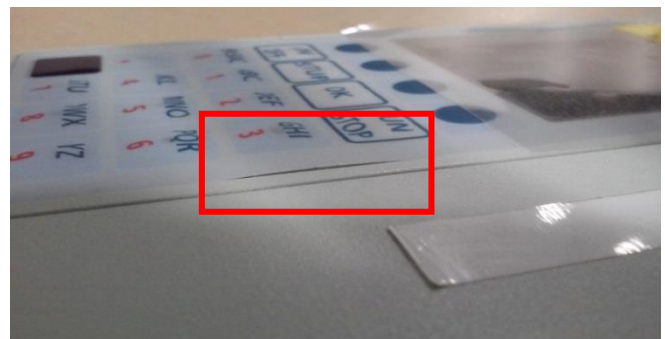
Lifted Keypad above the recess at Key 3 area (Reject)

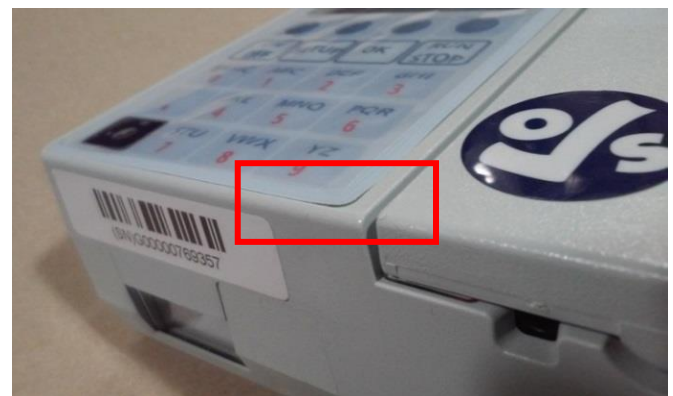
Lifted Keypad above the recess (Reject)

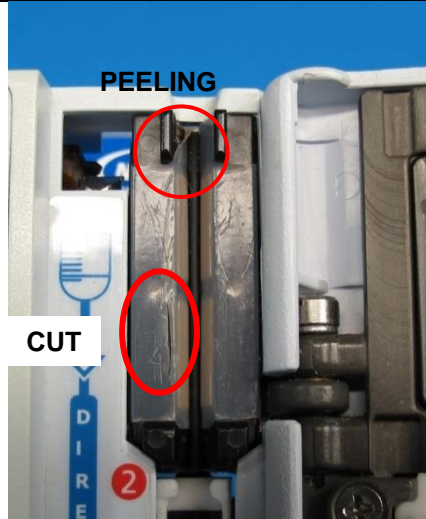
<p>11.1 Ensure the tape of the Ultrasonic Sensor is not torn, peeling or cut on the surface or corners.</p> <p>11.2 Replace the Ultrasonic if tears or cuts exist.</p>

<p>Damaged ultrasonic sensor tape</p>
--	--

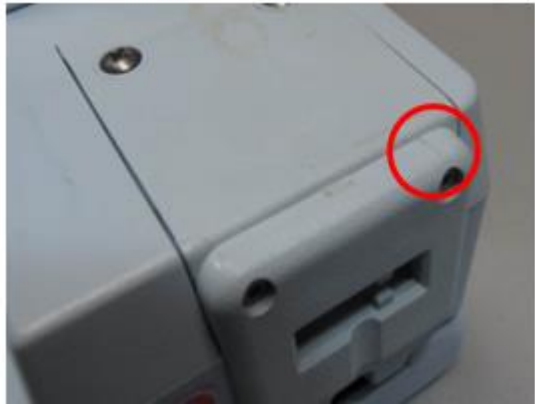
<p>13.1 Inspect the Keyhole Assembly for cracks in the plastics.</p> <p>13.2 Replace the Keyhole Assembly if cracks exist</p> <p>13.3 Ensure all screws are installed and seated properly.</p> <p>13.4 Replace the screws or Keyhole assembly as required.</p>

<p>Crack in Keyhole Assembly</p>
<p>13.5 Inspect the Keyhole Cup Label; ensure it is the latest Revision per DWG 35709.</p> <p>13.6 Replace the Keyhole Assembly if Label requires replacement.</p>	<div>

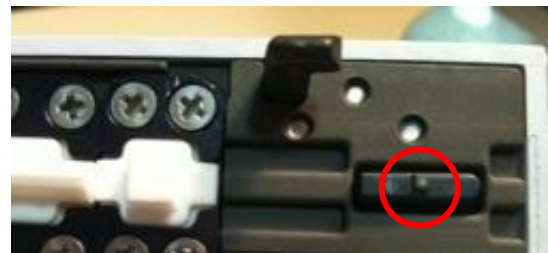
- 16.8 Inspect the Upstream and Downstream pushers by:
- 16.8.1 Ensuring they are in place and secure
 - 16.8.2 The screws securing the pushers shall NOT protrude above the pusher.
 - 16.8.3 Pusher should not have any abnormalities.
- 16.9 Replace one or both of the pushers if the above criteria are not met.

Dimpled downstream pusher

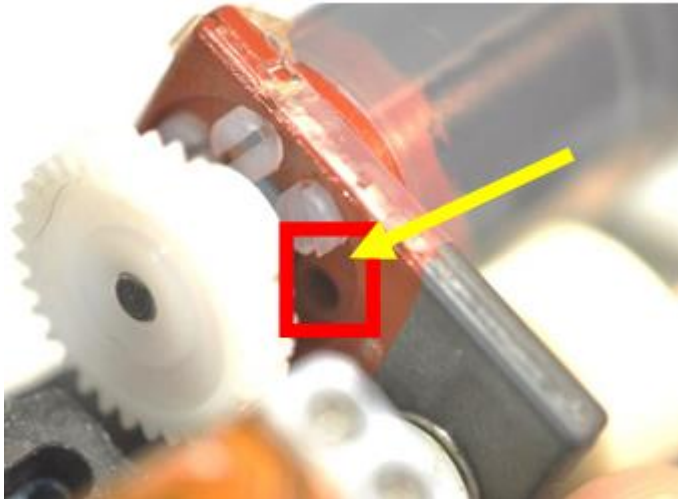
<p>Mechanism Hardware highlighted in blue</p>	
<p>17.6 Inspect the nylon cheesehead screws holding the motor to the Upper Bearing Mount. The nylon screws must be present and fully installed.</p> <p>17.6.1 Replace any missing or broken screws.</p>

<p>Example of broken/missing motor screw</p>

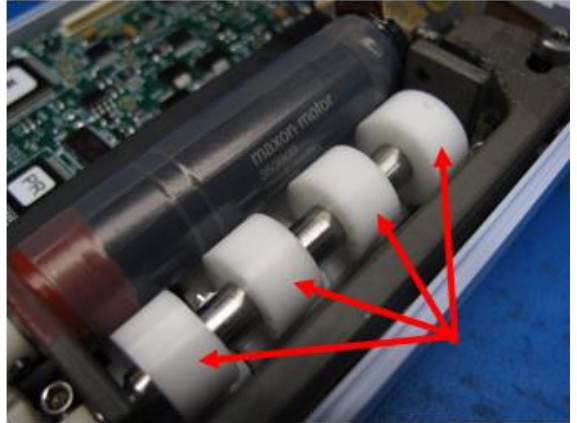
<p>Example: Grease must be applied to the following locations. Picture illustrates no grease is present.</p>

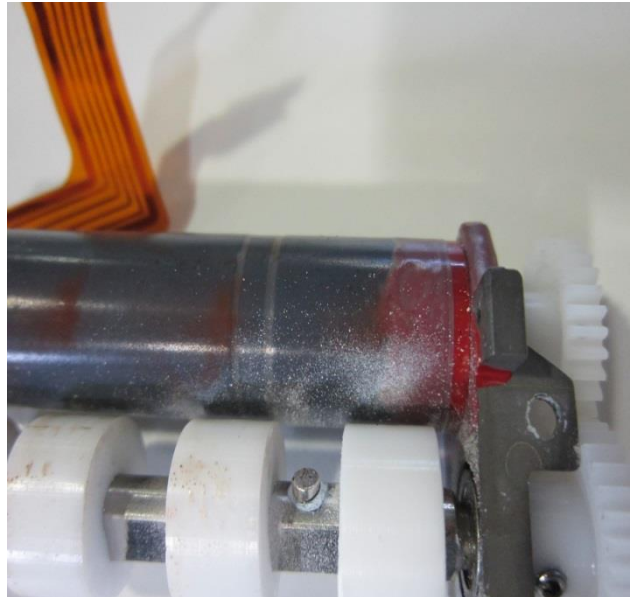
<p>17.11 Inspect the Cam Lobes for deterioration.</p> <p>17.11.1 White particulate from the Cam lobes is evidence of deterioration.</p> <p>17.11.2 Cracks are also unacceptable.</p> <p>17.12 Replace affected components as necessary.</p>

<p>Figure 56: Cam shaft with white particulate from cam lobes (Replace affected components).</p>
<p>17.13 Inspect the following flexes for tears, breaks and other damage.</p> <p>17.13.1 Upper Aux Flex</p> <p>17.13.2 Ultrasonic Flex</p> <p>17.13.3 Motor Flex</p> <p>17.13.4 Keypad Flex</p> <p>17.13.5 Lower Aux Flex</p> <p>17.13.6 Force Sensor Flex</p> <p>17.14 Replace any component with a damaged flex.</p>	
<p>17.15 Inspect the Color Sensor Bracket to ensure it is not:</p> <p>17.15.1 Bent</p> <p>17.15.1.1 Pressing on the gear.</p> <p>17.15.1.2 Interfering with keyhole installation..</p> <p>17.16 Replace the Upper Aux if the Color Sensor Bracket is bent or broken.</p>

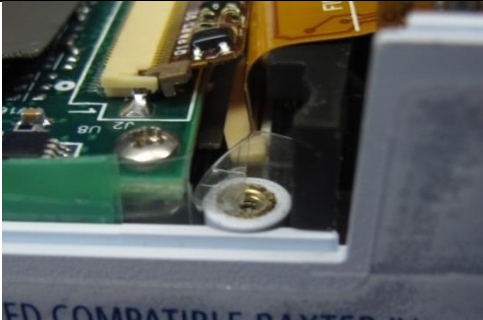
<p>Top of link highlighted blue</p>
<p>17.20 If present, inspect the ESD Barrier for:</p> <p>17.20.1 Cracks</p> <p>17.20.2 Breaks</p> <p>17.20.3 Crushed areas</p> <p>17.21 Replace if Cracks, Breaks or if the barrier is crushed.</p>

<p>Cracked ESD Barrier</p>

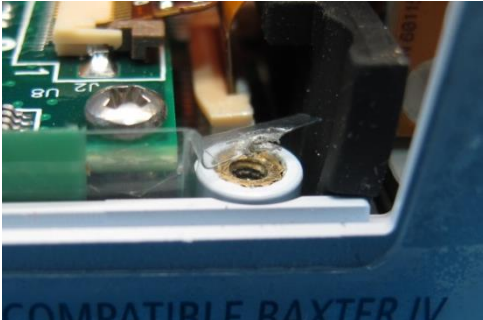
<p>Crushed ESD Barrier</p>

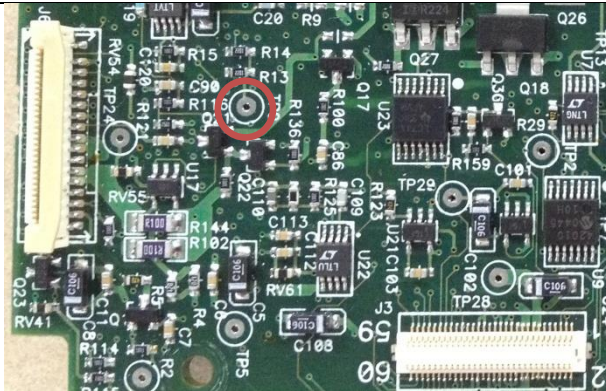
- 17.22 Inspect the I/O Board for Silver test points (TPx).
- 17.23 Replace the I/O Board if Silver test points exist.

I/O Board containing silver test points

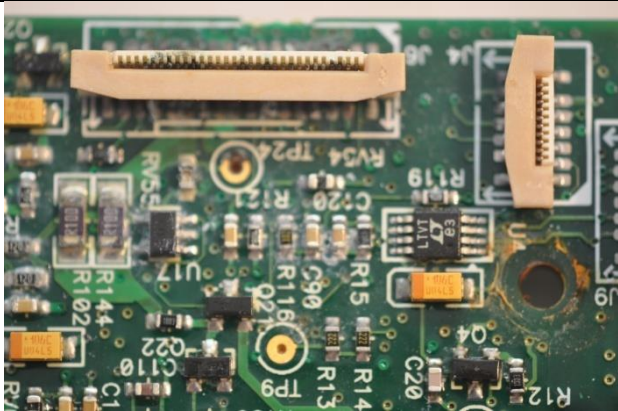
- 17.24 Inspect all visible areas for signs of water marks, corrosion.
- 17.25 If water marks, corrosion and/or residue exist, then remove the Processor Board and I/O Board from the Front case and inspect further.

I/O Board with corrosion

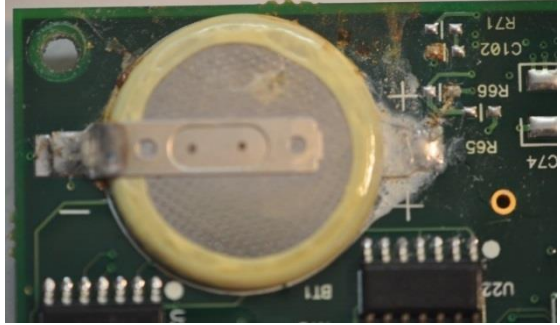
<p>18.1 Inspect the Processor Board for Shielding. Shielding dependent on Rev. of I/O Board. If revision of the I/O Board is at a revision level K or higher, ensure shielding material is installed to the I/O and Processor Boards.</p> <p>18.2 Install Shielding as required.</p>	
<p>18.3 Inspect the board for signs of fluid intrusion, water marks, corrosion and/or residue.</p> <p>18.4 Replace boards containing water marks, corrosion and/or residue.</p>

<p>Figure 64: Processor Board with corrosion</p>
<p>18.5 Inspect for broken, damaged or missing components.</p>

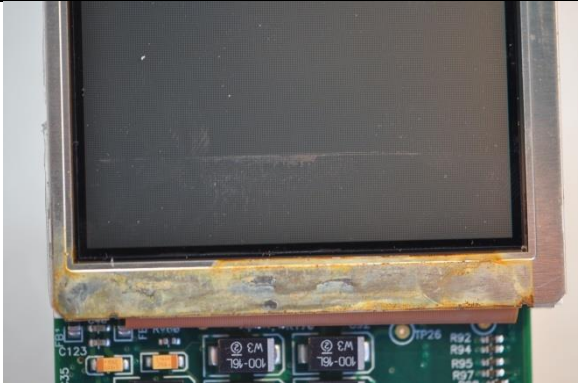
20.1 See POPULATED FRONT CASE INSPECTION for additional inspection criteria.	
20.2 Inspect the board for signs of fluid intrusion, water marks, corrosion and/or residue. 20.3 Replace board / Display containing water marks, corrosion and/or residue.

<p>Display with rust caused by fluid intrusion</p>
20.4 Inspect for broken, damaged or missing components.
