# Stanford Research Systems

## Troubleshooting RGAs

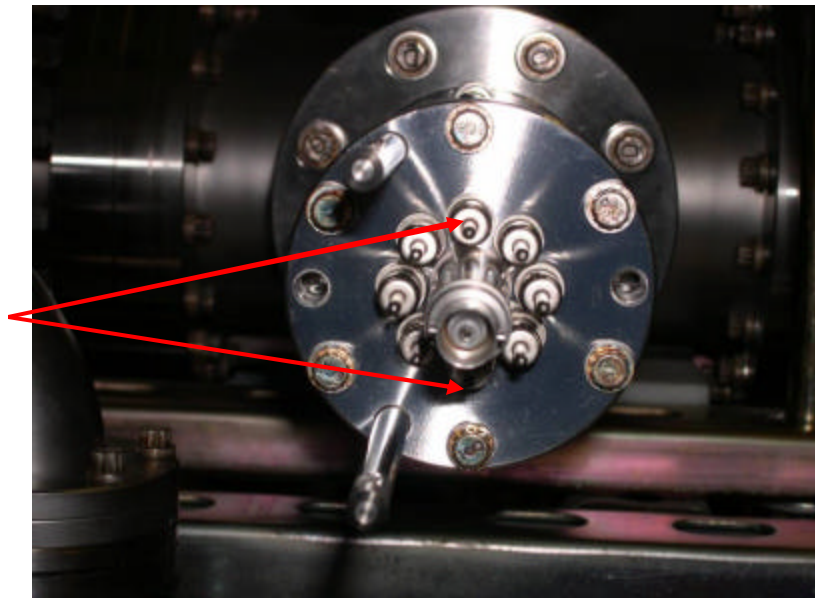
Filament Supply and  
Return

1. Check the total pressure in your chamber. It should be below  $1e-4$  Torr.
2. Next, in the RGA Windows software, go the Head Menu, and set everything back to defaults. Scan again. If this does not help, go to the next step.
3. The most likely problem is a burnt/broken/degraded filament. Even though you may not see the Error/Burnt/Leak LED light up, the filament may still be damaged.
  - a. Turn off power, and remove the ECU (electronics control unit)
  - b. You will see 8 feedthrough pins on the probe as shown in the manual.
  - c. Measure the impedance (DC resistance) across the filament supply and return pins. This should be less than one ohm. It should not be shorted, or an open circuit. If it is, the filament will need to be replaced.

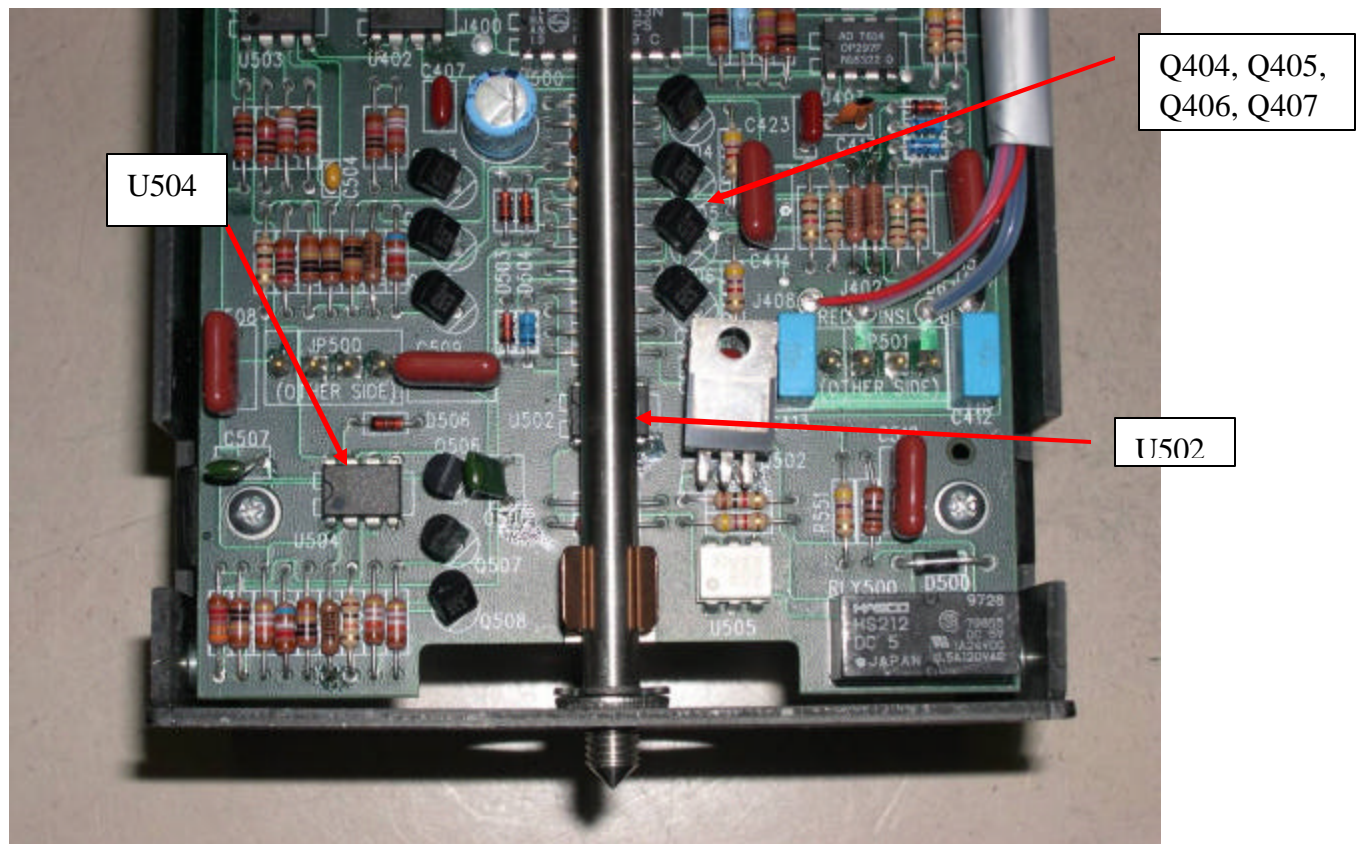
5. If everything is ok so far, then the next step is to check the ECU.
6. You will need to remove the bottom cover of the ECU.  
(Note: If the RGA has Option 02 Built in AC power module, then pull out this module by unscrewing it, but leave the DC power cable connected to the bottom board on the ECU.)
7. Reconnect the ECU to the probe.
8. Turn power on.
9. Use the RGA software to turn on the filament (of course, assuming that you still have the probe exposed to high vacuum), but do not scan.
10. Locate two jumpers marked on the bottom board – JP500 and JP501. Each jumper has 4 pins.
11. Measure the DC voltage on each of the 8 pins w.r.t. ground (use analog ground or chassis as ground).

Expected Voltage	Problem and resolution
Pin 1	-90 VDC	U504 which controls the bias for the focus plate is bad, and will need to be replaced. Part # LM358 (SRS part# 3-508)
Pin 2	0	No connection
Pin 3	0	No connection
Pin 4	-57 VDC	Filament Return Voltage. Contact SRS for repairs

Expected Voltage	
Pin 1	-56.5 VDC	Filament Supply. Contact SRS for repairs
Pin 2	< +2 VDC	+DC Supply for Quadrupole rods. Q404 (MPSA92, SRS Part# 3-627) and Q405 (MPSA42, SRS part# 3-628) need to be replaced.
Pin 3	12 VDC	Anode Grid Voltage. U502 (LM358, SRS part# 3-508) needs to be replaced
Pin 4	> -2 VDC	-DC Supply for Quadrupole rods. Q406 (MPSA92, SRS Part# 3-

627) and Q407 (MPSA42, SRS part# 3-628) need to be replaced.
