# CompactLogix Controllers, Revision 16

Catalog Numbers 1768-L43, 1768-L45

This revision of the firmware release notes, 1768-RN016I, provides updated information specific to firmware revision 16.24 for the CompactLogix controllers.

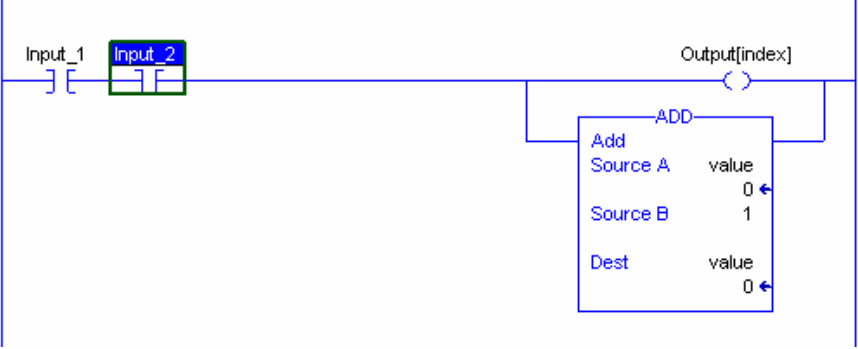
Firmware Revision	Description
16.24	<p>Fault handlers can be defined at the controller and program scope levels. These fault handlers are typically used to handle major recoverable faults that can occur during runtime execution of an application due to programming errors. A typical example of this would be handling indirect addressing that has gone out of range; MyTag[index], where index is larger than the size of the array.</p> <p>Faults can also be handled by the controller during pre-scan of the controller program on the transition to Run mode. Again, for example, the handling of indirect addressing that has gone out of range.</p> <p>There is an anomaly when these methods attempt to handle a fault.</p> <p>These are the possible ways the anomaly can manifest itself:</p> <ul style="list-style-type: none"> <li>• The controller will experience a major non-recoverable fault. I/O goes to their configured safe state, and the user application is cleared from memory. At this point, a Code 1 Type 60 or 61 major recoverable fault will be logged in the controller. This requires you to redownload the application.</li> <li>• Tag data corruption.</li> <li>• Online saving or uploading failures.</li> <li>• Anomalous program execution.</li> </ul> <p>For example, if a rung is being scanned false and there is an instruction that has false execution, the fault handler executes so the remainder of the rung will scan true. In the example below, the OTE instruction has an index out of range. After returning from the fault handler, the ADD instruction will execute, even though the rung input conditions are false.</p>
